Re: Rio Penasco Draw Remediation Project
Section 25, T18S-R25E SW/NE
Eddy County, New Mexico

Yates Petroleum Corporation
Rio Penasco Draw Reclamation Plan
Section 25, T18S-R25E
Eddy County, New Mexico
January 27, 2012

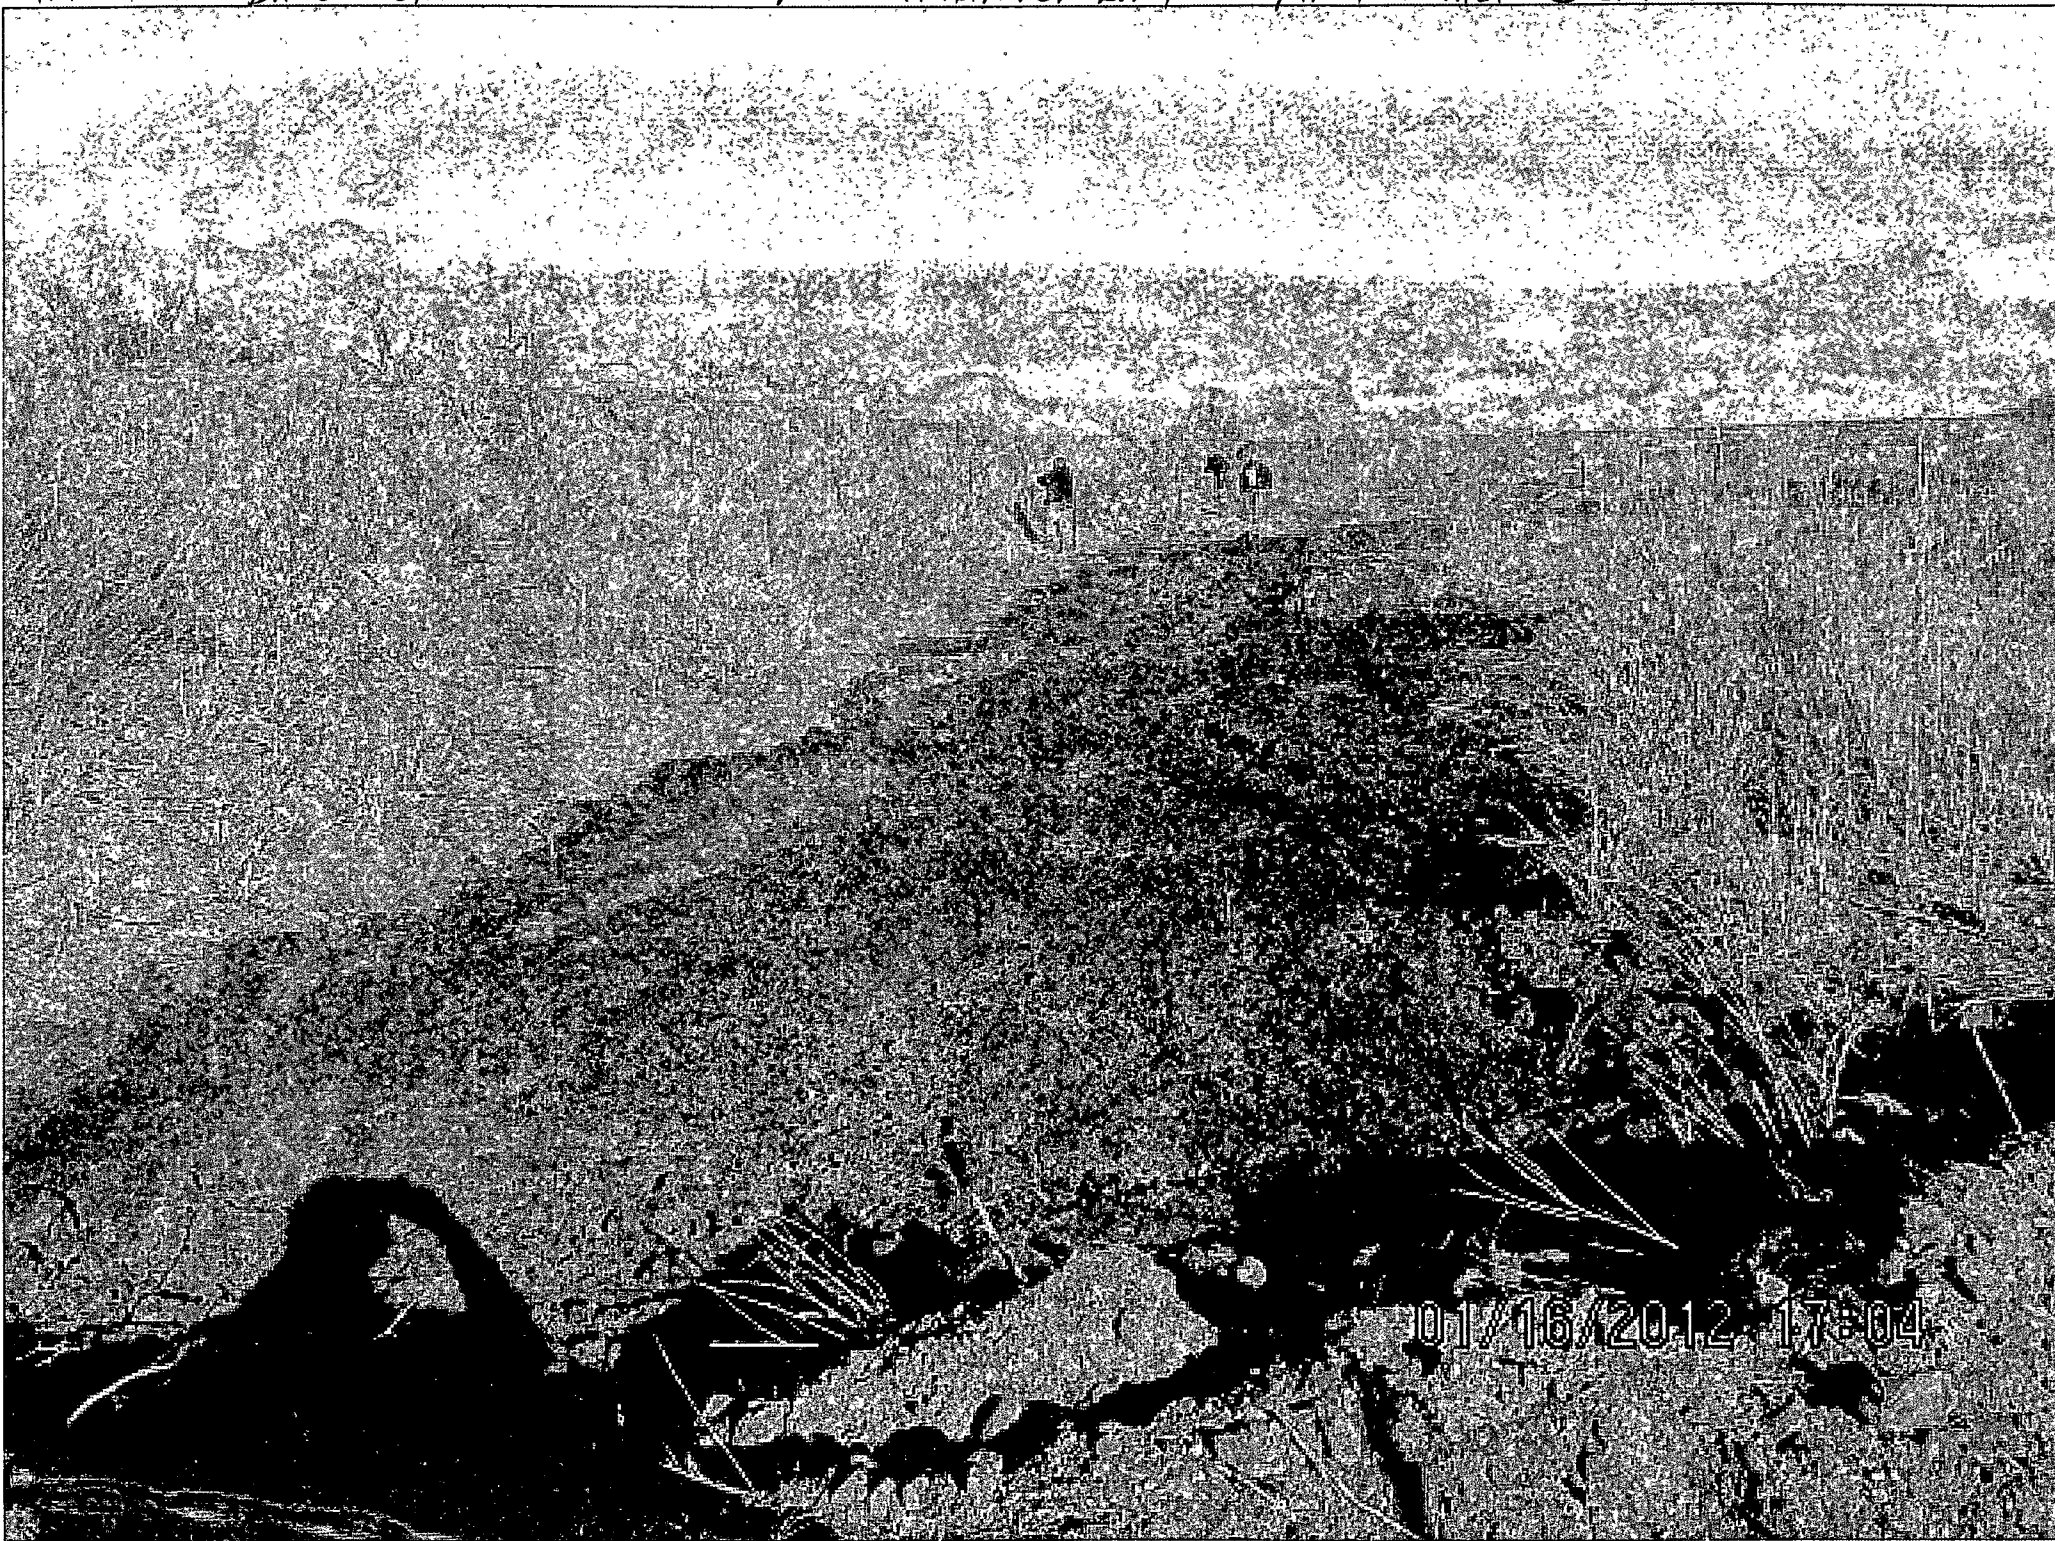
VATES PET DAGGER DRAW WATER LINE NEAR HORNBAKER STRY FIRST INITIAL CLEAN UP
