## Randy Federal Water Transfer Station

## Closure Report

**RE: TERMINATION REQUEST**

**Apache – Randy Federal Water Transfer Station AD**

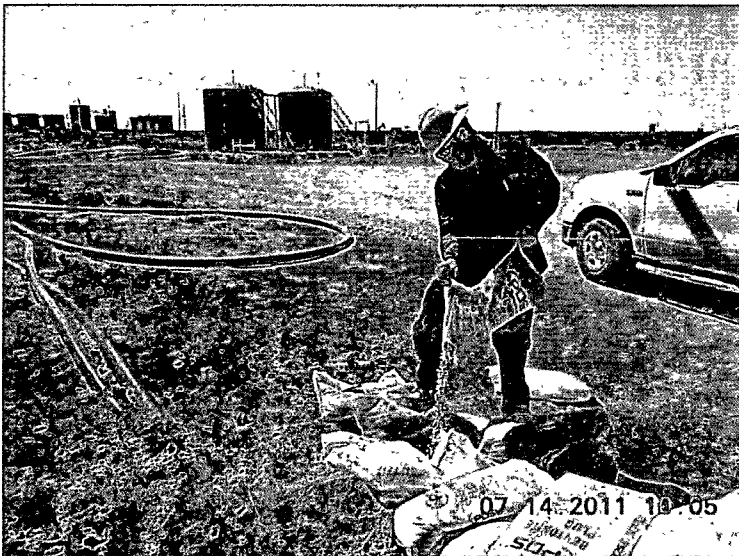
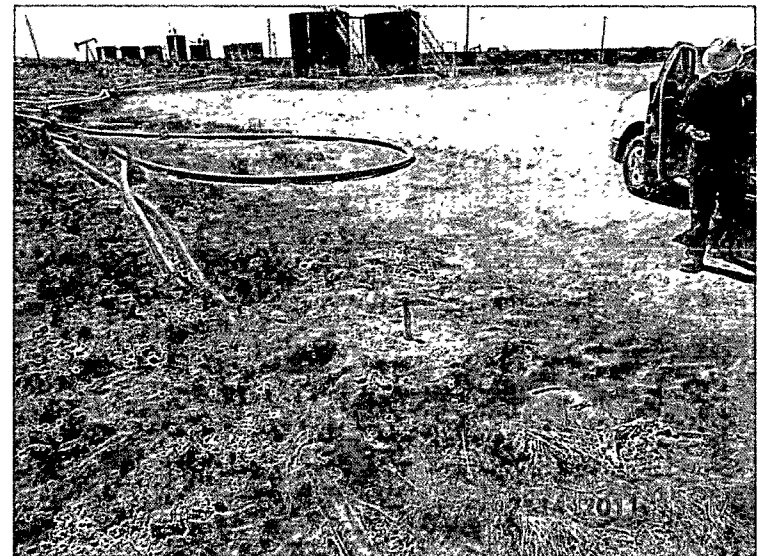
Plugging MW with bentonite, facing SE 7/14/2011

Temp MW plugged and staked, facing SE 7/14/2011

personnel removed the monitoring well casing and plugged the borehole to ground surface with bentonite (Appendix B).

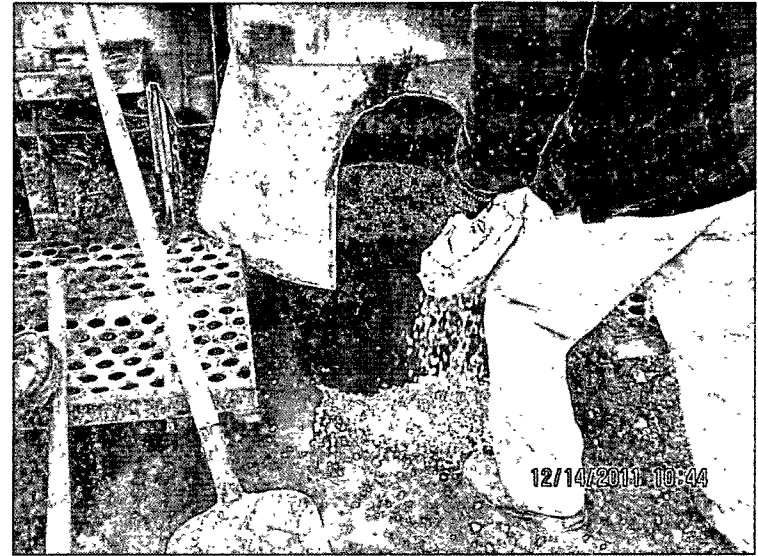
Plugging SB1 in total with bentonite

Plugging SB2 in total with bentonite

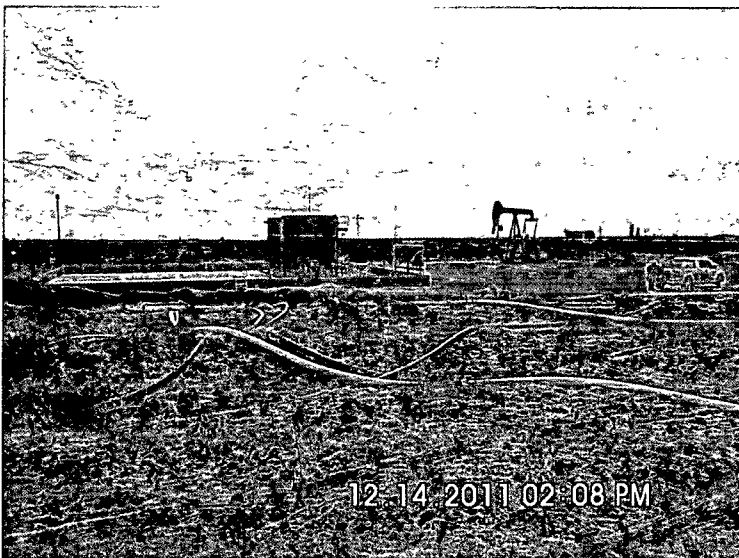
Sampling in north spray area, facing south 12/14/2011

North overspray area, facing south 12/14/2011

Point samples were also collected at surface and 6 inches bgs within the leak overspray area north of the caliche pad, among the concentration of surface flow lines (Figure 4). The samples were field tested for chloride, and headspace measurements were taken in the field using a PID. Field chloride and headspace measurements were low, and the samples were submitted to a laboratory for chloride and TPH (GRO/DRO) analyses (Appendix D). Chloride was low and TPH was non-detect in all samples.
