From: Hansen, Edward J., EMNRD
Sent: Thursday, April 19, 2012 11:12 AM
To: 'Hack Conder'
Cc: Leking, Geoffrey R, EMNRD; 'Katie Jones'; 'Laura Pena'; 'Scott Curtis'
Subject: Remediation Plan (1R425-08) Termination - ROC Vacuum Jct J-26-2 Site

RE: Termination Request
Vacuum Jct. J-26-2 (1R425-08): UL/J, Sec. 26, T17S, R35E
RICE Operating Company – Vacuum SWD System

**RICE OPERATING COMPANY
JUNCTION BOX FINAL REPORT**

Vacuum jct. J-26-2

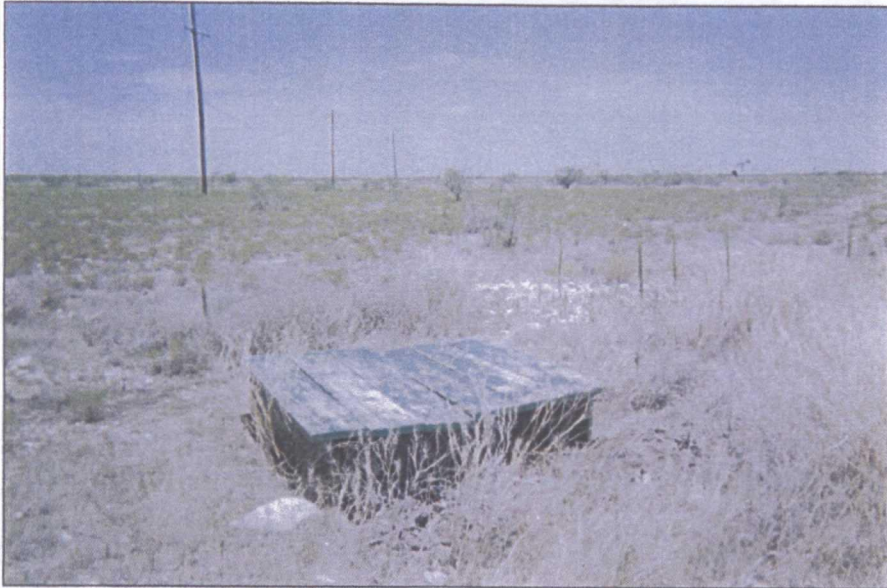
7/1/2005

undisturbed junction box

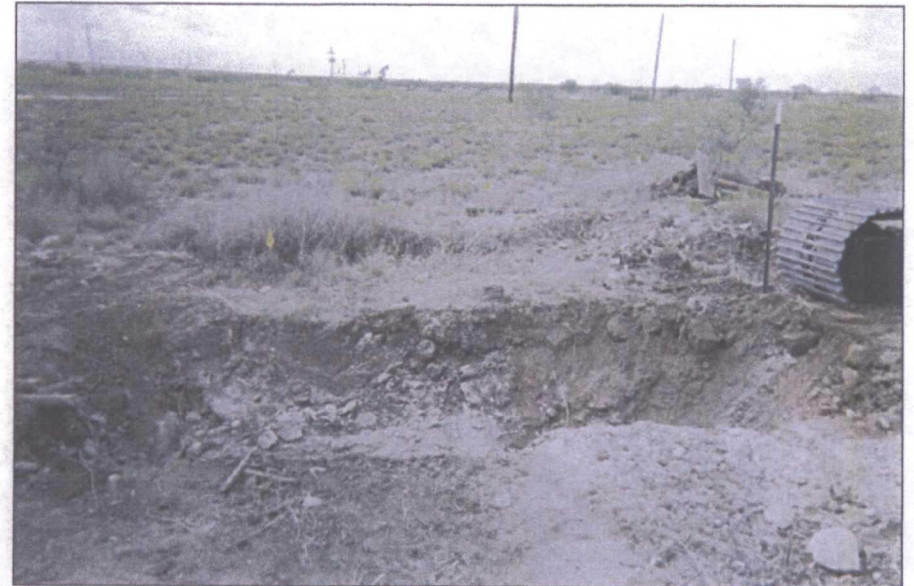
8/4/2005

delineation trench at former junction site

as part of the Vacuum SWD System abandonment. After the box was removed, a delineation

trench was made at the former junction site using a backhoe while soil samples were collected every ft of depth from 1 to 7 ft BGS. Chloride field

tests yielded low concentrations and exhibited a conclusive trend of decline with depth. The soil samples did not exhibit any physical indications of

hydrocarbon or chloride impact and PID screenings were also very low. A grab sample from 7 ft BGS was analyzed at a laboratory for confirmation of

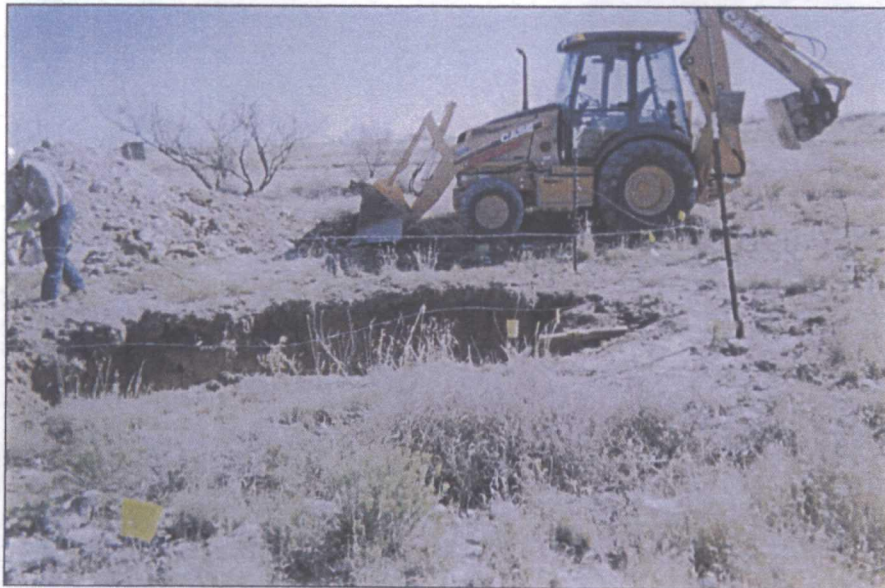
11/21/2005

backfilling trench

field tests. TPH concentrations were not present within the lab's detection limits (<10.0 ppm), meeting NMOC guidelines. The excavated soil was

blended on site and then backfilled into the trench and contoured to the surrounding surface. The disturbed surface was seeded with a blend of native

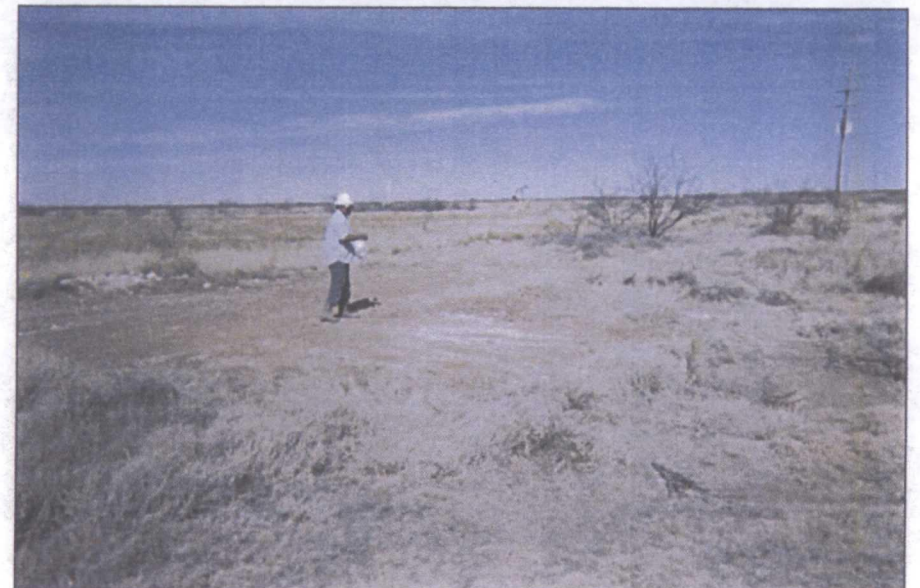
11/23/2005

seeding backfilled site

vegetation and is expected to return to productive capacity at a normal rate. Since the Vacuum SWD System is no longer active, a new junction box is
