From: Hansen, Edward J., EMNRD
Sent: Monday, April 23, 2012 1:30 PM
To: 'Hack Conder'
Cc: Leking, Geoffrey R, EMNRD; 'Katie Jones'; 'Laura Pena'; 'Scott Curtis'
Subject: Remediation Plan (1R425-25) Termination - ROC Vacuum Vent K-33 Site

RE: Termination Request
Vacuum vent K-33 (1R425-25): UL/K, Sec. 33, T17S, R35E
RICE Operating Company – Vacuum SWD System

**RICE OPERATING COMPANY
JUNCTION BOX FINAL REPORT**

Vacuum K-33 vent

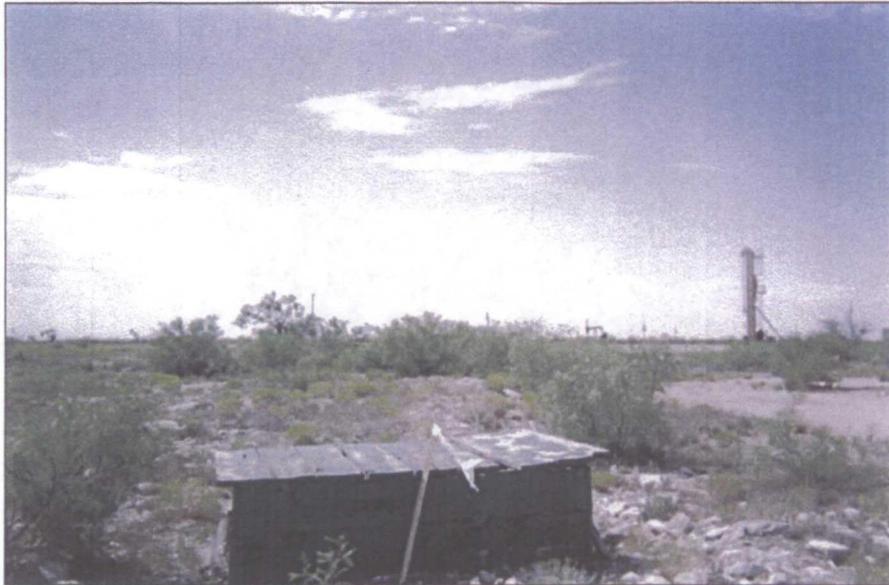
6/30/2005

undisturbed junction box

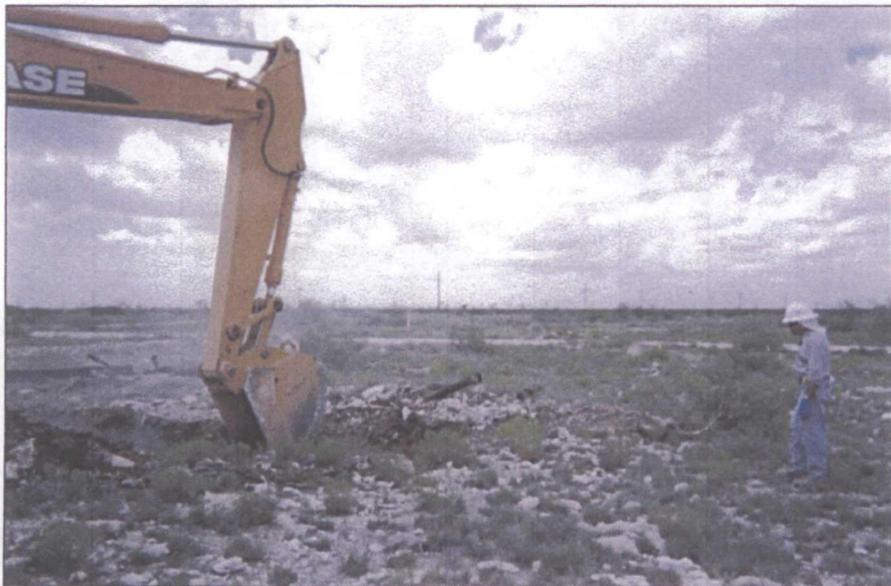
8/12/2005

delineation trench at former box site

part of the Vacuum SWD System Abandonment. After removing the box materials, a delineation trench was made using a backhoe while soil samples were collected at regular intervals to 7 ft BGS. Chloride field tests were conducted on each soil sample and exhibited low concentrations similar to background level. PID screenings were also performed on the samples and were also very low. A grab sample at 7 ft BGS was analyzed at a laboratory for confirmation of field tests. NMOCD TPH guidelines were met. The excavated soil was blended on site and then backfilled into the trench and contoured to the surrounding terrain. The disturbed surface was seeded with a blend of native vegetation and is expected to return to productive capacity at a normal rate.

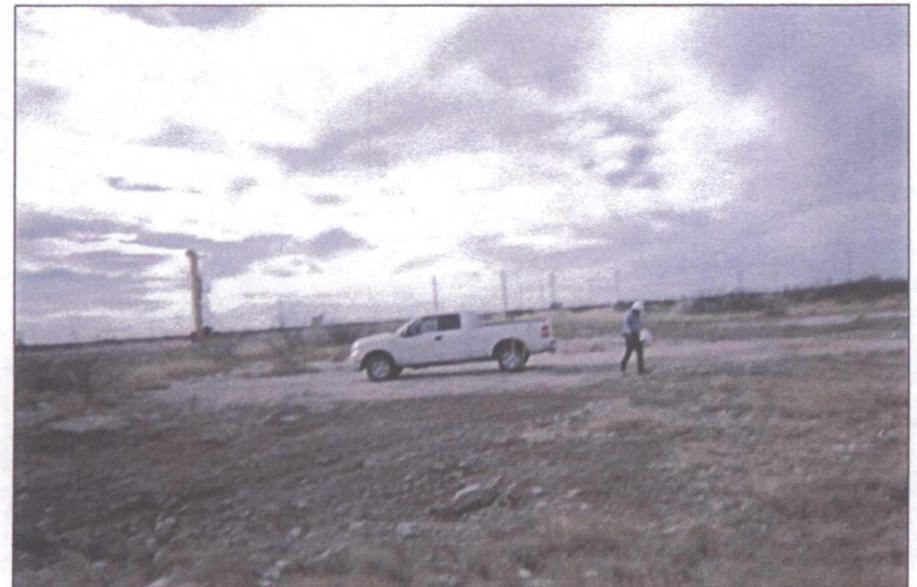
12/23/2005

seeding backfilled site
