**RE: ICP Report and Termination Request  
for the Rice Operating Company's  
EME D-3 Site  
Unit Letter D, Section 3, T20S, R37E, NMPM, Lea County, New Mexico  
Remediation Plan (1R427-86) Termination**

**RE: ICP Report and Termination Request  
Rice Operating Company – EME SWD System  
EME D-3 (1R427-86): UL/D sec. 3 T20S R37E**

## ***EME D-3***

Legals: UL/D sec. 3  
T-20-S R-37-E  
LEA COUNTY, NM  
NMOCD Case#: 1R427-86

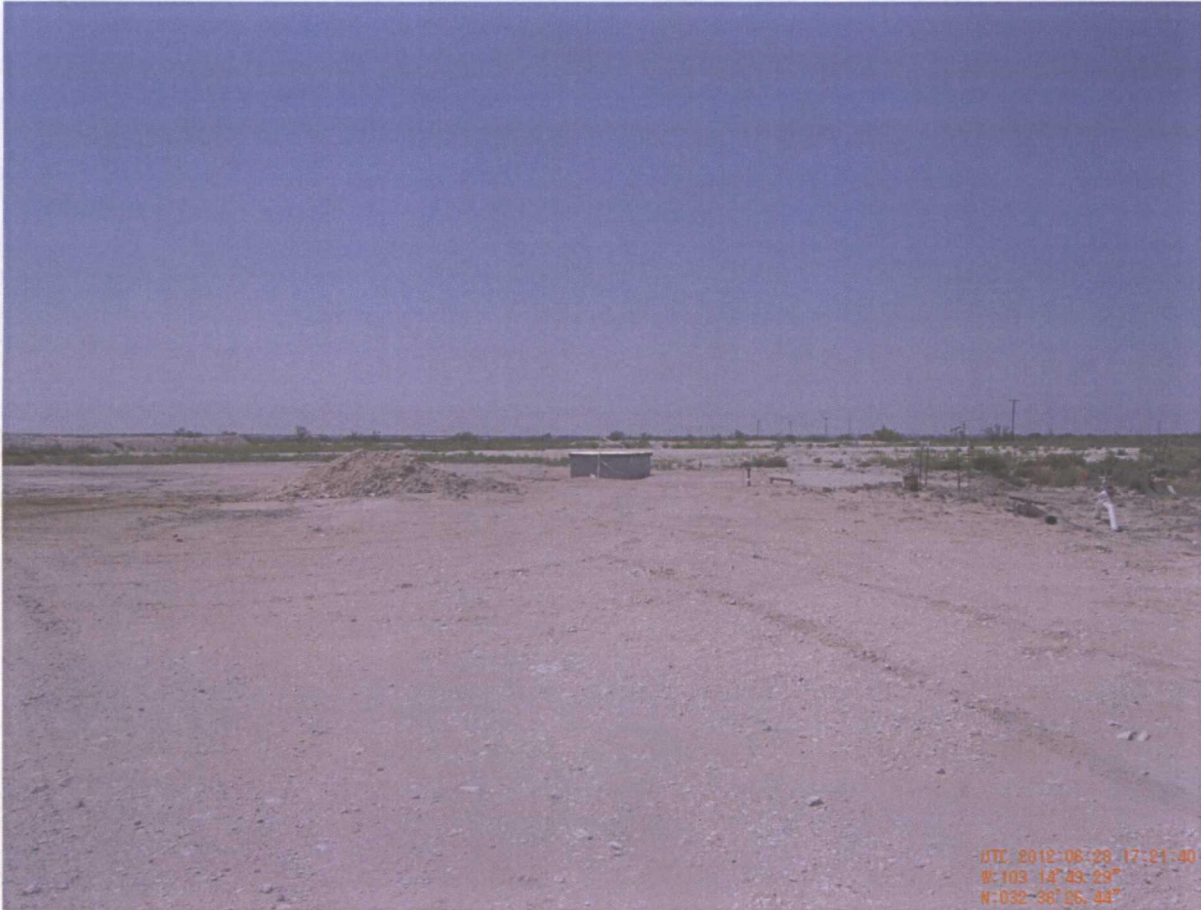
Site Photo

Site Location Photo, facing south

Based on the soil bore information, it is evident that the residual chlorides in the vadose zone are so low that they will in no way contribute to the degradation of groundwater beneath the site. In addition, the 20 ft x 20 ft compacted clay layer will also inhibit the downward migration of residual chlorides to groundwater. Finally, the site is located within an active land farm, so re-vegetation of the site is not warranted (Appendix B). Therefore, ROC requests 'remediation termination' status of the regulatory file.
