EME I-7 EOL  
2011

**RICE OPERATING COMPANY  
JUNCTION BOX DISCLOSURE\* REPORT**

# EME I-7 EOL

Unit I, Section 7, T19S, R37E

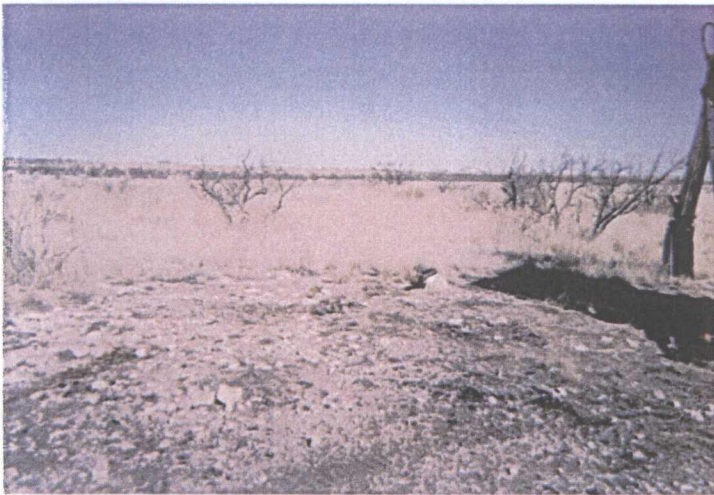
Site prior to excavation, facing north 2.15.11

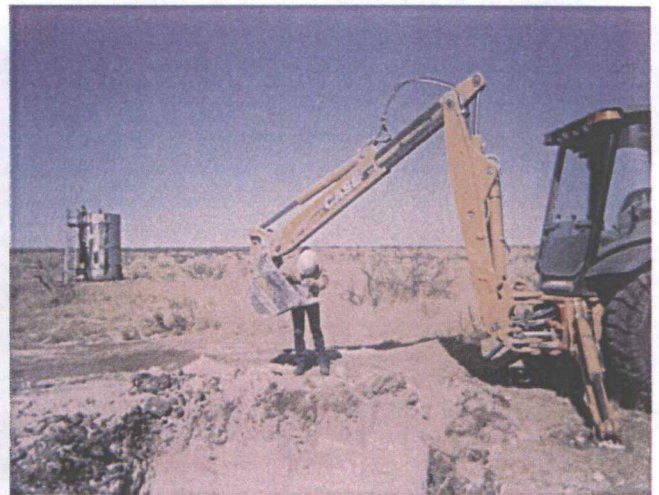
Collecting sample, facing northwest 3.23.11

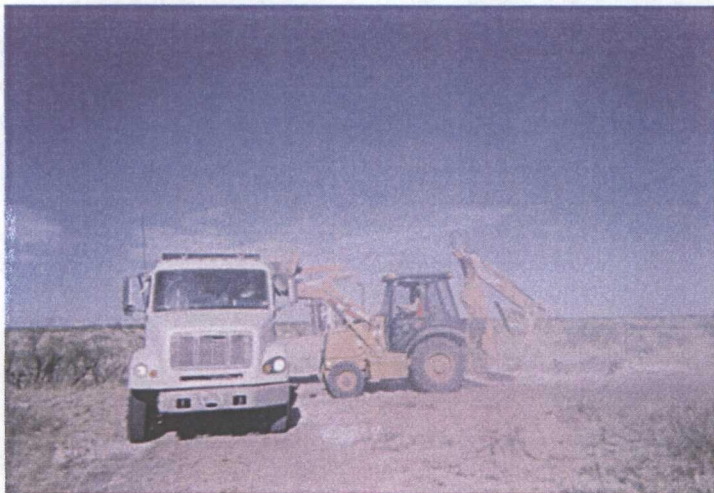
Exporting soil, facing east 4.5.11

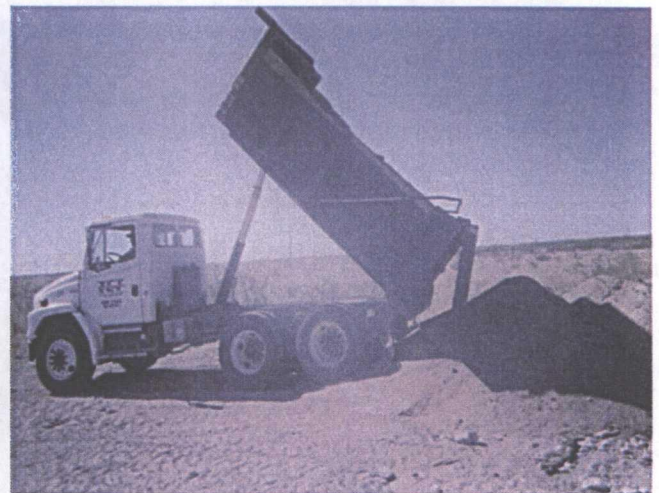
Importing blow sand, facing east 4.8.11

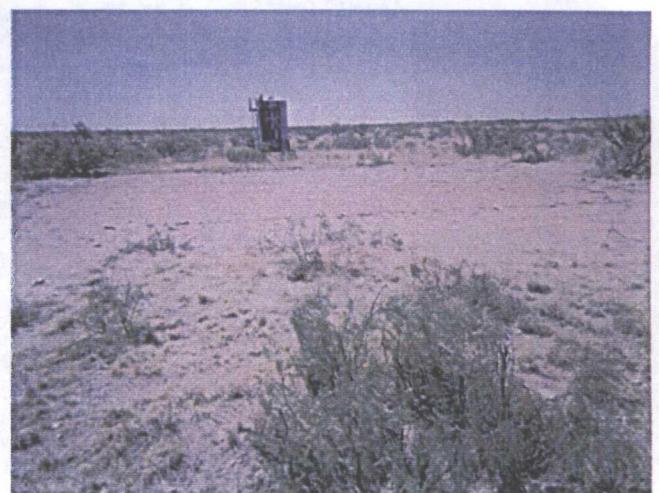
Site completed, facing west 5.12.11
