**RICE OPERATING COMPANY  
JUNCTION BOX DISCLOSURE\* REPORT**

SWD SYSTEM	JUNCTION	UNIT	SECTION	TOWNSHIP	RANGE	COUNTY	BOX DIMENSIONS - FEET		
Eunice Monument Eumont (EME)	P-18 EOL	P	18	19S	37E	Lea	Length	Width	Depth
							Eliminated

# EME P-18 EOL

Unit P, Section 18, T19S, R37E

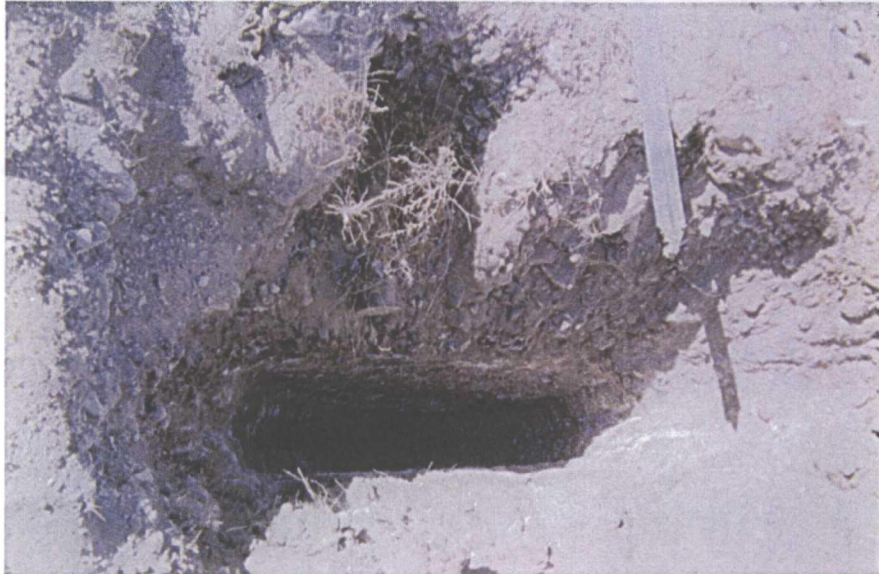
1.26.11

Excavating site

**General Description of Remedial Action:** This junction box and line were eliminated during the pipeline replacement/upgrade program. After the former junction box was removed, an investigation was conducted using a backhoe to collect soil samples at regular intervals producing a 10x10x12 ft deep excavation. Chloride field tests were performed on soil samples which yielded low chloride. Organic vapors were measured using a PID which yielded elevated concentrations. The excavated soil was blended on site and representative composite samples were collected from the excavation walls, the excavation bottom, and the blended backfill. The samples were sent to a commercial laboratory for analysis of chloride and TPH. Sample analysis showed elevated levels of TPH. The excavation was backfilled with the blended soil to ground surface and contoured to the surrounding area. On 3/2/2012, the site was seeded with a blend of native vegetation and is expected to return to a productive capacity at a normal rate. NMOCD was notified of potential groundwater impact on 3/13/2012.

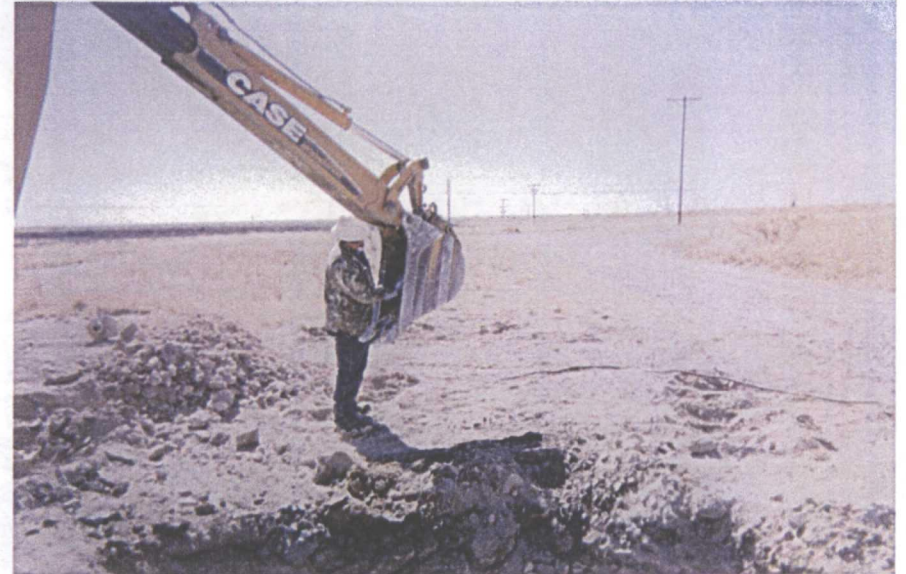
2.14.11

Collecting sample

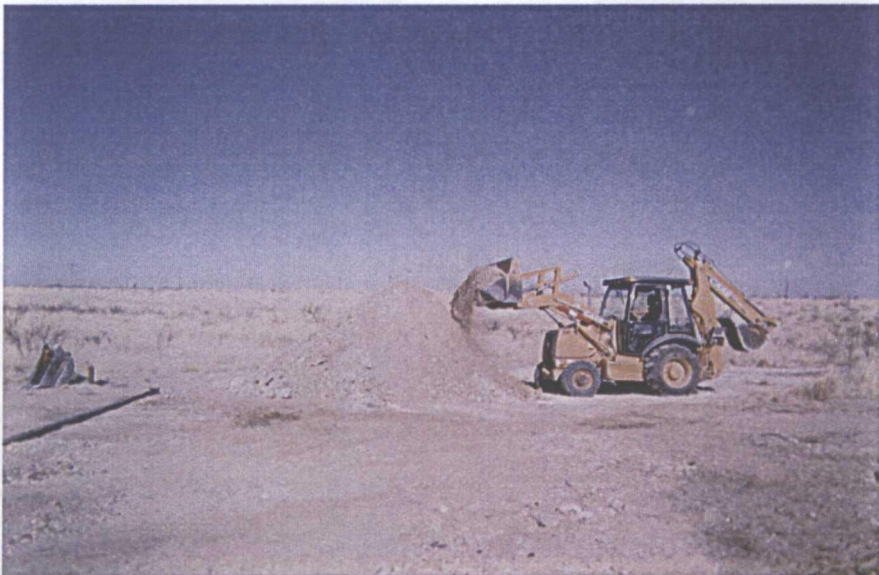
2.14.11

Blending backfill

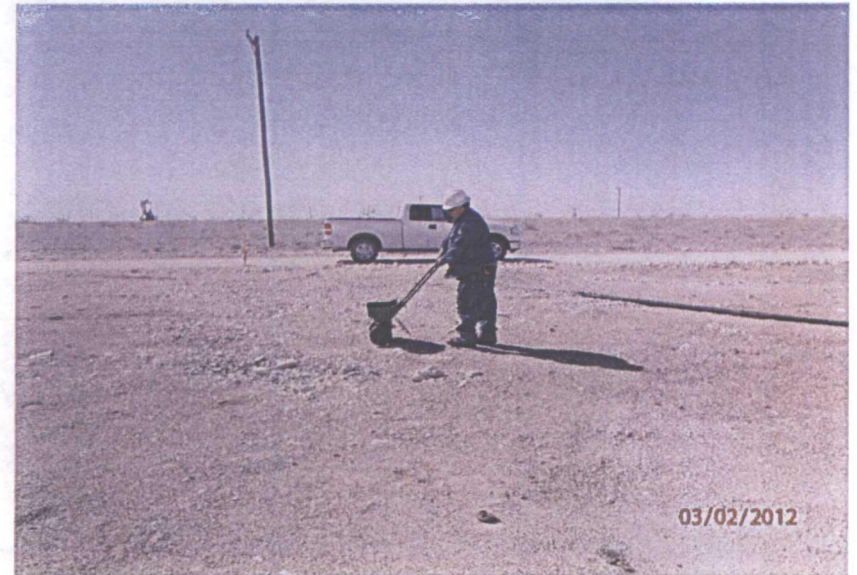
3.2.12

Seeding site

Custom seed mix <input checked="" type="checkbox"/>	Prescribed mix <input type="checkbox"/>	Seed mix name: 2 lbs blue grama	Seedingdate: 3-2-11
Broadcast <input checked="" type="checkbox"/>			
Method: Portable seeder			
Soil conditions during seeding: Dry <input checked="" type="checkbox"/> Damp <input type="checkbox"/> Wet <input type="checkbox"/>			
Photos attached <input checked="" type="checkbox"/>	Observations:		
Number of photos:

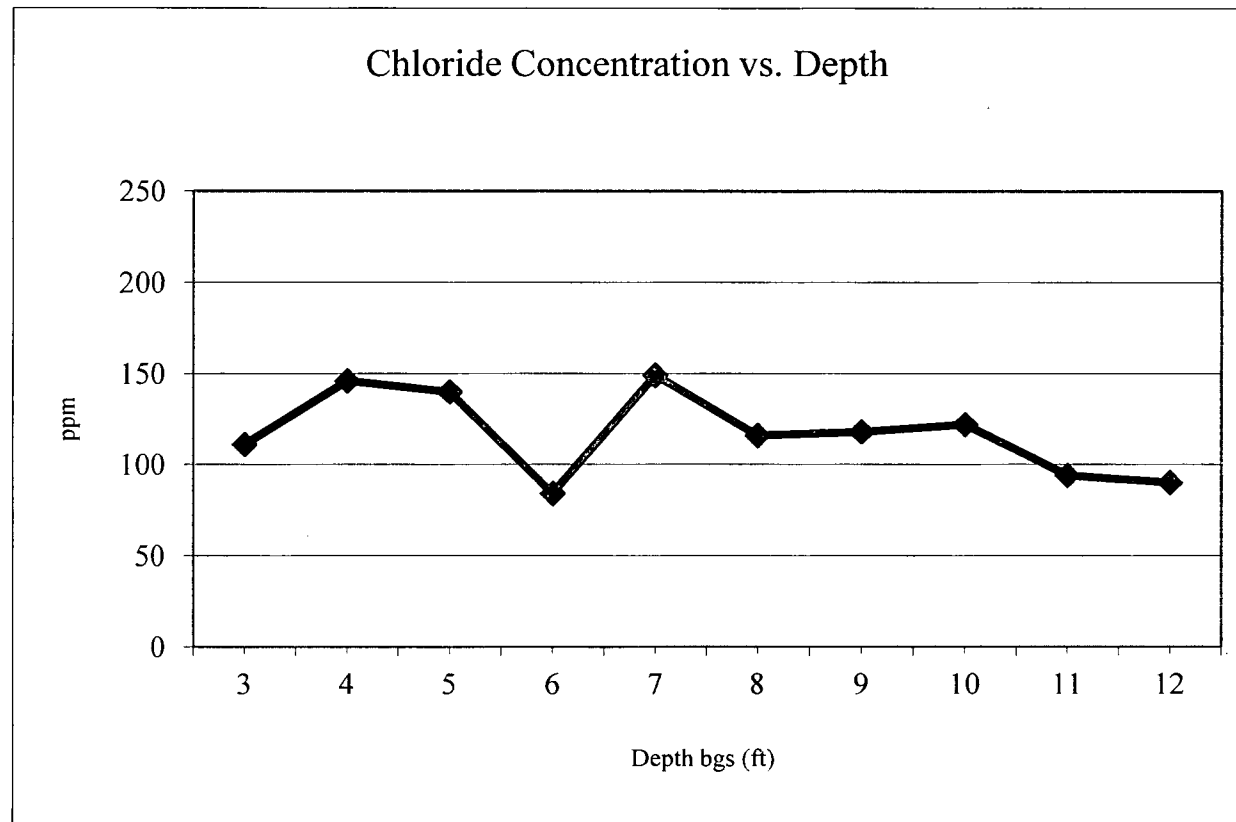
**EME P-18 EOL**

*Backhoe samples at junction (source)*

Depth bgs (ft)	[Cl <sup>-</sup> ] ppm
3	111
4	146
5	140
6	84
7	149
8	116
9	118
10	122
11	94
12	90

Groundwater = 35 ft

CHLORIDE FIELD TESTS		
LOCATION	DEPTH	mg/kg
background	6"	148
4-WALL Comp	n/a	148
Bottom Comp	12'	148
Blended Backfill	n/a	151
Vertical delineation trench at the former junction (source)	3'	111
	4'	146
	5'	140
	6'	84
	7'	149
	8'	116
	9'	118
	10'	122
	11'	94
	12'	90
