RE: Termination Request
EME K-19 EOL: UL/K, Sec. 19, T19S, R37E
RICE Operating Company – Eunice Monument Eumont SWD System

EME K-19 EOL

Unit K, Section 19, T19S, R37E

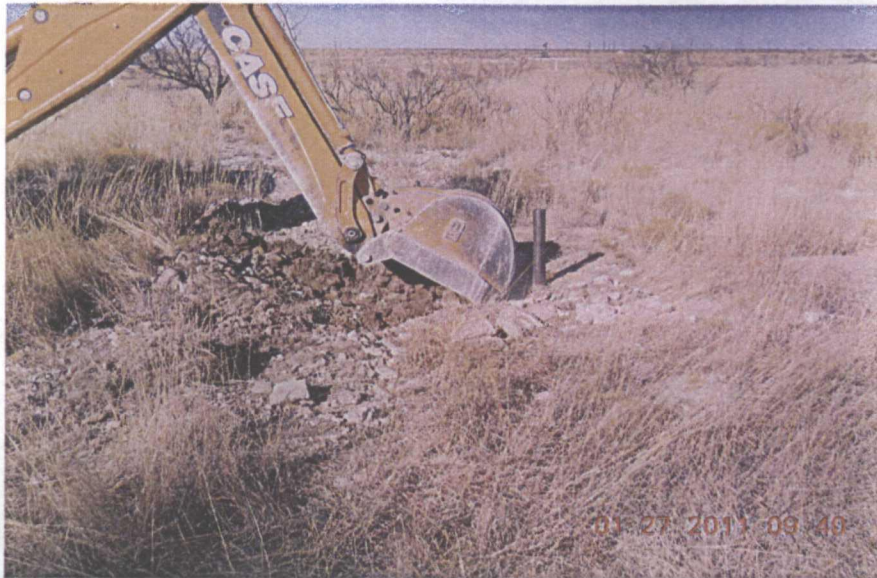
1/27/2011

Collecting sample

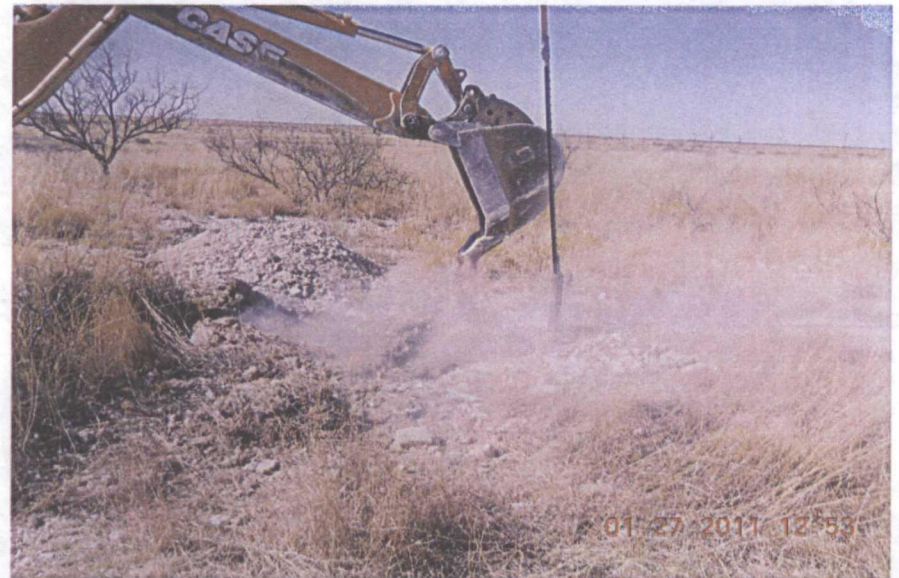
1/27/2011

Backfilling site

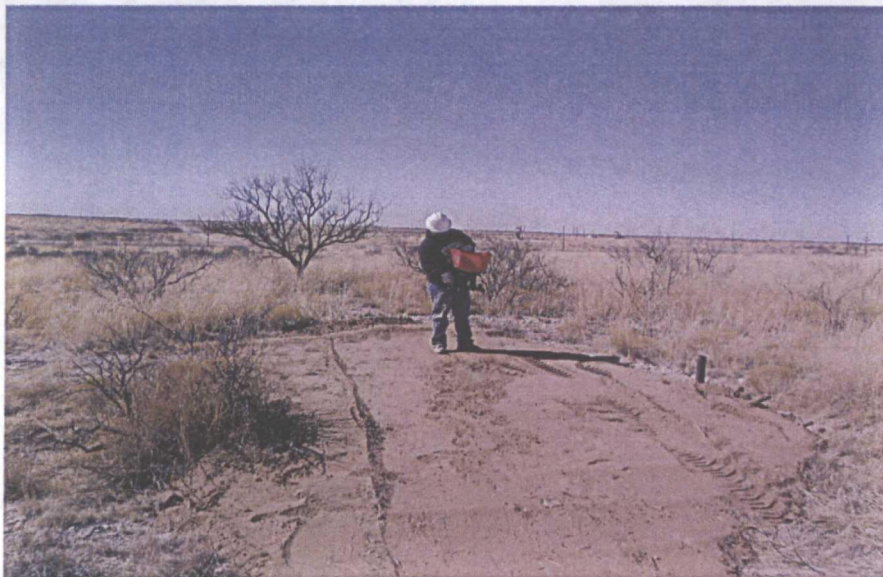
2/11/2011

Seeding site

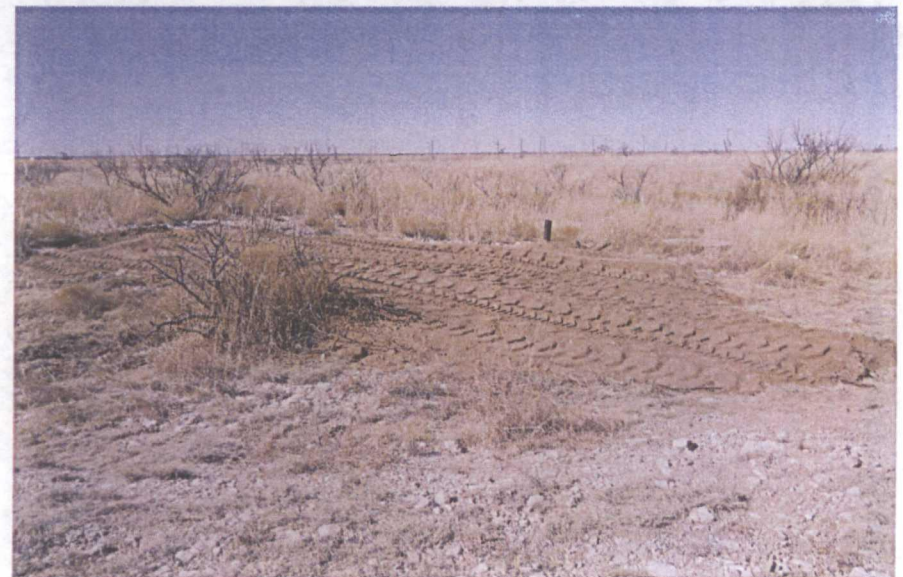
2/11/2011

Site complete
