**RICE OPERATING COMPANY
JUNCTION BOX DISCLOSURE* REPORT**

BD Jct. A-2

Unit A, Section 2, T23S, R37E

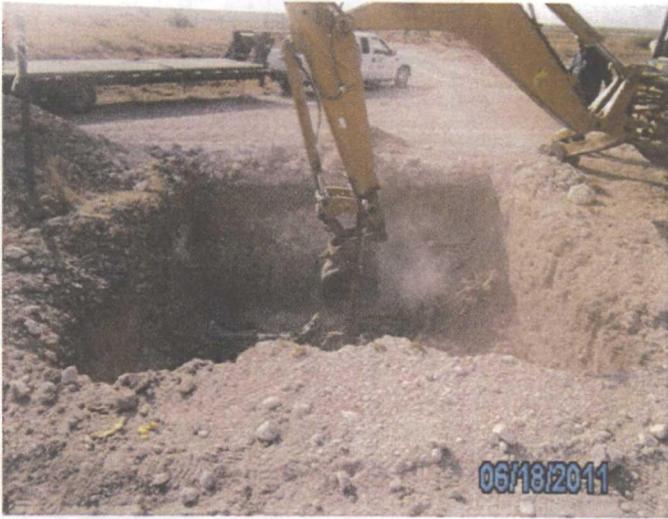
Digging source, facing east 6.18.11

General Description of Remedial Action: An investigation was conducted using a

backhoe to collect soil samples at regular intervals producing a 10x10x12-ft excavation.

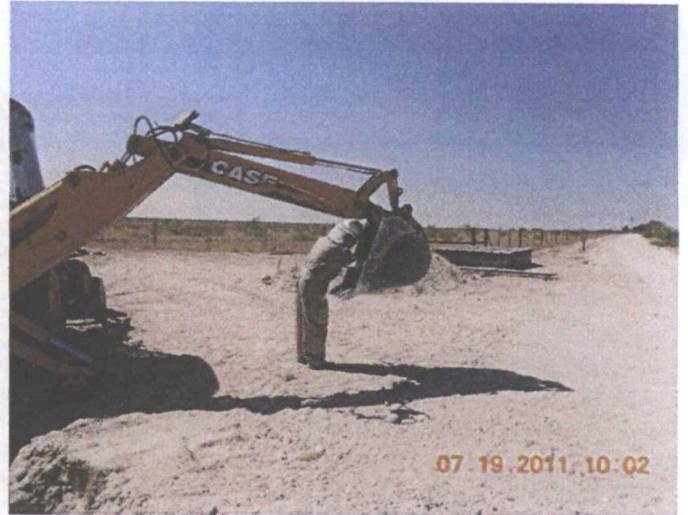
Collecting sample, facing south 7.19.11

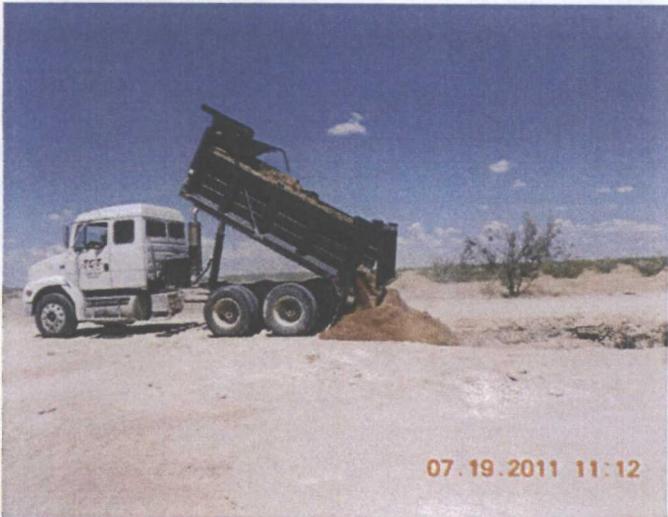
Importing backfill soil, facing north 7.19.11

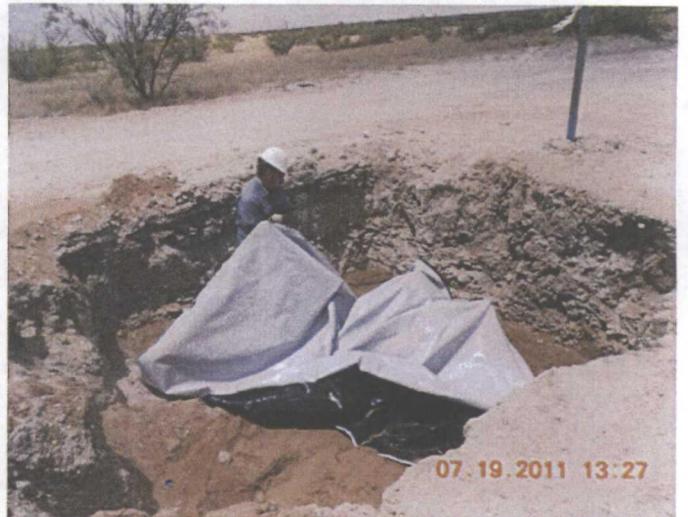
Installing liner, facing northwest 7.19.11

4-ft BGS. On 7/19/2011, a 20-mil reinforced liner was installed at 4-ft BGS and the excavation was backfilled with the remaining imported soil to

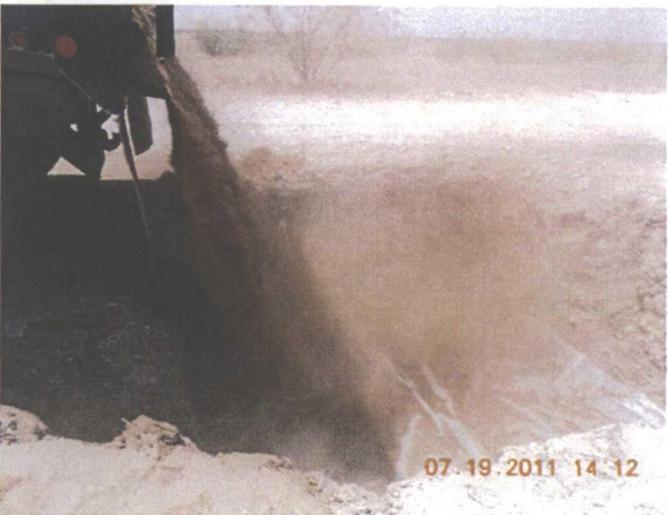
Backfilling site above liner, facing west 7.19.11

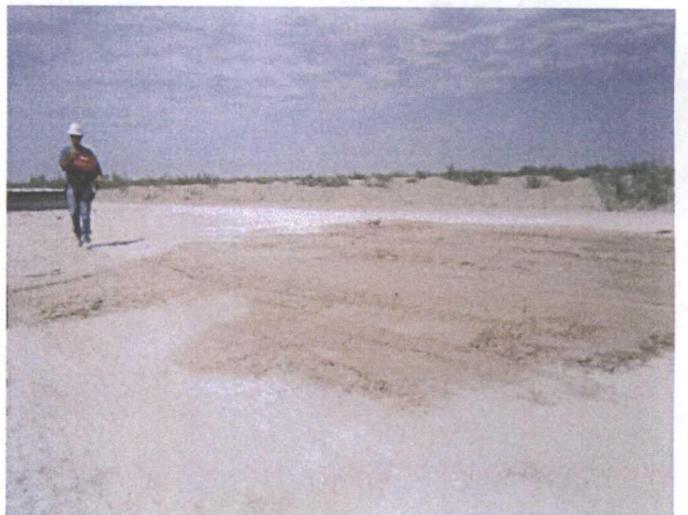
Seeding site, facing west 7.20.11

ground surface and contoured to the surrounding area. On 7/20/2011, the site was seeded with a blend of native vegetation and is expected

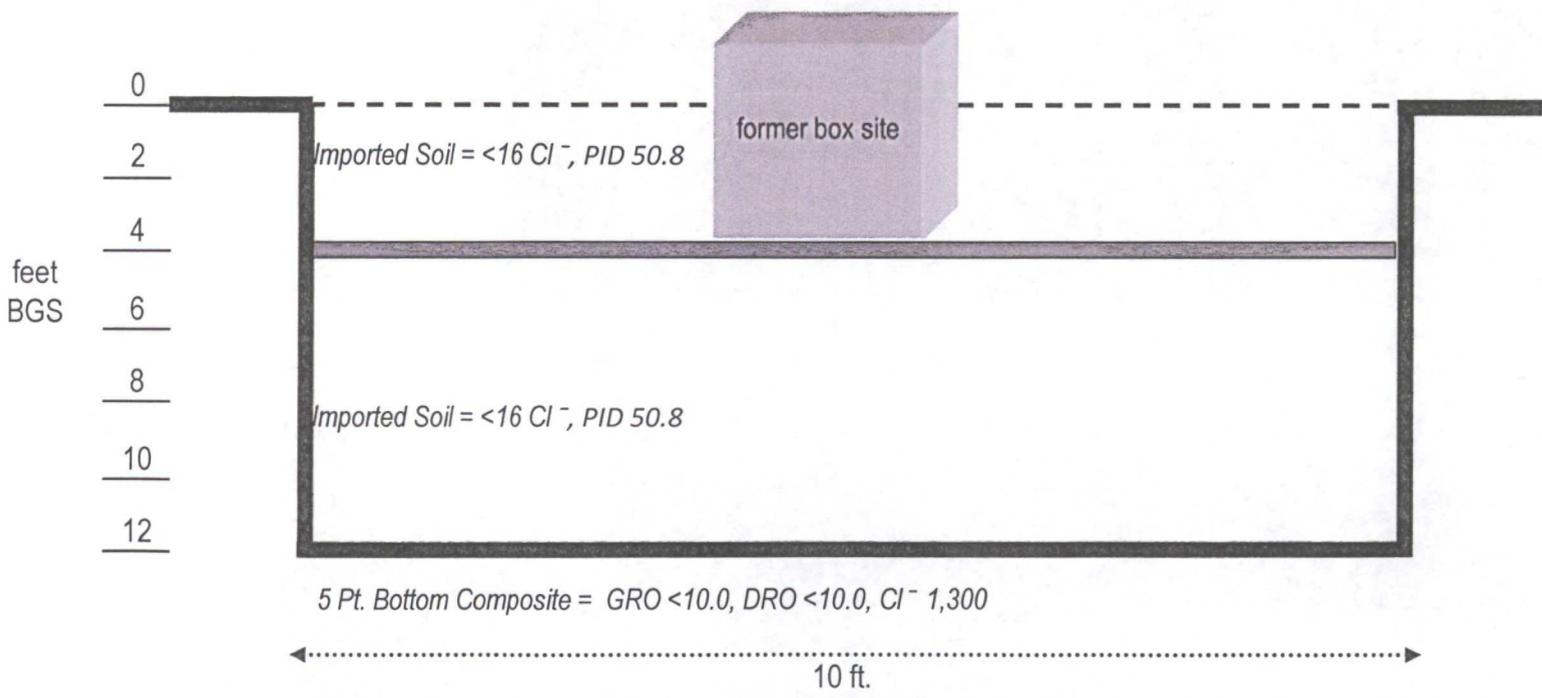
Excavation Cross-Section

Excavation Boundary

20-mil Reinforced Liner

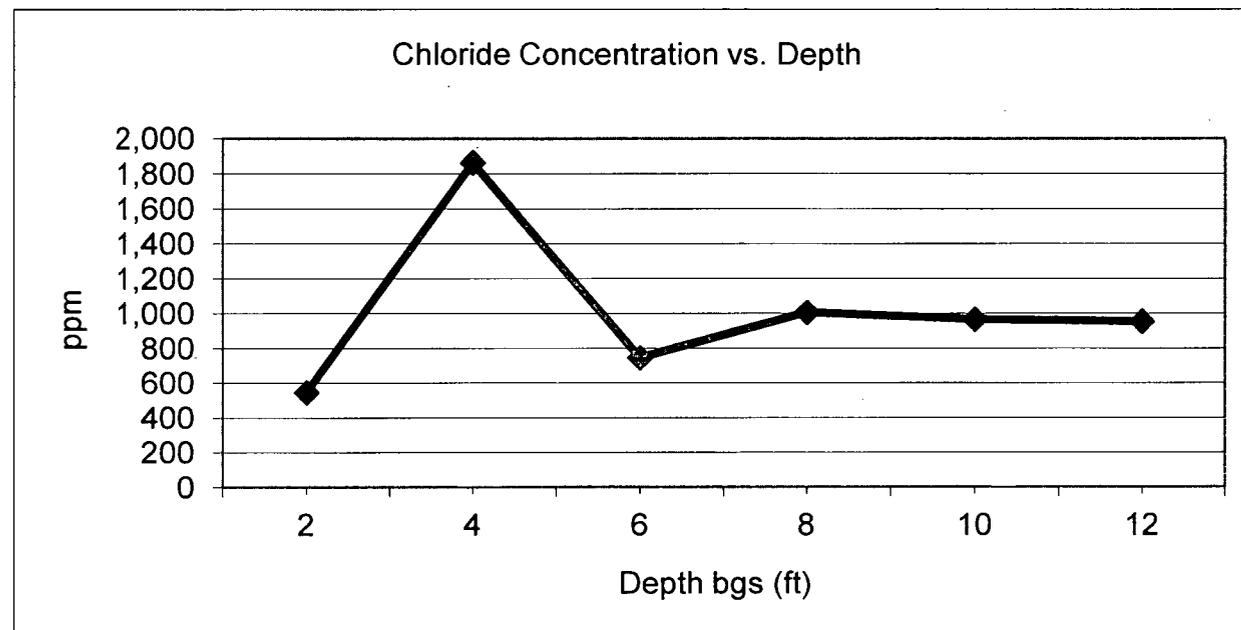
Backhoe samples at 5 ft North of the junction (source)

Depth bgs (ft)	[Cl ⁻] ppm
2	546
4	1,863
6	745
8	1,006
10	966
12	954

Groundwater = 57 ft
