**RICE OPERATING COMPANY
JUNCTION BOX DISCLOSURE* REPORT**

SWD SYSTEM	JUNCTION	UNIT	SECTION	TOWNSHIP	RANGE	COUNTY	BOX DIMENSIONS - FEET		
Blinebry-Drinkard (BD)	Jct. H-11	H	11	23S	37E	Lea	Length	Width	Depth
							Eliminated

BD Jct. H-11

Unit H, Section 11, T23S, R37E

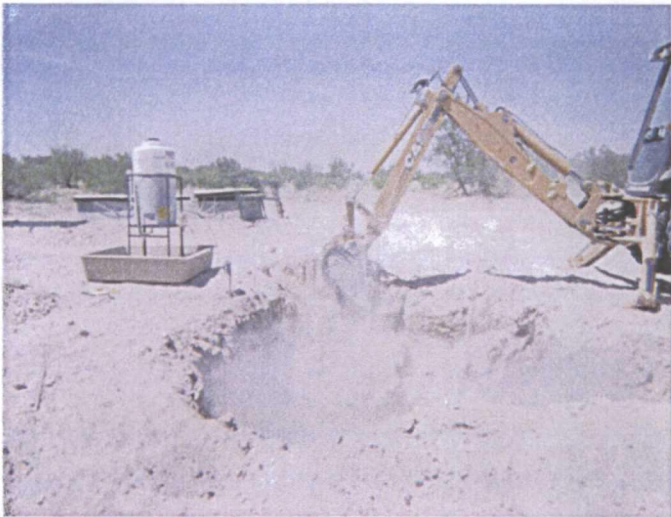
4.19.11

Digging vertical, facing north

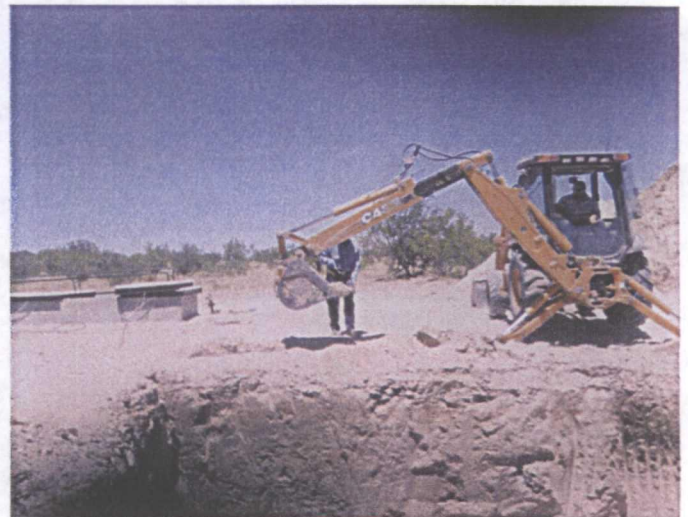
4.27.11

Collecting sample, facing north

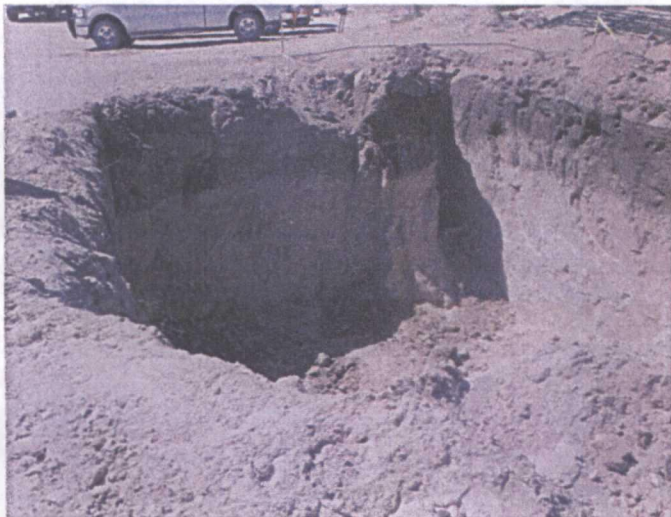
4.28.11

Final excavation, facing west

General Description of Remedial Action: This junction box was eliminated during the pipeline replacement/upgrade program. After the former junction box was removed, an investigation was conducted using a backhoe to collect soil samples at regular intervals producing a 25x20x12 ft deep excavation. Chloride field tests performed on each sample resulted in concentrations that did not relent with depth. Organic vapors were measured using a PID which yielded relatively low concentrations. The excavated soil was blended on site, and representative composite composite samples of the excavation bottom, the excavation walls, and the blended backfill were sent to a commercial laboratory for analysis of chloride and TPH. A total of 348 yards of blended backfill was transported to a NMOCD approved disposal facility. The remaining backfill was blended on site with clean imported soil. A representative composite sample of the blended backfill with imported soil was sent to a commercial laboratory for analysis of chloride and TPH. A 5 ft. deep shelf was excavated extending 5 ft out from the east wall to prepare the excavation for a 20-mil reinforced liner. On 6/3/2011, a 20-mil reinforced plastic liner was installed at 5 ft BGS and the excavation was backfilled with clean imported soil to ground surface and contoured to the surrounding area. On 6/10/2011, the site was seeded with a blend of native vegetation and is expected to return to a productive capacity at a normal rate. NMOCD was notified of potential groundwater impact on 3/12/2012.

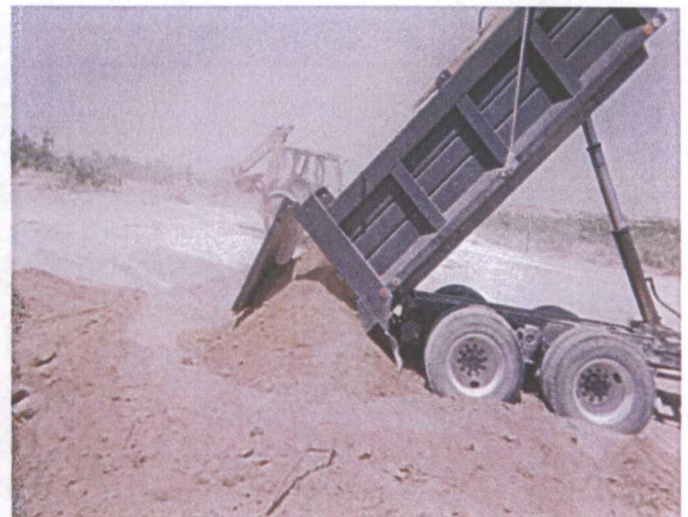
6.9.11

Importing topsoil, facing east

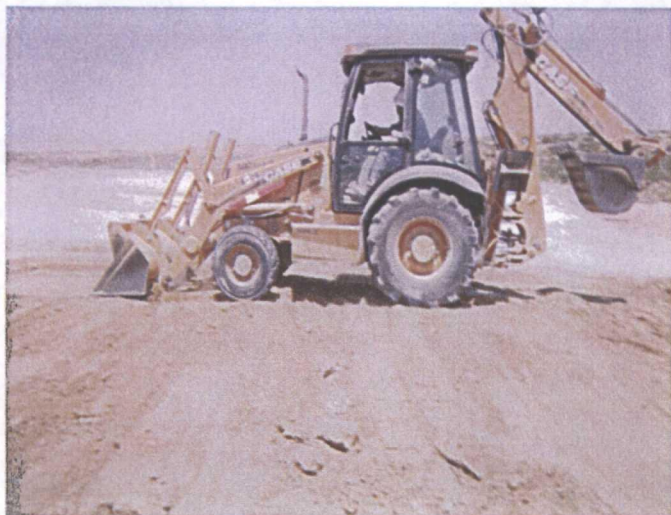
6.9.11

Spreading backfill, facing south

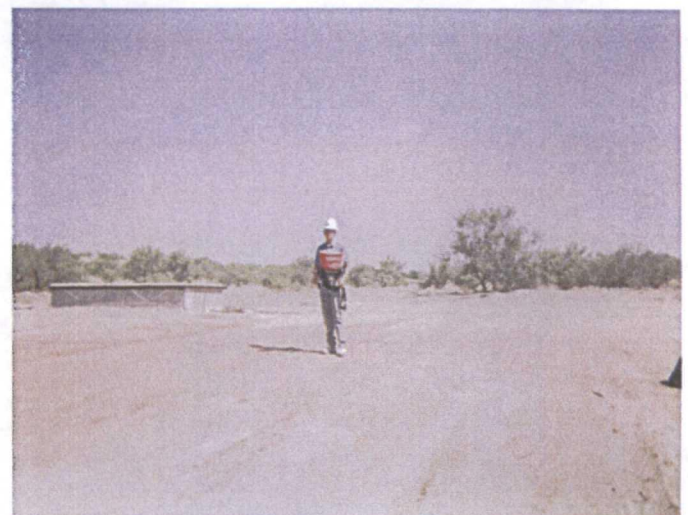
6.10.11

Seeding site, facing north
