**INVESTIGATION & CHARACTERIZATION PLAN (ICP)  
EME Jct. F-29-2  
Unit F, SEC. 29, T19S, R37E, Monument, Lea County, New Mexico  
NMOCD CASE # 1R427-318**

**RICE OPERATING COMPANY  
JUNCTION BOX DISCLOSURE REPORT**

## EME Jct. F-29-2 extra box

Unit F, Section 29, T19S, R37E

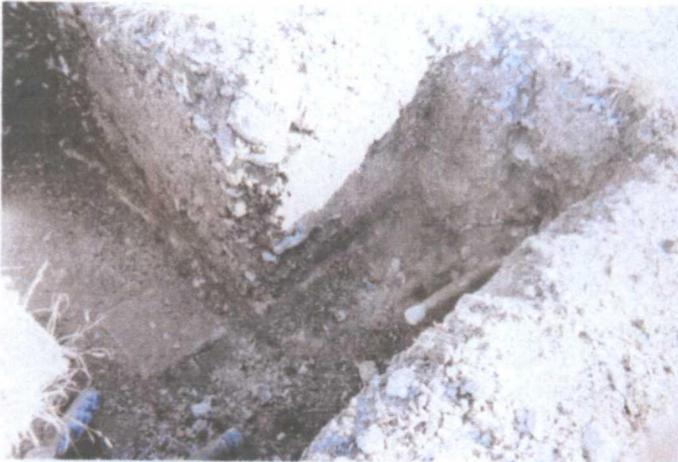
11/17/2008

site prior to excavation, facing east

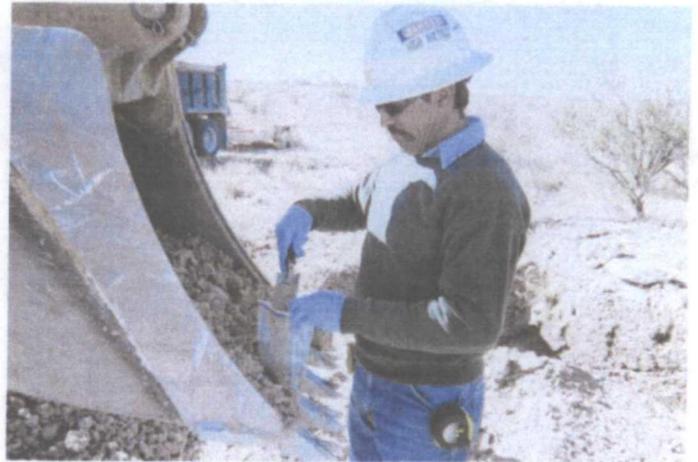
11/17/2008

A backhoe was used to excavate soils from an excavation measuring 30 feet by 30 feet by 12 feet deep around the former junction box. Soil samples were collected at regular intervals and analyzed in the field for chlorides using field-adapted Standard Method 4500-Cl<sup>-</sup>B and screened in the field using a photoionization detector (PID).

collecting a soil sample, facing east

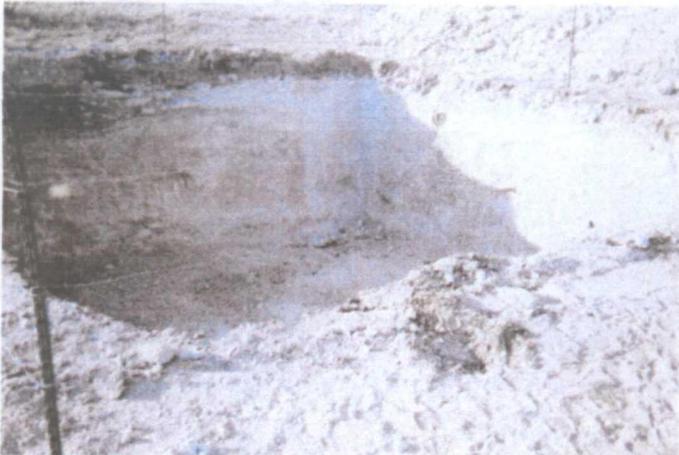
1/2/2009

A five-point wall composite sample was collected from each of the four walls and combined to make a representative four-wall composite sample, and a five-point composite sample was collected from the bottom of the excavation and submitted to Cardinal Laboratories for gasoline range organics (GRO), diesel range organics (DRO) and chloride analysis. DRO was detected at a concentration of 219 milligrams per kilogram (mg/kg) in the four-wall composite sample and 324 mg/kg in the five-point bottom composite sample. Chlorides were detected at a concentration of 272 mg/kg in the four-wall composite sample and 352 mg/kg in the five-point composite bottom sample. GRO was not detected in either of the samples.

final 30x30x12-ft excavation, facing north

Excavated soils were blended on site with clean imported back soil and backfilled into the excavation to ground surface. The area was contoured to the surrounding landscape.

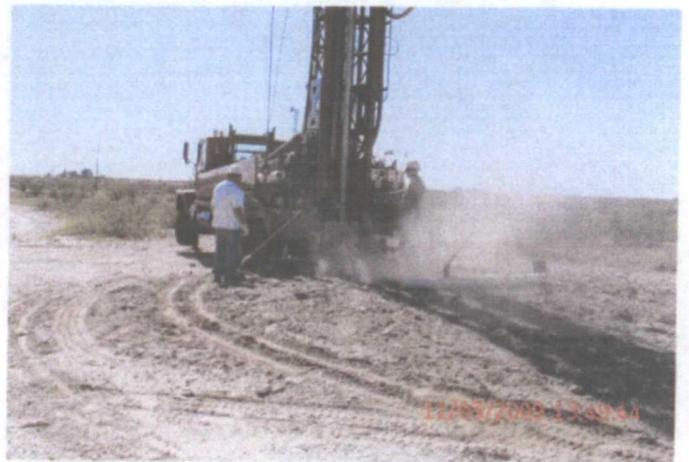
To further investigate the depth of hydrocarbon impact at the site, a soil boring was advanced 13 feet south of the former junction box location. Soil samples were collected every three feet and analyzed in the field for chlorides using field-adapted Standard Method 4500-Cl<sup>-</sup>B and screened in the field using a photoionization detector (PID). Two samples were submitted to Cardinal Laboratories for laboratory analysis. The 15 foot sample was submitted for GRO, DRO and chloride analysis. Chlorides were detected at a concentration of 400 mg/kg. GRO and DRO were not detected. The 19-21 foot sample was submitted for GRO, DRO, benzene, toluene, ethylbenzene, xylenes and chloride analysis. GRO was detected at a concentration of 139 mg/kg and DRO was detected at a concentration of 1,180 mg/kg. Chlorides were detected at a concentration of 352 mg/kg. Benzene was not detected. Toluene, ethylbenzene and xylenes were detected at concentrations of 0.136, 0.310 and 2.52 mg/kg, respectively.

depth of TPH presence, a soil boring was initiated on 11/3/2009 at 13 ft south of the former junction box. Soil samples were collected and field tested for chlorides and organic vapors. The 15 and 19 ft samples were sent to a commercial laboratory for analysis of chloride and TPH, and BTEX for the 19 ft sample. Lab analysis of confirmed elevated concentrations of TPH in the 19 ft sample. The entire borehole was plugged with bentonite to the ground surface.

drilling SB #1, 13 ft south of former jct box

The borehole was plugged with bentonite from surface to total depth.

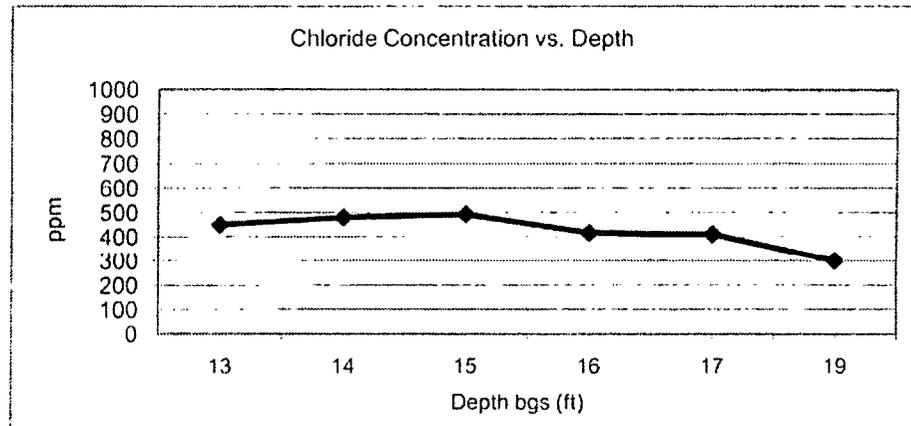
CHLORIDE CONCENTRATION CURVE

SOIL BORING samples at 13 ft south of the junction (source)

Depth bgs (ft)	[Cl <sup>-</sup> ] ppm
13	451
14	481
15	494
16	417
17	411
19	300

Groundwater = 23 ft
