**RE: Termination Request  
for the Rice Operating Company's  
Vacuum M-33 Site  
Unit Letter M, Section 33, T17S, R35E, NMPM, Lea County, New Mexico  
Remediation Plan (1R425-28) Termination**

RE: Termination Request  
Vacuum M-33 (1R425-28): UL/M, Sec. 33, T17S, R35E  
RICE Operating Company – Vacuum SWD System

**RICE OPERATING COMPANY  
JUNCTION BOX FINAL REPORT**

## Vacuum jct. M-33

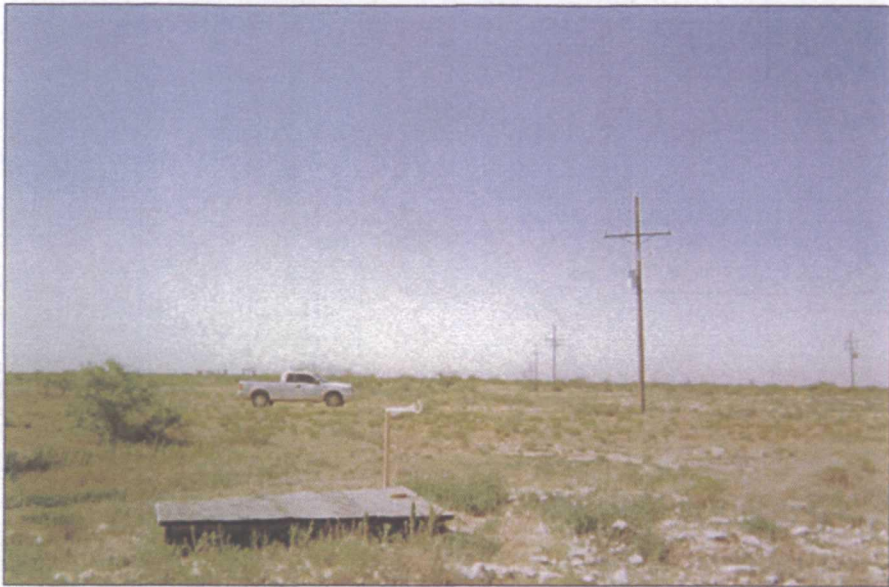
undisturbed junction box

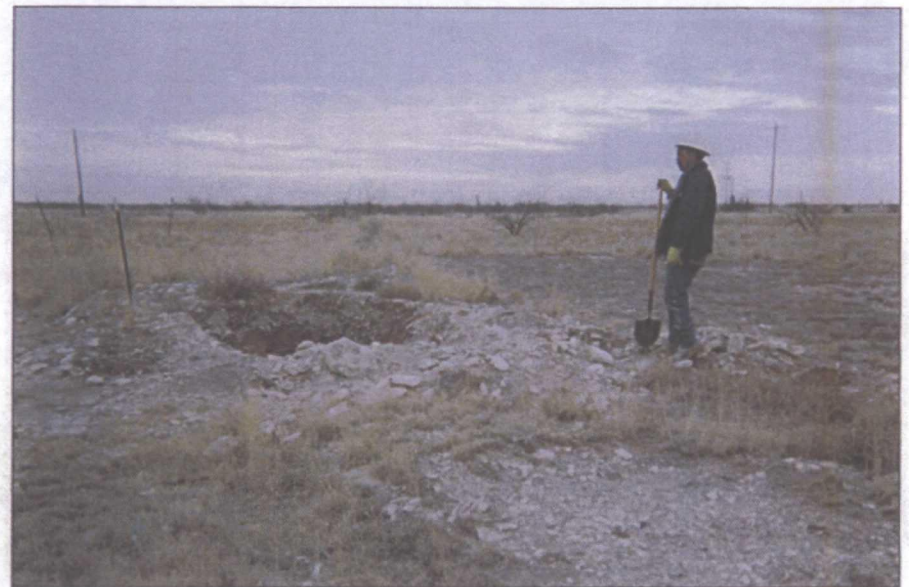
delineation trench at former box site

General Description of Remedial Action: This junction box was addressed as part of the Vacuum SWD System abandonment. The box was removed and the jct. site was delineated using a backhoe while chloride field tests and PID measurements were performed on the soil samples collected at regular intervals. Chloride concentrations were relatively low 5-17 ft below the box. VOC concentrations were also very low (0.1-2.1 ppm). A bottom grab sample from the 17-ft-deep trench was collected for laboratory analysis which confirmed the field measurements. The excavated soil was blended on site and then backfilled into the excavation and contoured to the surrounding terrain. The disturbed surface is expected to return to productive capacity at a normal rate.

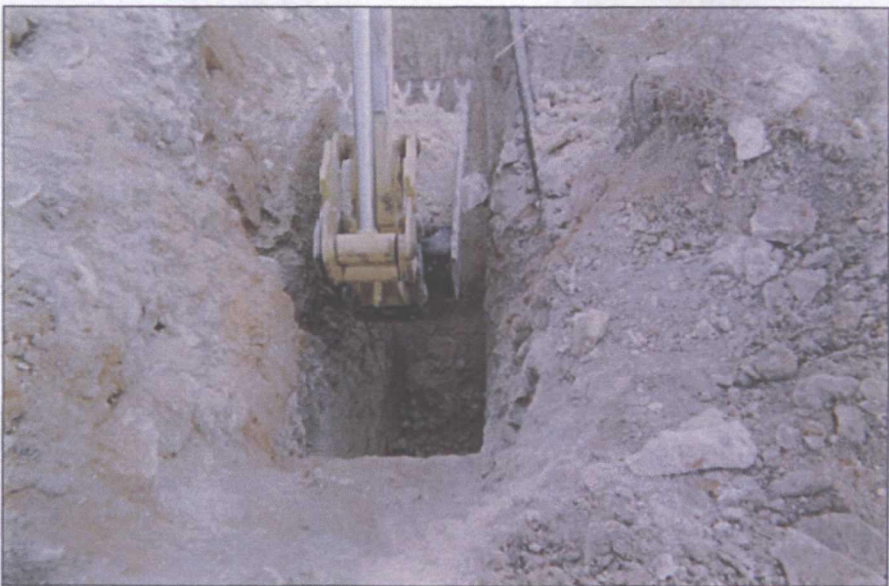
collecting a sample

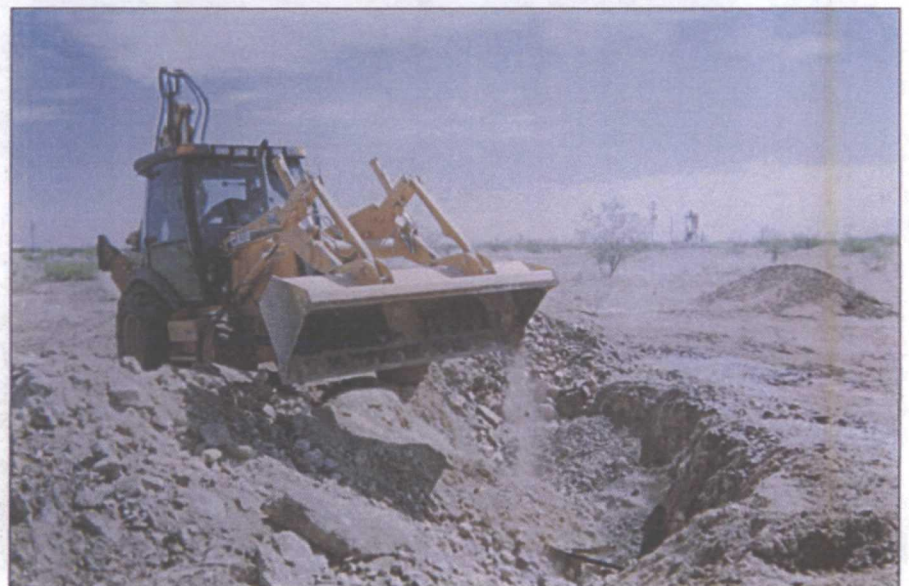
backfilling trench

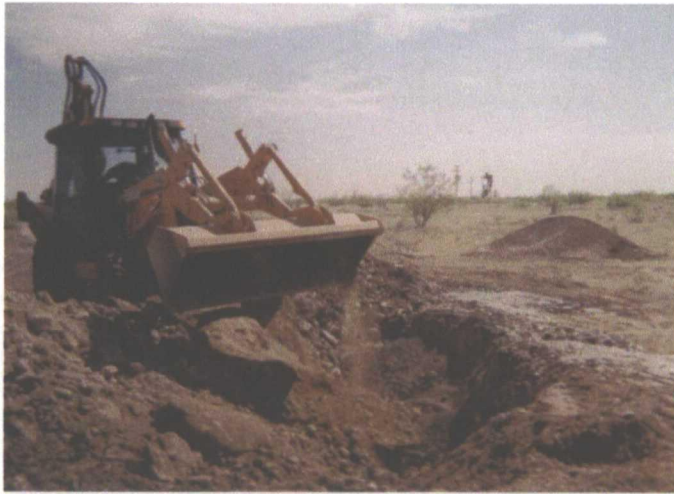
Facing northeast

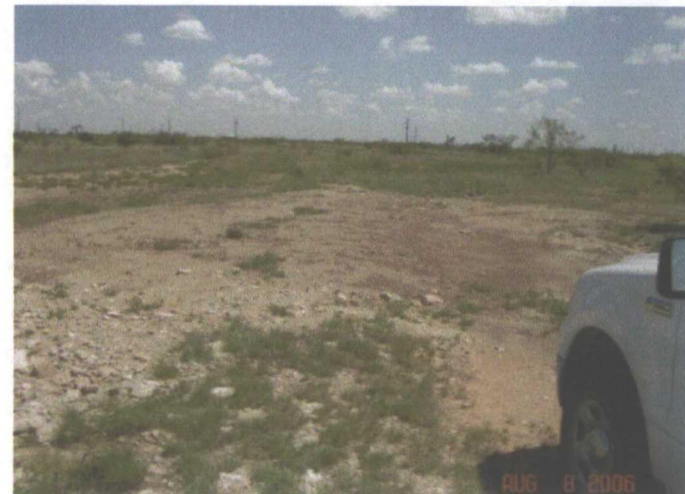
Facing north

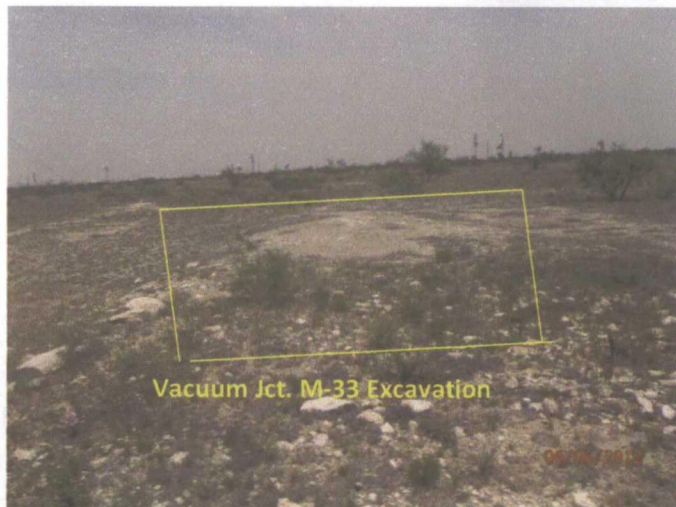
Facing northeast
