**RE: Termination Request  
for the Rice Operating Company's  
Vacuum Jct E-8 Site  
Unit Letter E, Section 8, T18S, R35E, NMPM, Lea County, New Mexico  
Remediation Plan (1R425-73) Termination**

RE: Termination Request  
Vacuum Jct. E-8 (1R425-73): UL/E, Sec. 8, T18S, R35E  
RICE Operating Company – Vacuum SWD System

**RICE OPERATING COMPANY  
JUNCTION BOX FINAL REPORT**

# Vacuum Jct. E-8

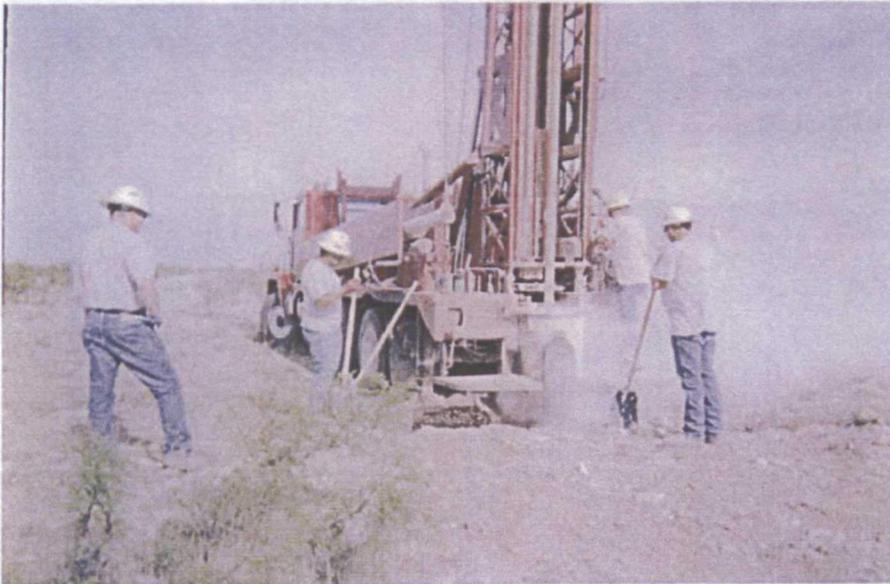
drilling SB #1 at the former junction box 6/18/2009

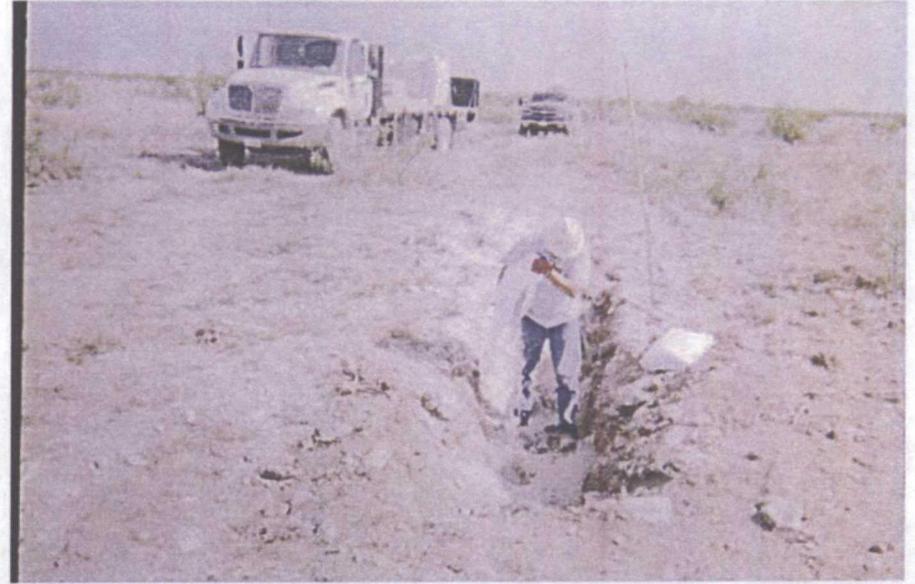
plugging SB #1 with bentonite 6/18/2009

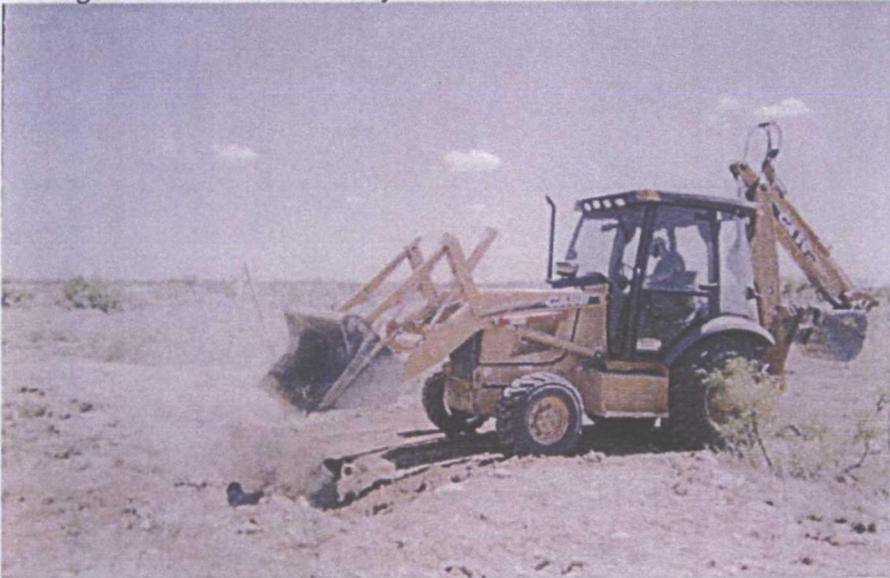
backfilling the former junction box site, facing northwest 6/25/2009

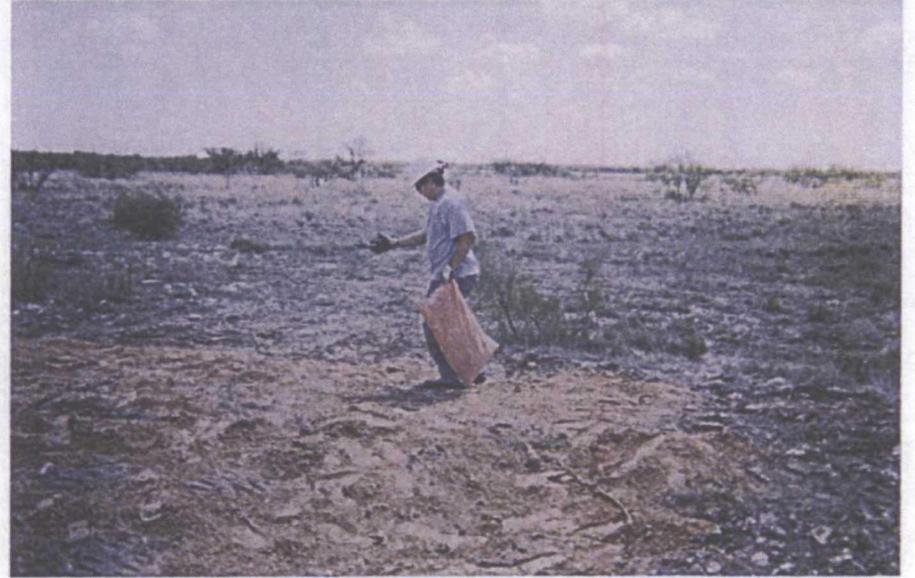
seeding backfilled site, facing east 6/25/2009
