RE: **Corrective Action Plan (CAP)**

Rice Operating Company – Vacuum SWD System

Vacuum Jct N-28-1: UL/N, Sec. 28, T17S, R35E (formerly Vacuum Jct K-28-1)

NMOCD Case Number: 1R425-87

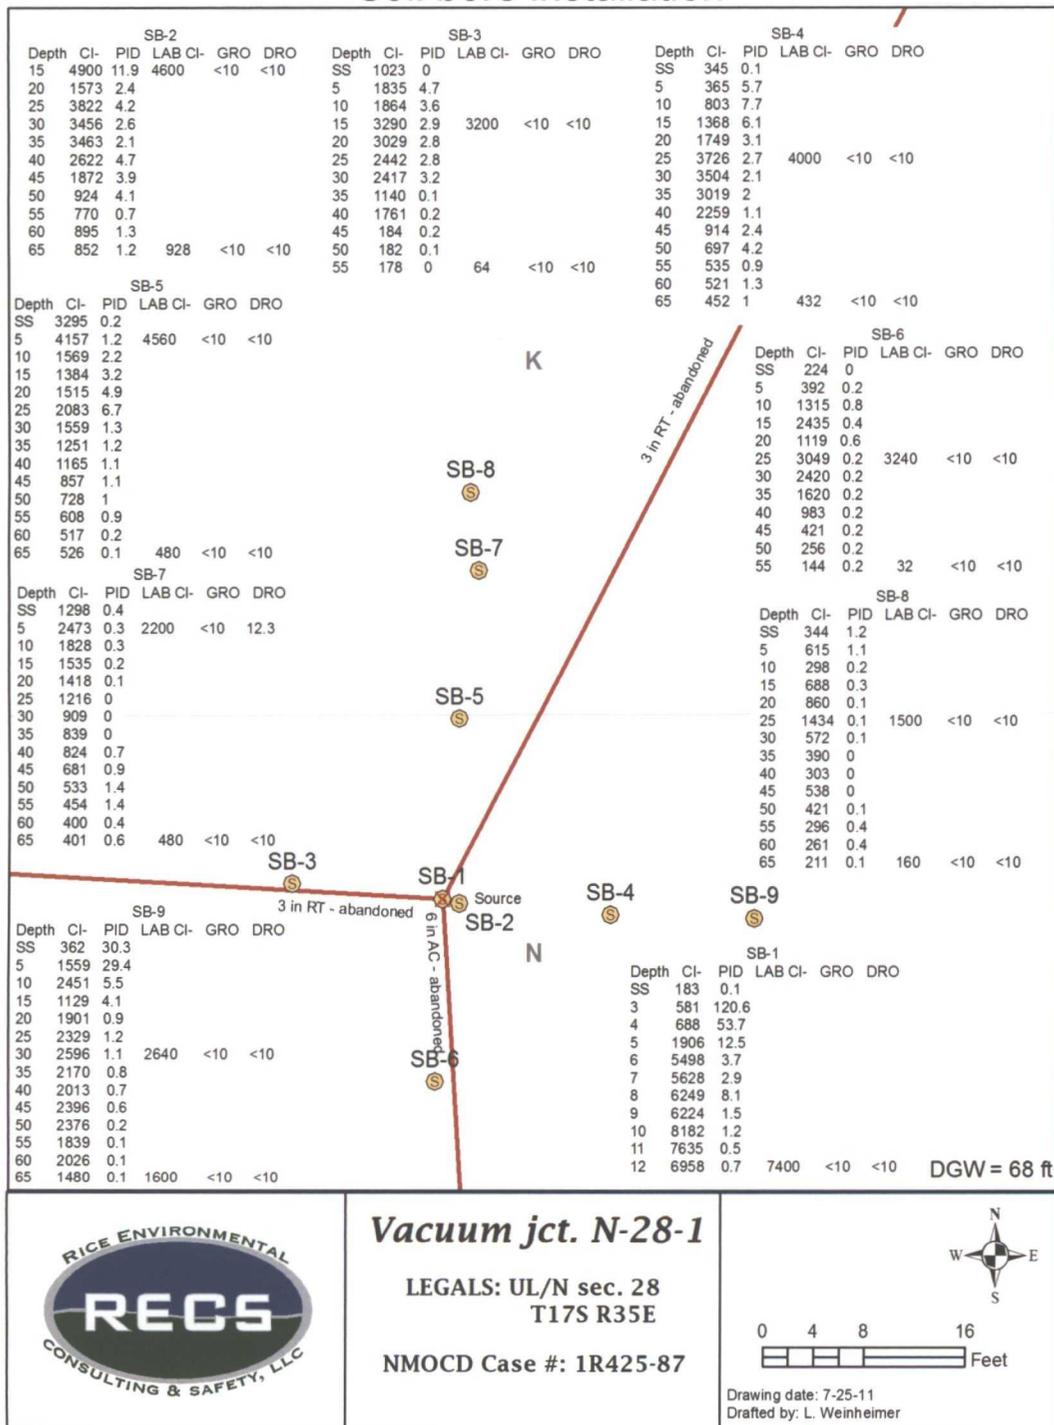
Figure 2 – Vacuum Jct N-28-1 summary of soil boring sampling locations and analyses.

Residual soil chlorides are high in the at-source soil boring (SB-2) from the surface to a depth of 65 ft bgs. The depth to groundwater at this site is approximately 68 ft below ground surface (bgs). The lateral extent of residual soil chlorides was defined by SB-3 to the west, SB-8 to the north and SB-6 to the south where a three-point decline (with the lowest sample testing less than 250 mg/kg) was found in the lowest intervals sampled. The easterly extent was defined by SB-4, where chloride concentrations decreased from 4,000 mg/kg to 432 mg/kg at 65 ft bgs. SB-9, drilled east of SB-4, is encroaching upon an abandoned lease facility (Figure 3). Residual soil petroleum hydrocarbons were generally negligible in each of the soil bores. Petroleum hydrocarbons were therefore determined not to be of concern.

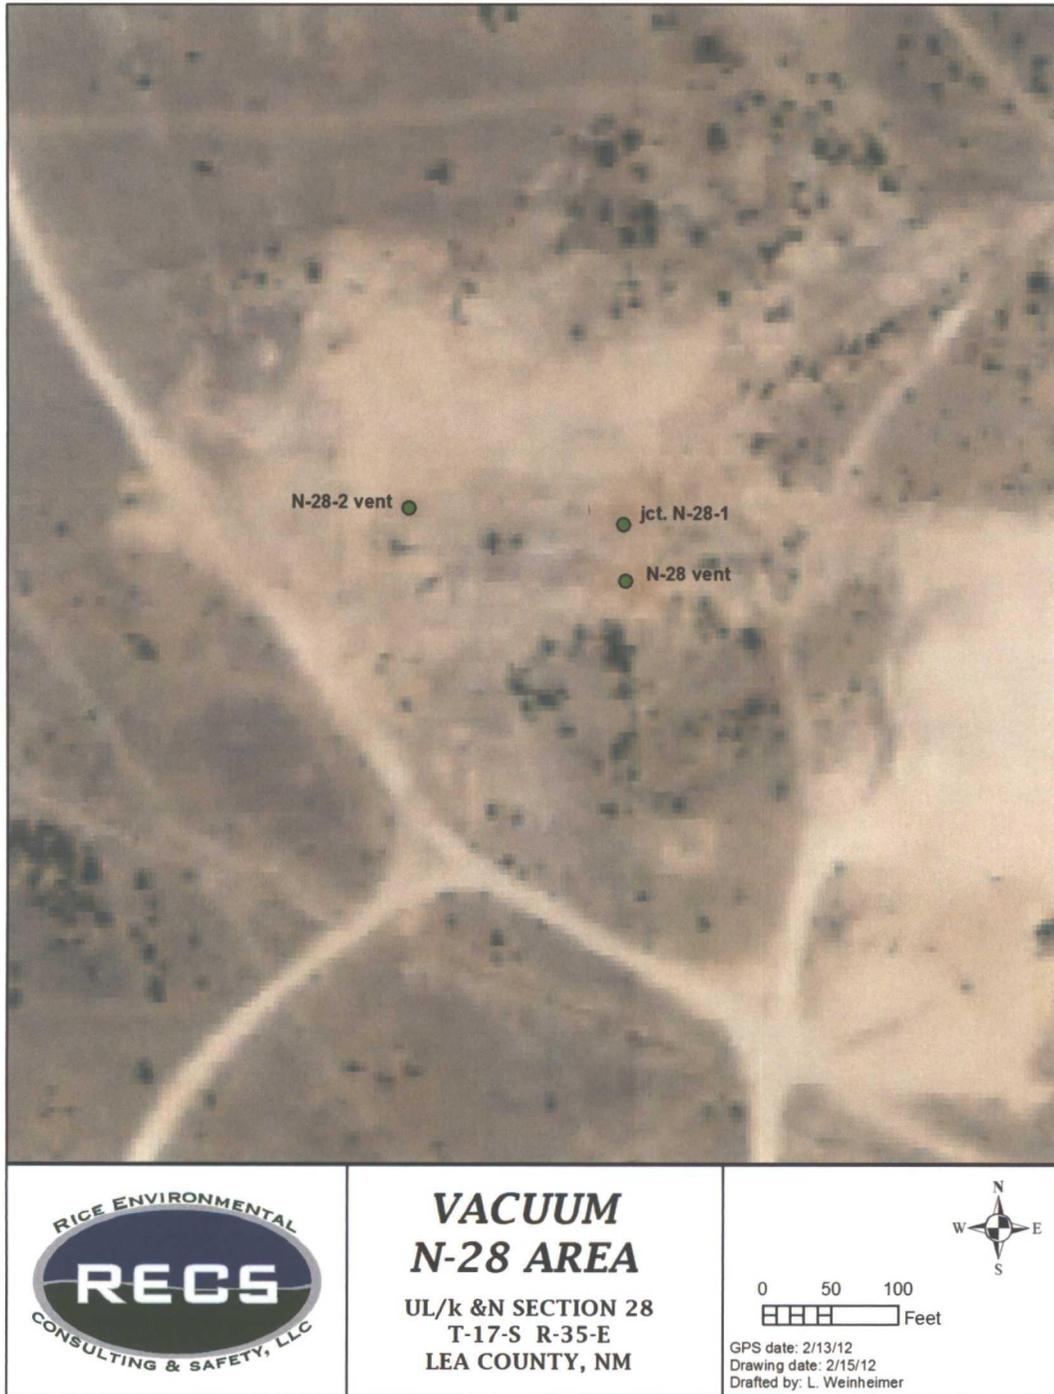
Figure 4 – Aerial of Vacuum Jct N-28-1 location in 2011.

It should be noted that site is located within the immediate vicinity of oil field facilities having a long history with apparent surface spillage (Figures 4 to 9) and that the elevated levels of residual soil chlorides are likely due to activities not directly caused by ROC operations. Nevertheless, in order to protect groundwater quality from the potential migration of residual soil chlorides ROC proposes the following actions to serve as a Corrective Action Plan (CAP) for this project. *These measures will provide protection beyond the impacts directly caused by past operation of the Vacuum Jct N-28-1 junction box.*

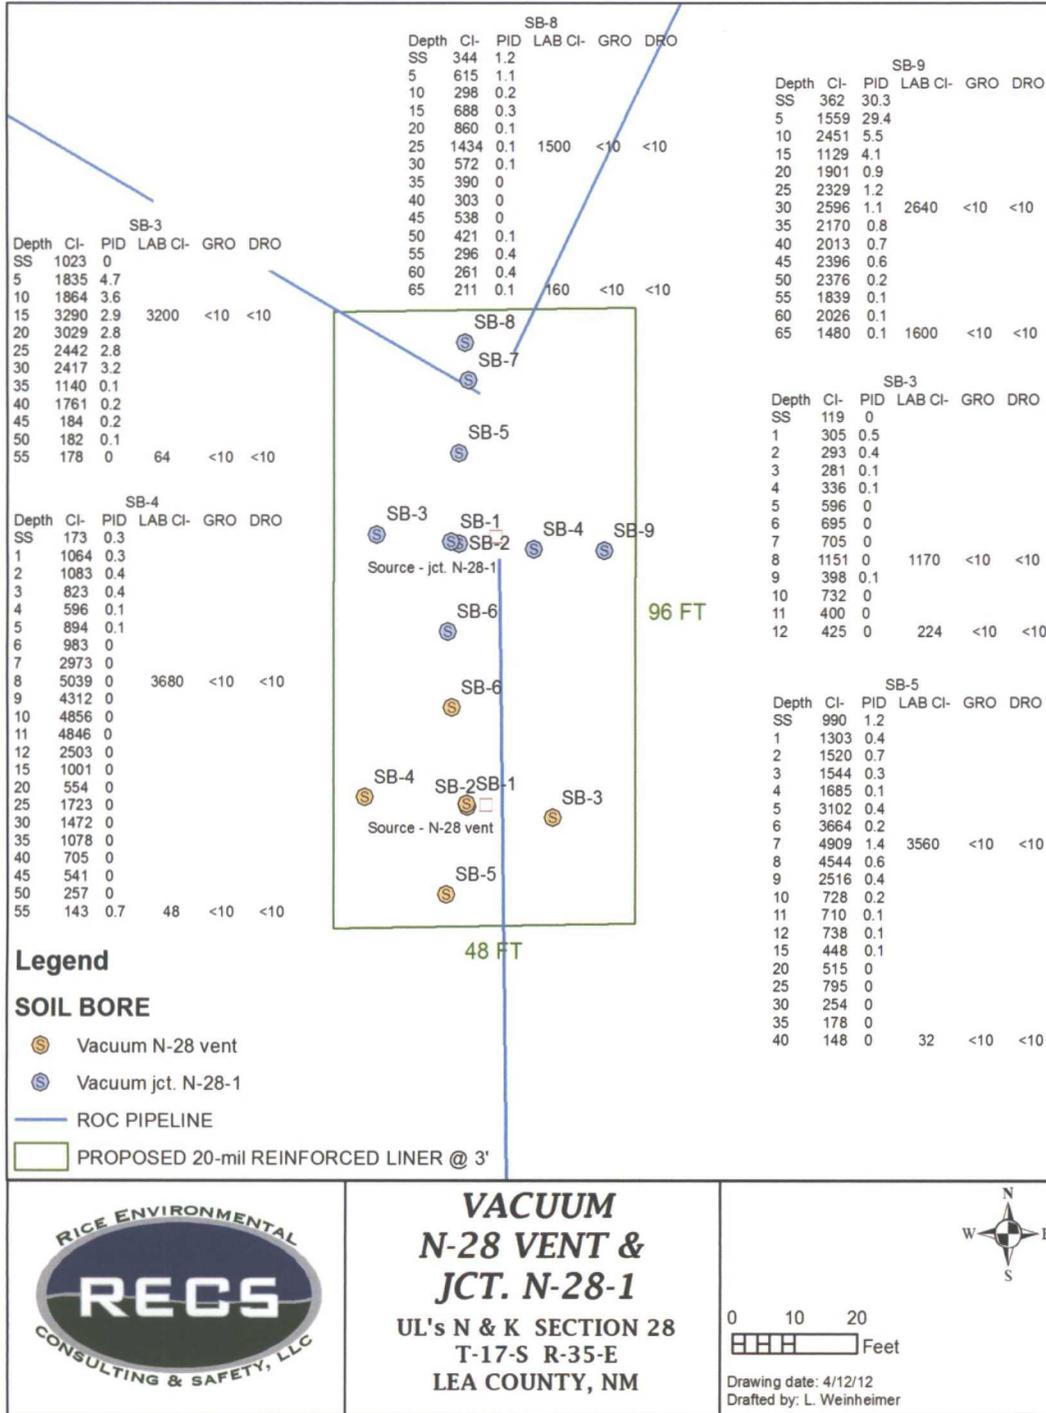
Figure 10 - Soil boring locations and analysis summary and surface footprint of proposed excavation and sub-surface synthetic infiltration barrier. Due to the close proximity of this location and the ROC Vacuum N-28 vent location, the excavation and liner will encompass the affected areas of both former junction boxes.

- Excavate the area encompassed by the soil borings (48 by 96 ft as shown in Figure 10) to a depth of approximately 3 ft bgs (limited by the presence of hard rock). Due to the close proximity between this location and the ROC Vacuum N-28 vent location, the excavation and liner will encompass the affected areas of both former boxes.
- Install a 20-mil, reinforced poly liner over a 6 inch layer of clean blow sand and pad this with another 6 inch layer of the same (aerial view given in Figure 10).
- The excavation will then be backfilled with soil that chlorides measure less than 500 mg/kg and PID hydrocarbons measure less than 100 ppm. Excavated soil will be evaluated for use as backfill, and any soil requiring disposal will be properly disposed of at a NMOCD approved facility.
- Restore the ground surface to natural contours and seed with a blend of native vegetation mix.
