**RE: ICP Report and Termination Request
Rice Operating Company – EME SWD System
EME jet. P-27 (1R427-283): UL/P sec. 27 T19S R36E**

EME jct. P-27

NMOCD Case #: 1R427-283

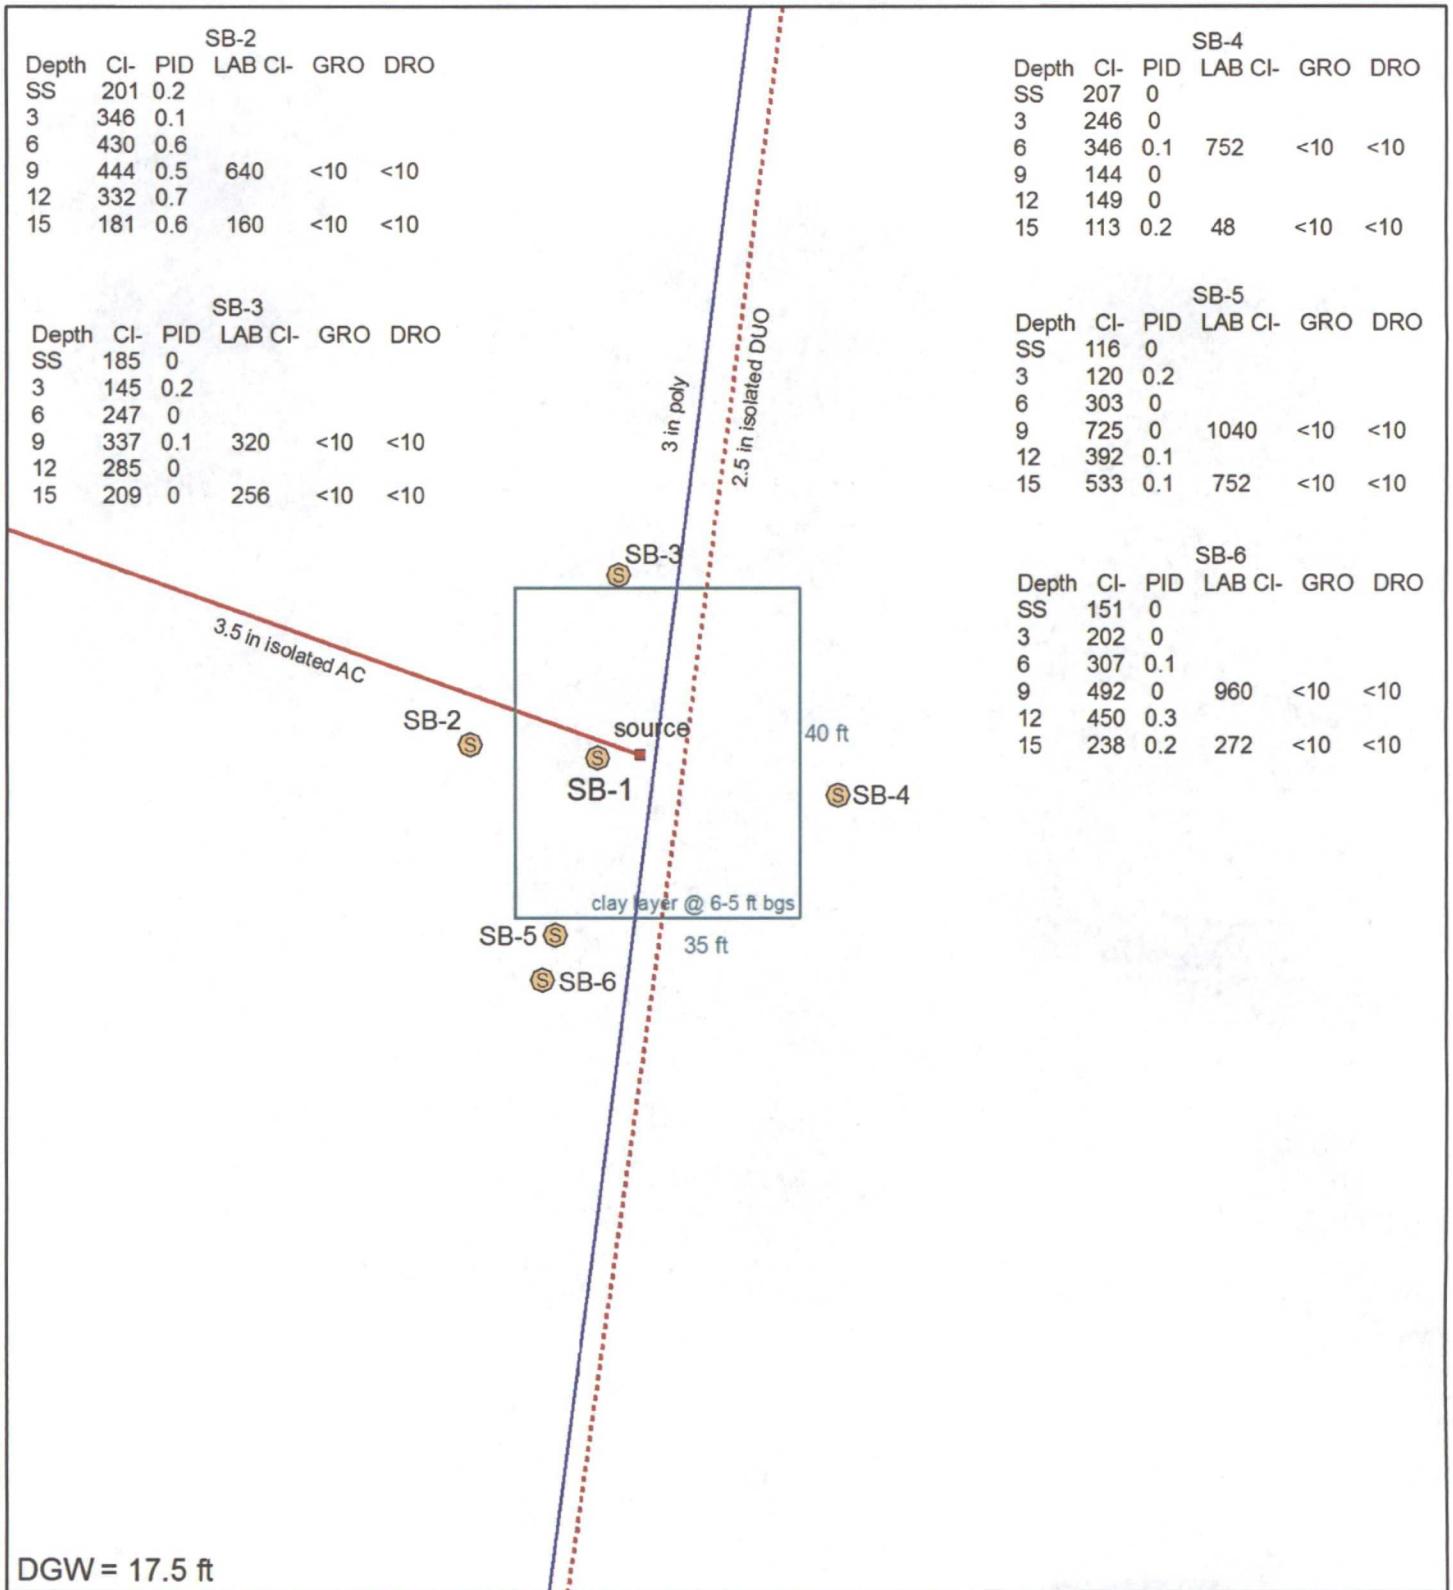
Figure 2

As part of the Investigation and Characterization Plan (ICP) approved by NMOCD on November 17th, 2011, six soil bores were installed at the site on December 13th and 15th, 2011 (Figure 2). SB-1 was installed on December 13th to check for the presence of groundwater at the site. Red bed clay, which delineates the bottom of the aquifer, was encountered at 18 ft bgs. Since no groundwater was evidenced during boring, the bore was advanced to 40 ft bgs to allow any groundwater present to accumulate within the bore. SB-1 was packed open for 48 hours and then gauged for groundwater by Harrison & Cooper, Inc. Groundwater was found in SB-1 at a depth of 17.5 ft bgs. The aquifer beneath the site was determined to be exceptionally thin, since the red bed clay that delineates the bottom of the aquifer and depth to groundwater were located within 6 inches of each other (Figure 3). Sampling was not conducted on SB-1, since no samples could be attained between the bottom of the junction box excavation of 12 ft bgs and the top of the capillary fringe.

Since groundwater was discovered at the site, SB-2 through SB-6 was subsequently advanced at the site on December 15th. RECS personnel field tested the soil for chlorides and screened in the field with a photo-ionization detector for hydrocarbons. Representative samples from the bores were taken to a commercial laboratory for confirmation of chloride and hydrocarbon field numbers (Appendix A). In SB-2 through SB-6, chloride laboratory readings decreased with depth from a high at 6-9 ft bgs to a low at the capillary fringe below or near 250 mg/kg, except for SB-5 which decreased to a chloride reading of 752 mg/kg at 15 ft bgs. GRO and DRO readings were non-detect for all samples (Figure 2).

Soil Bore Installation

DGW = 17.5 ft

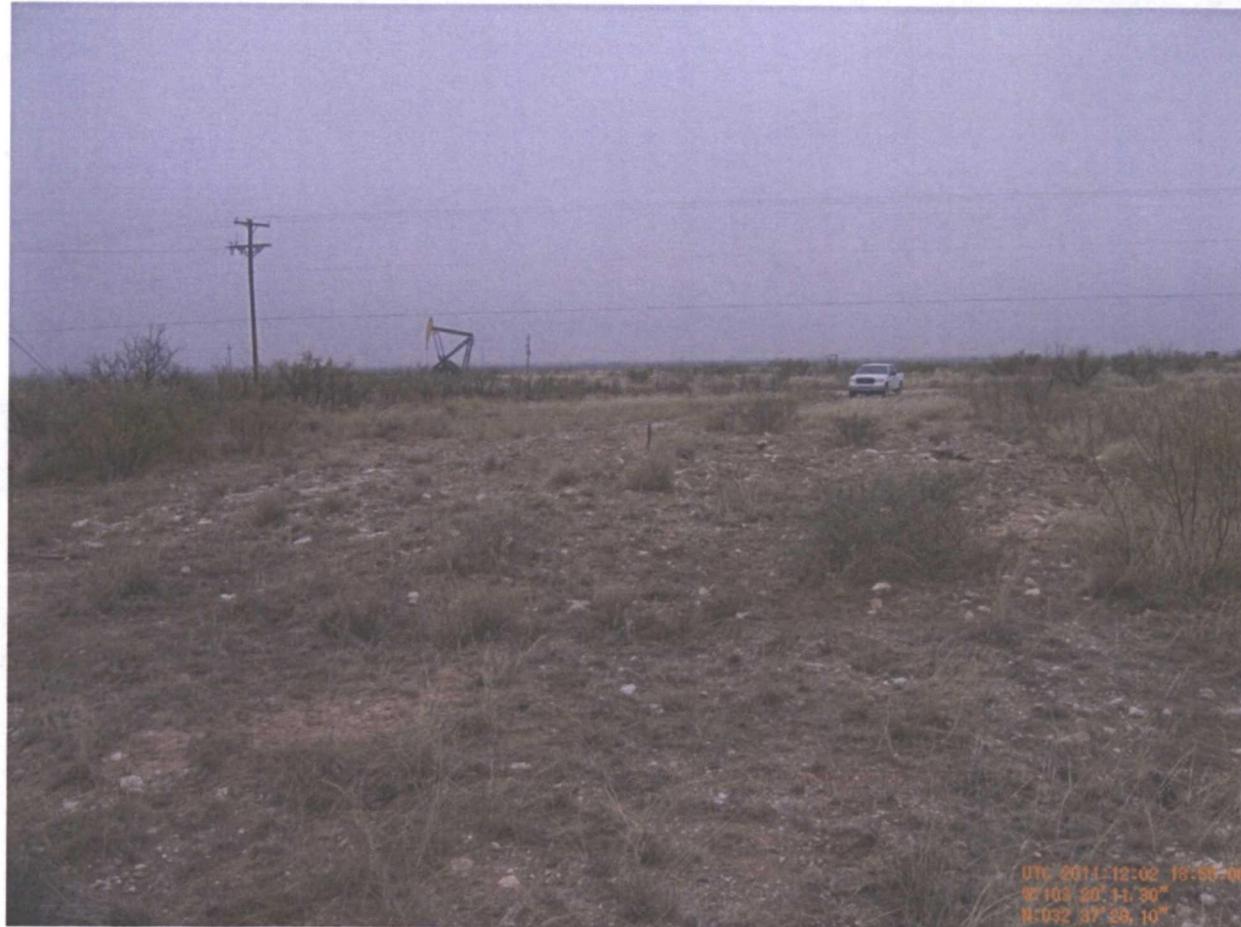
Figure 3

Site photo, facing south

12/2/11

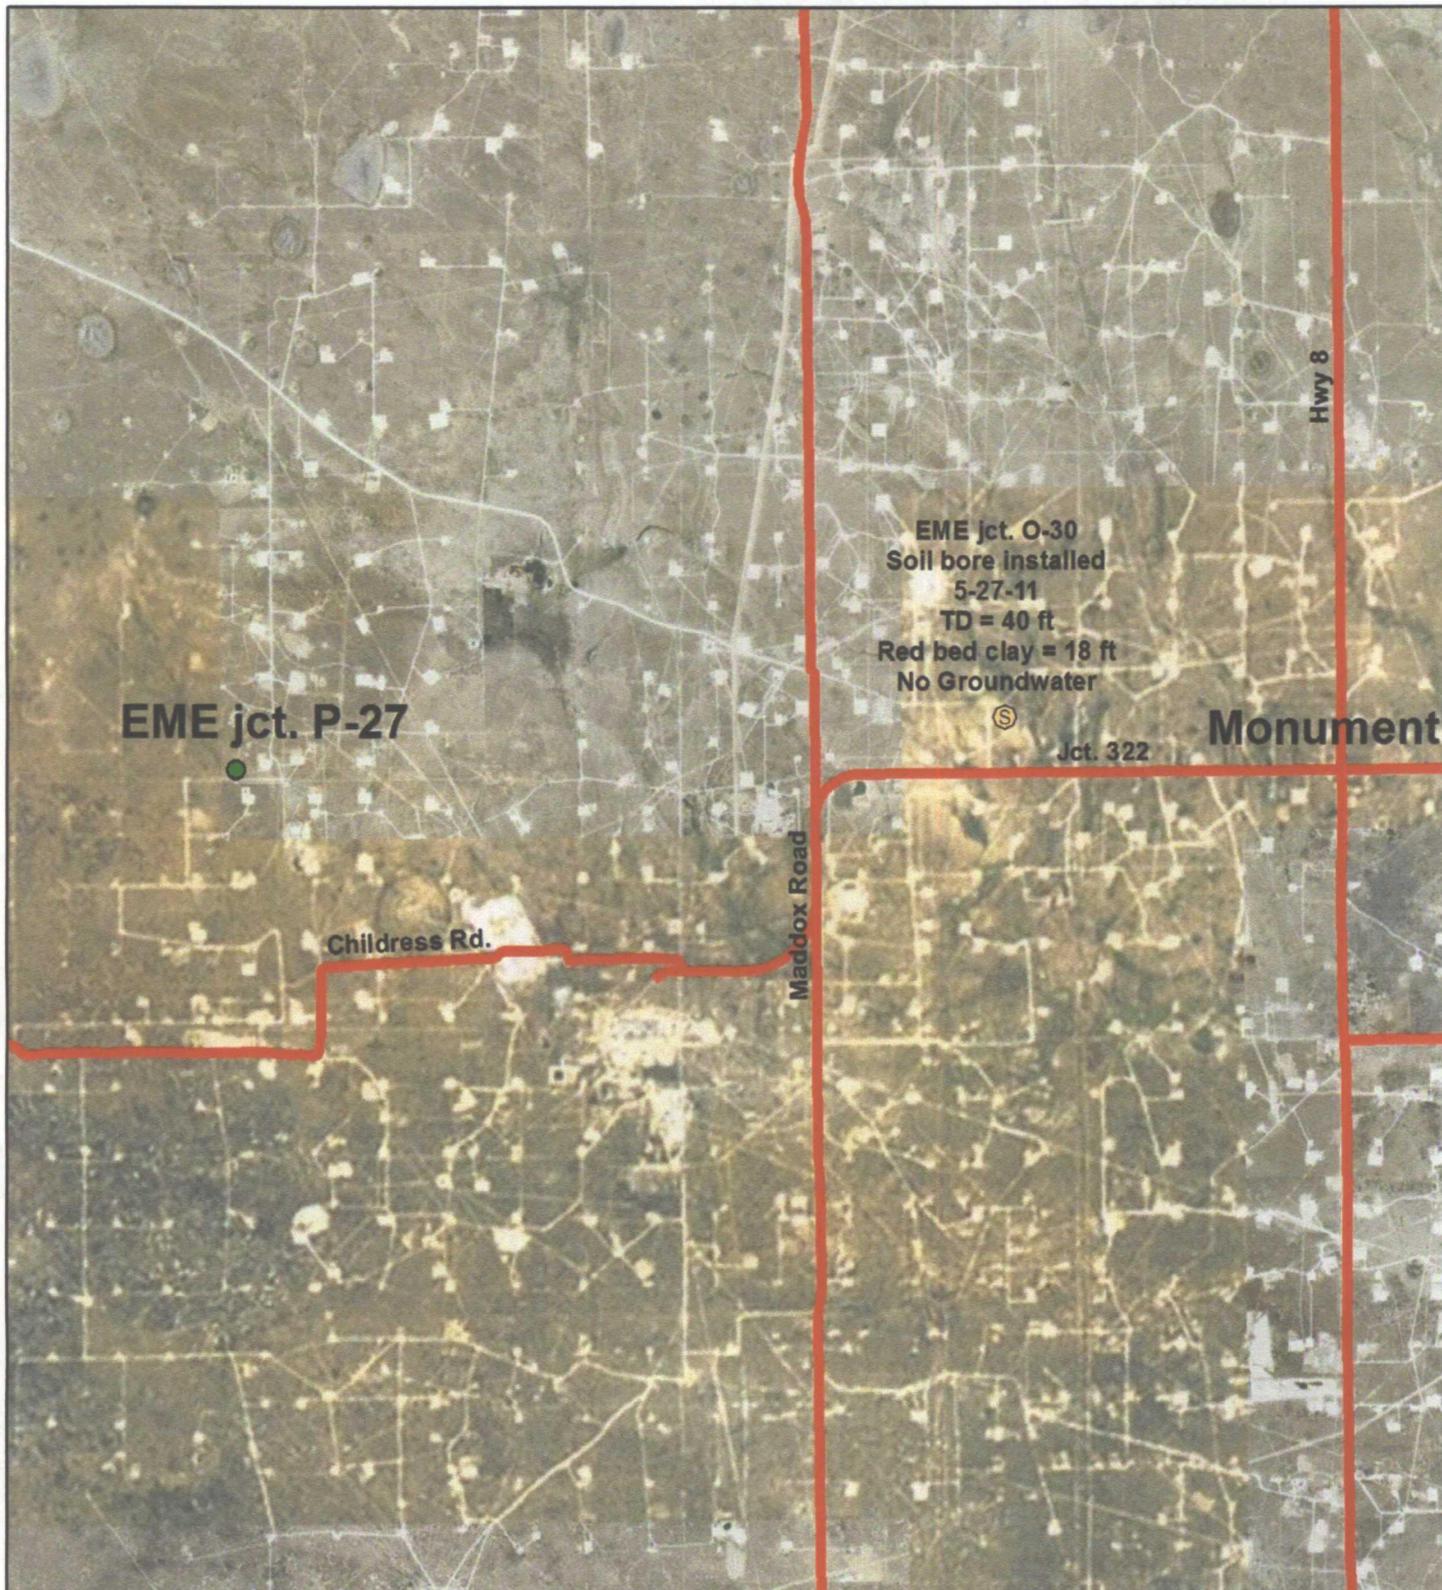
Area of No Groundwater

As per NMOCD request, a plat depicting the relationship of EME jct. P-27 to EME jct. O-30 is attached. The EME jct. O-30 site has no groundwater as evidenced by the soil bore log (also attached), in which red bed clay was encountered at 18 ft bgs. The EME jct. O-30 soil bore log also serves as a comparison to the EME jct. P-27 soil bore log, which shows red bed clay was encountered at 18 ft bgs and extends through the total depth of the soil bore, 40 ft bgs. Both sites have similar lithology results preceding the encountering of red bed clay. As such, the aquifer at this location does not contain the specific capacity to yield the desired amount of water due to lack of saturated thickness.
