RE: Corrective Action Plan Report for Vadose Zone Remediation

Rice Operating Company – BD SWD System

BD N-11 boot (1R426-259): UL/N sec. 11 T22S R37E

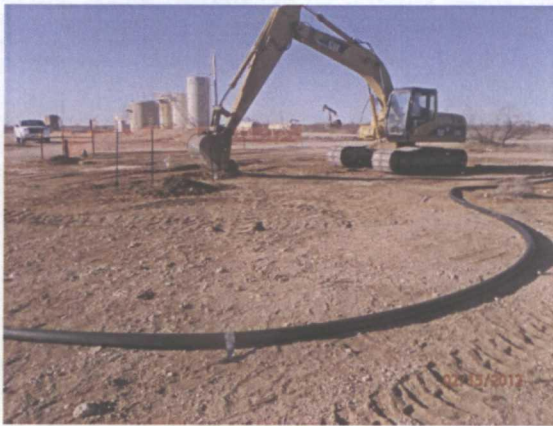
Beginning excavation, facing south 2/15/12

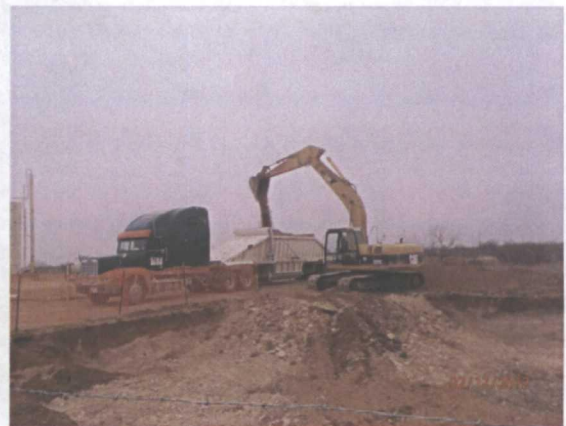
Exporting soil, facing southwest 2/17/12

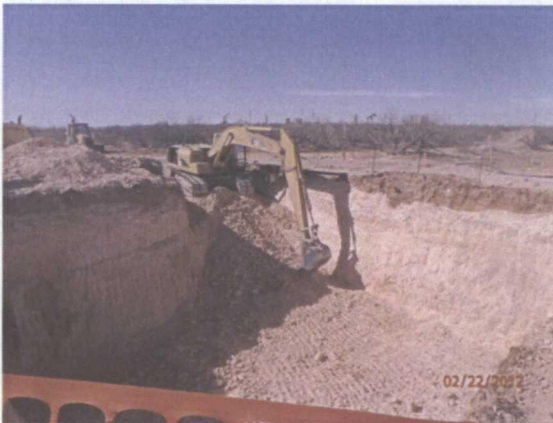
46'x51' excavation at 20' bgs, facing northwest 2/22/12

Beginning on February 15th, 2012, RECS personnel were on site to begin excavating for liner installation. The site was excavated to 46 ft x 51 ft x 20 ft bgs, and an additional 10 ft x 10 ft x 10 ft deep area surrounding SB-3 was excavated at the base of the 46 ft x 51 ft excavation to a total depth of 30 ft bgs. A total of 2,532 yards of soil was taken to a NMOCD approved facility for disposal. Clean sand was imported to the site to serve as padding for the liners. A six inch sand pad was installed at the base of the 10 ft x 10 ft excavation and a 20-mil reinforced poly liner was installed and properly seated at the base of the excavation. A six inch sand pad was installed over the liner and then the excavation was backfilled with imported caliche to the base of the 46 ft x 51 ft excavation. At the base of the 46 ft x 51 ft excavation, another six inch sand pad was installed and a 20-mil reinforced poly liner was installed and properly seated throughout the excavation. A six inch sand pad was installed over the liner and the excavation was backfilled with imported caliche to 4 ft bgs. The caliche was roller-packed in three foot lifts to prevent the excavation from settling over time. The remaining excavation was backfilled with imported sand from 4 ft bgs to ground surface and contoured to the surrounding location.

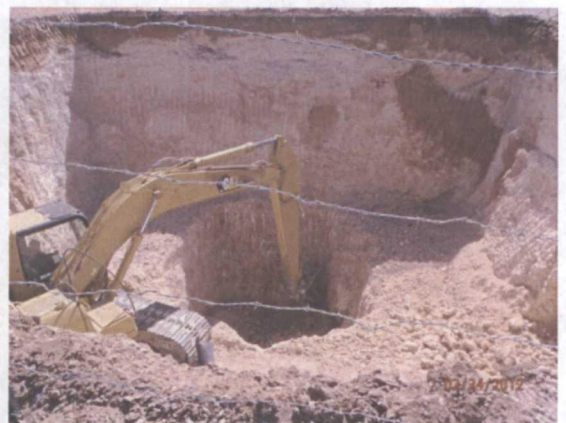
Excavating 10'x10' area surrounding SB-3, facing south 2/24/12

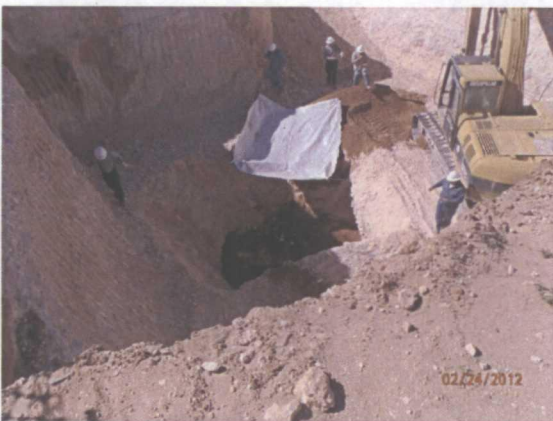
Installed liner above a 6" sand pad, facing northwest 2/24/12

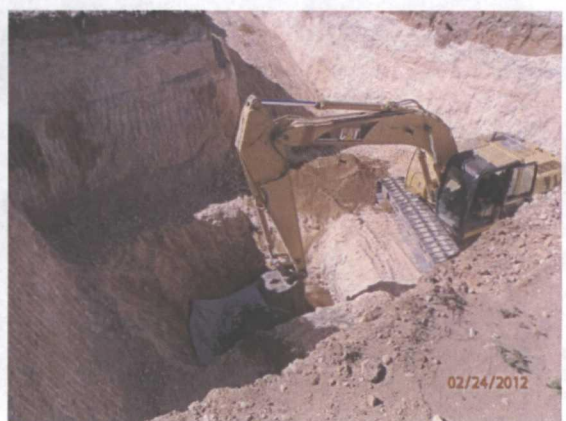
Installing sand pad above liner, facing northwest 2/24/12

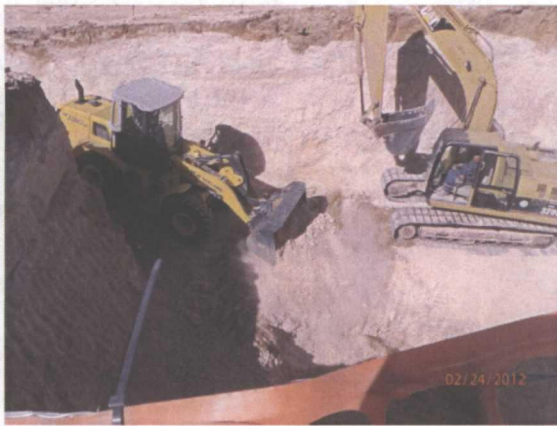
Backfilling with caliche, facing north 2/24/12

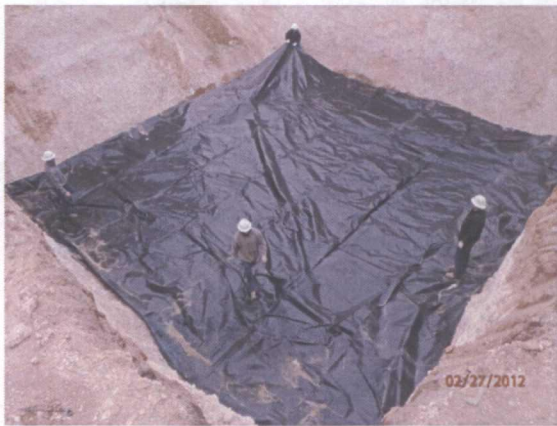
Installing the 46'x51' 20-mil reinforced liner, facing northwest 2/27/12

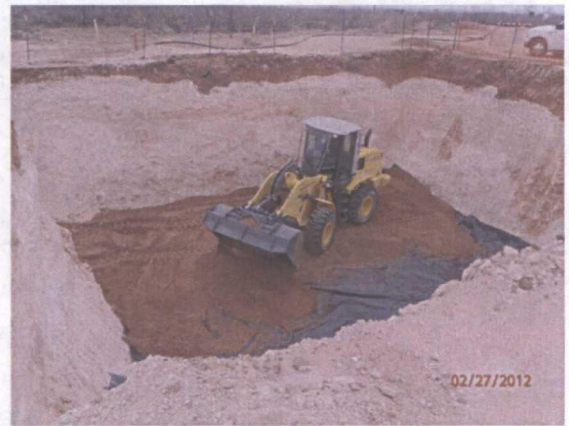
Installing 6" sand pad above liner, facing northeast 2/27/12

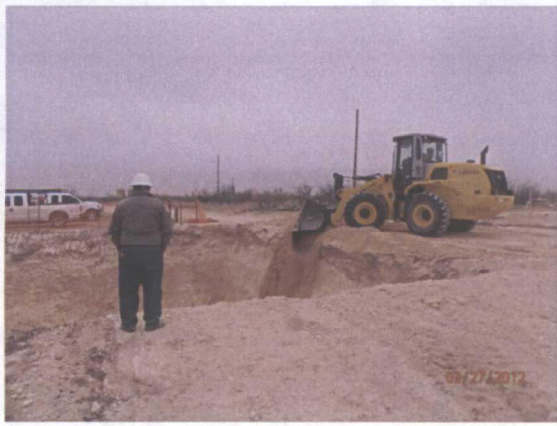
Importing caliche, facing east 2/27/12

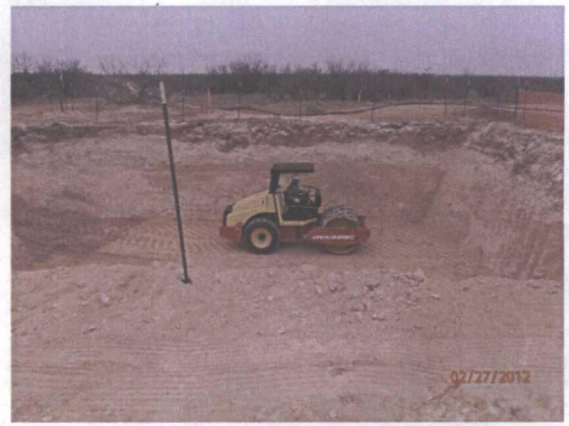
Roller packing first 3' lift, facing north 2/27/12

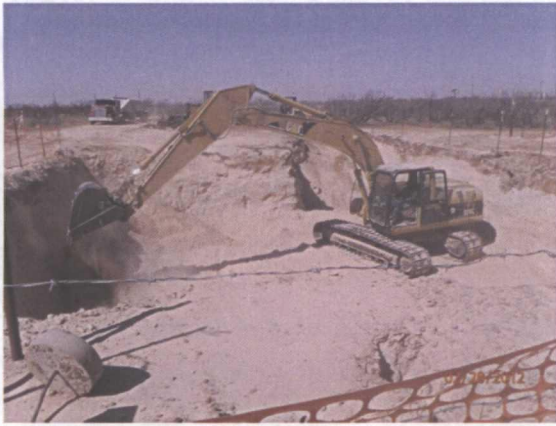
Backfilling excavation with caliche, facing south
2/28/12

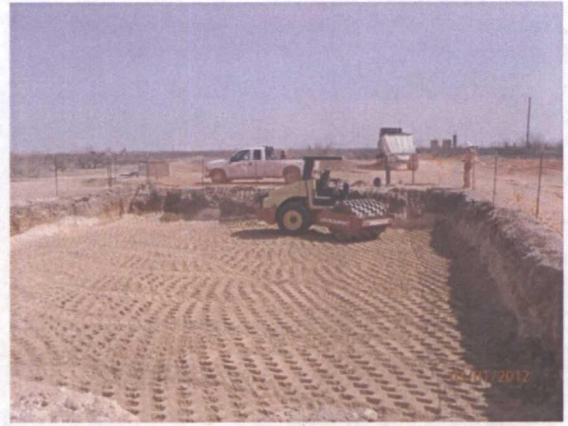
Roller packing site to 4' bgs, facing east 3/1/12

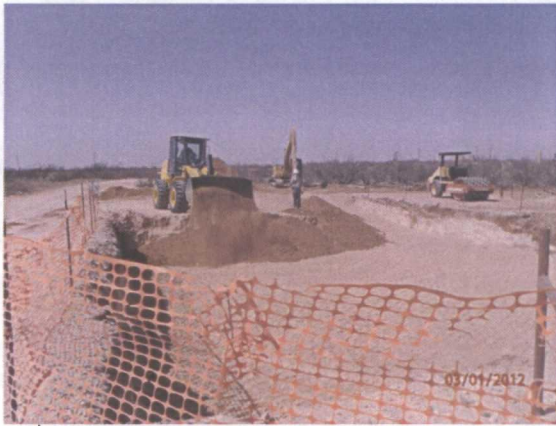
Installing sand to ground surface, facing west
3/1/12

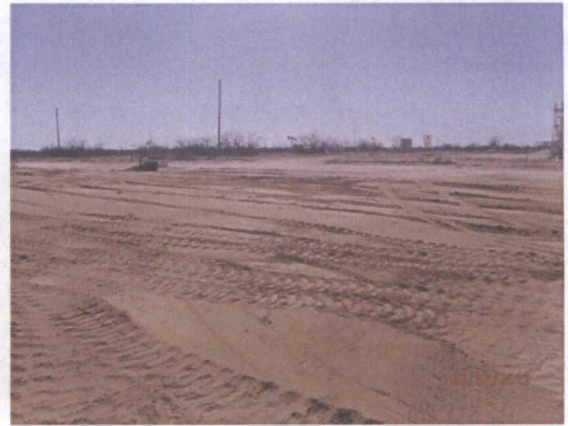
Site backfilled and leveled, facing southeast
3/7/12

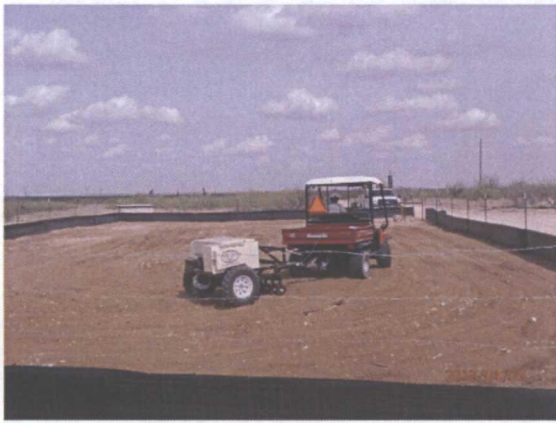
Seeding and tilling, facing east 4/9/12

The site was seeded with a blend of native vegetation and a silt net fence was placed around the site to maintain seed integrity. Documentation for these activities can be found in Appendix B.

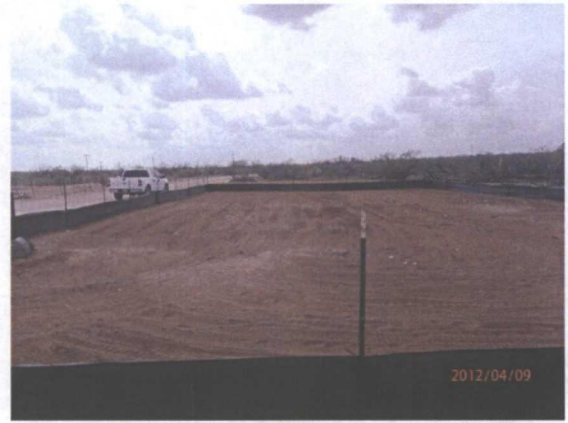
Site complete, facing west 4/9/12
