Re: **Rice Operating Company**  
Corrective Action Plan Progress Report  
BD N-18 Below Grade Tanks  
**NMOCD Case No. 1R-500** UL-N, Sec 18, T22S, R37E

This letter summarizes progress made in implementing the OCD approved Corrective Action Plan (CAP) of July 1<sup>st</sup>, 2011 and CAP Addendum of January 23<sup>rd</sup>, 2012 for Rice Operating Company's BD N-18 Below Grade Tank (BGT) project (Figures 1&2).

**Figure 4a** – Photographic record of soil excavation and installation of double synthetic liner system.

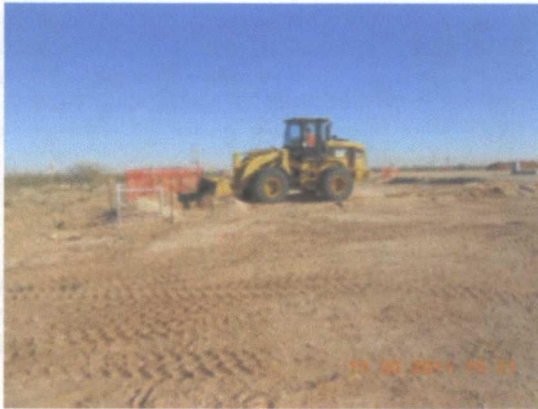
11/30/2011

excavating the site,  
facing east

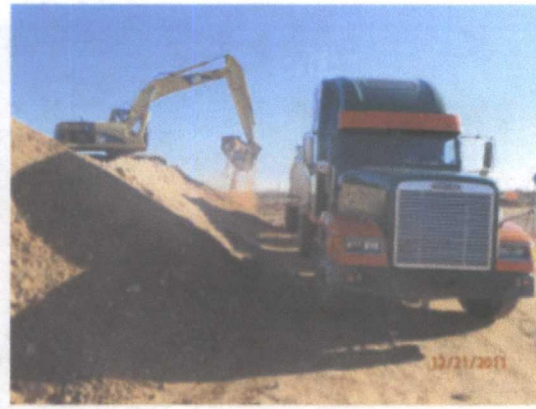
12/21/2011

exporting excavated soil,  
facing south

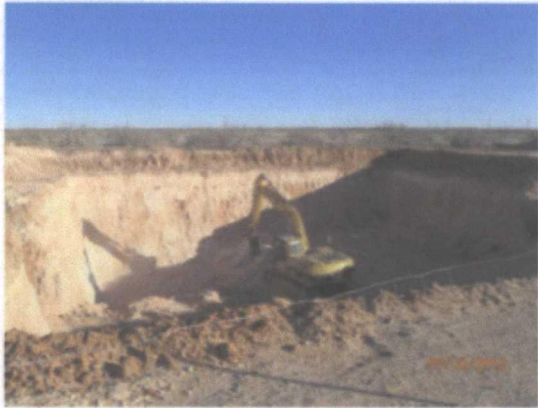
1/20/2012

excavating the 98'x98' area to 30' bgs,  
facing northwest

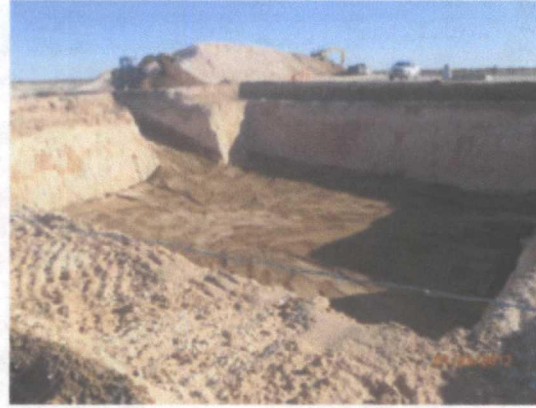
1/23/2012

excavation complete to 27' bgs with a 6" blow  
sand pad installed, facing southeast

ROC removed the two below-grade tanks in 2010 and began excavating beneath them to install the double-liner system in November 2011. Although the initial design was to install the 98 ft by 98 ft lower synthetic liner at 30 ft bgs, rock was encountered at 27 ft bgs. An eight-point composite soil sample from that depth tested 1,060 mg/kg for chlorides (Appendix A-1) and 45.9 ppm for PID hydrocarbons (Appendix A-2). ROC subsequently submitted a CAP Addendum to install the liner at 27 ft bgs and this was approved by OCD on January 23<sup>rd</sup>, 2012.

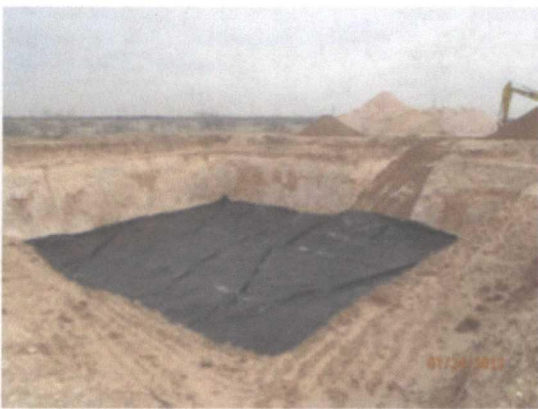
1/24/2012

98'x98' 20 mil reinforced liner installed at 26.5',  
facing northeast

The bottom of the excavation was padded with 6 inches of blow sand, and the 98 ft by 98 ft, 20 mil reinforced synthetic liner was properly seated. A 6 inch blow sand pad was then placed above the liner. The excavation was backfilled in 3 ft lifts with the previously excavated soil from Stockpile B, which had a laboratory chloride result of 608 mg/kg and a PID of 6.3 ppm, and from the 8 Pt Comp Spoil Pile, which had a laboratory chloride result of 464 mg/kg and a PID of 2.4 ppm (Appendix A-3, A-4). Once the excavation was backfilled up to 5 ft bgs, 6 inches of blow sand were used to pad the excavation. The second, near-surface 108 ft by 108 ft, 20 mil reinforced synthetic liner was installed and properly seated at 4.5 ft bgs with a 6-inch pad of clean blow sand carefully placed above it. The remaining excavation was backfilled with previously excavated soil from Stockpile A, which had a laboratory chloride reading of 304 mg/kg and a PID of 0.6 ppm, and from 8 Pt Comp Stockpile C, which had a laboratory chloride result of 352 mg/kg and a PID of 2.7 ppm, to within approximately 2 ft of the surface (Appendix A-3, A-4). The remaining volume was backfilled with clean, imported caliche, which tested 96 mg/kg and 144 mg/kg for chlorides (Appendix A-5) and 0.6 ppm and 1.6 ppm for PID hydrocarbons (Appendix A-6).

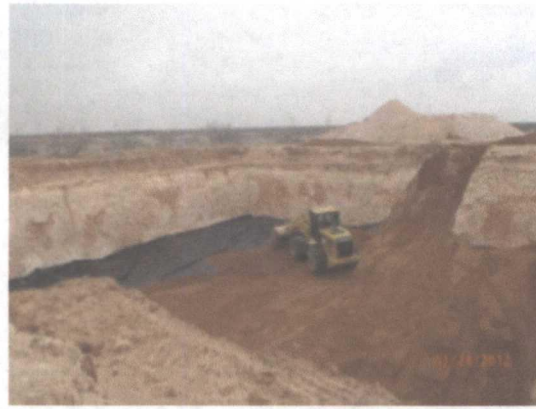
1/24/2012

installing a 6" blow sand pad above liner,  
facing northeast

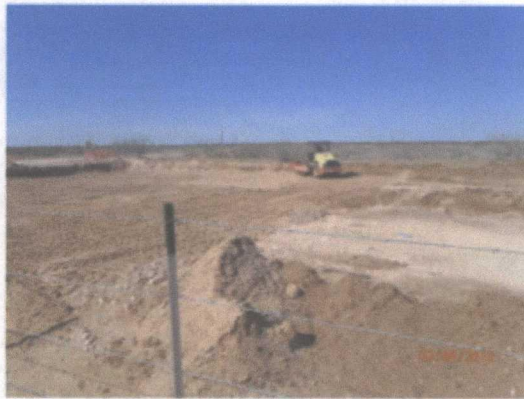
roller packing the backfilled excavation,  
facing northwest 2/6/2012

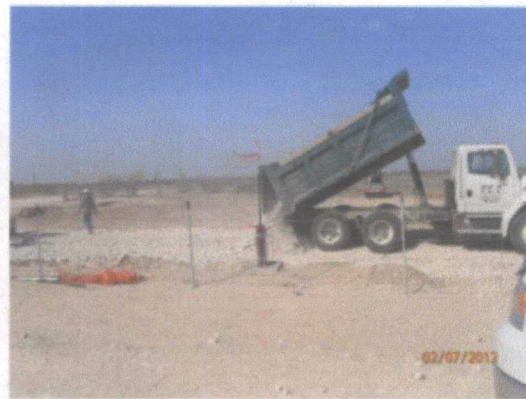
importing caliche,  
facing north 2/7/2012

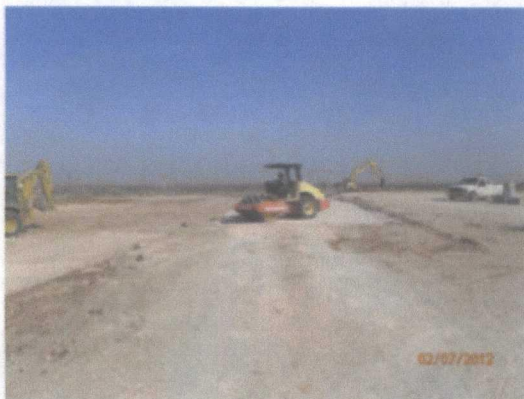
roller packing the backfilled site,  
facing east 2/7/2012

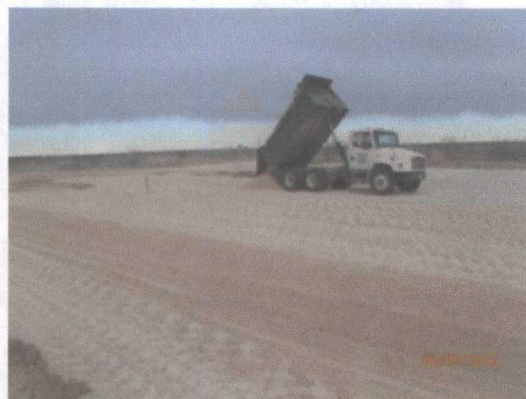
importing base coarse caliche,  
facing southeast 2/9/2012

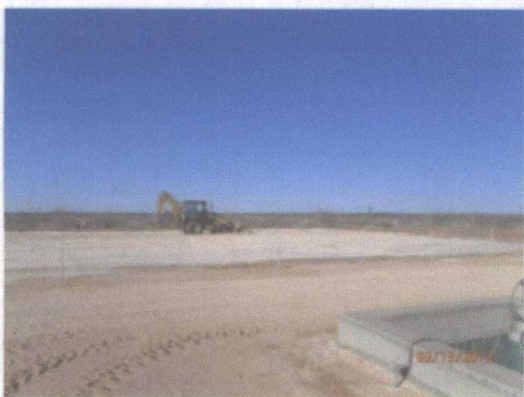
leveling the site using base coarse caliche,  
facing northwest 2/13/2012

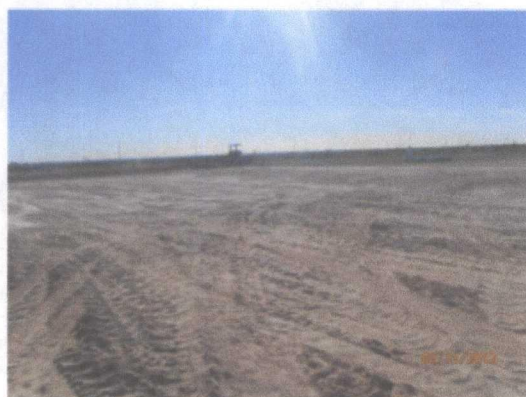
site complete,  
facing east 2/15/2012

Over the course of this work, which was completed on February 15<sup>th</sup>, 2012, a total of 806 cu yards of chloride-impacted soil material was removed and taken to Sundance Services for proper disposal. A total of approximately 1,456 cu yards of clean caliche were brought to the site to complete backfill and prepare a pad so that the site could be returned to normal use. A photographic chronology of the course of this work is given in Figures 4a-4c. Laboratory reports for soil chloride analyses and field PID reports are given in the Appendix.

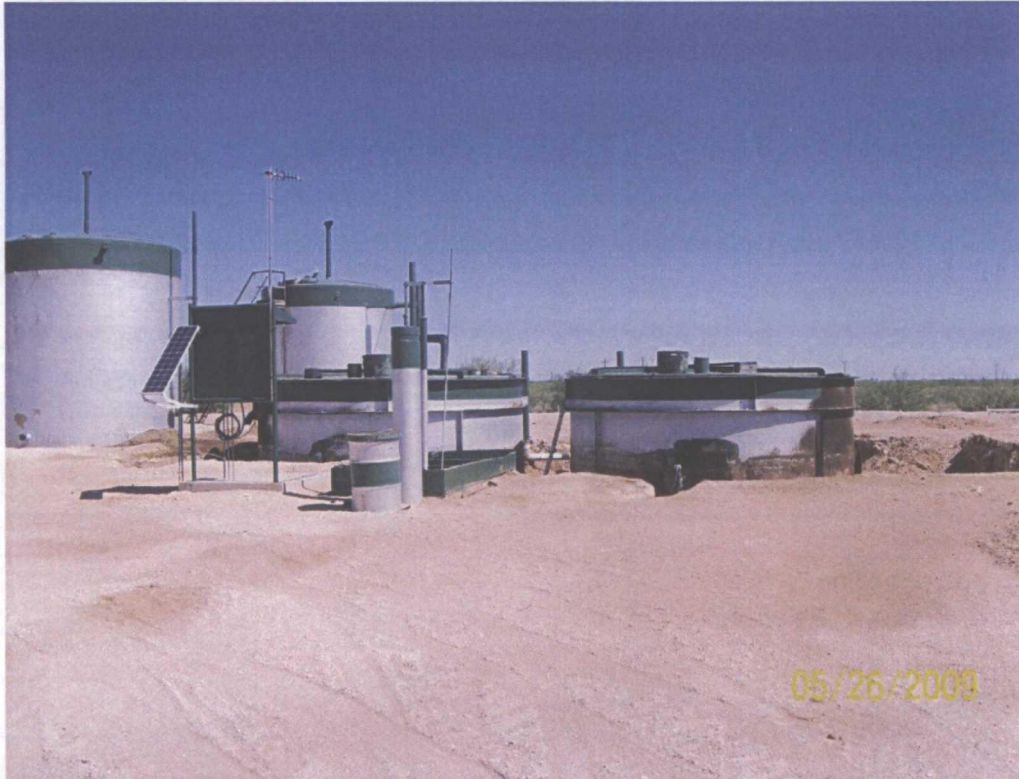
5/26/2009

Site photo of old facility

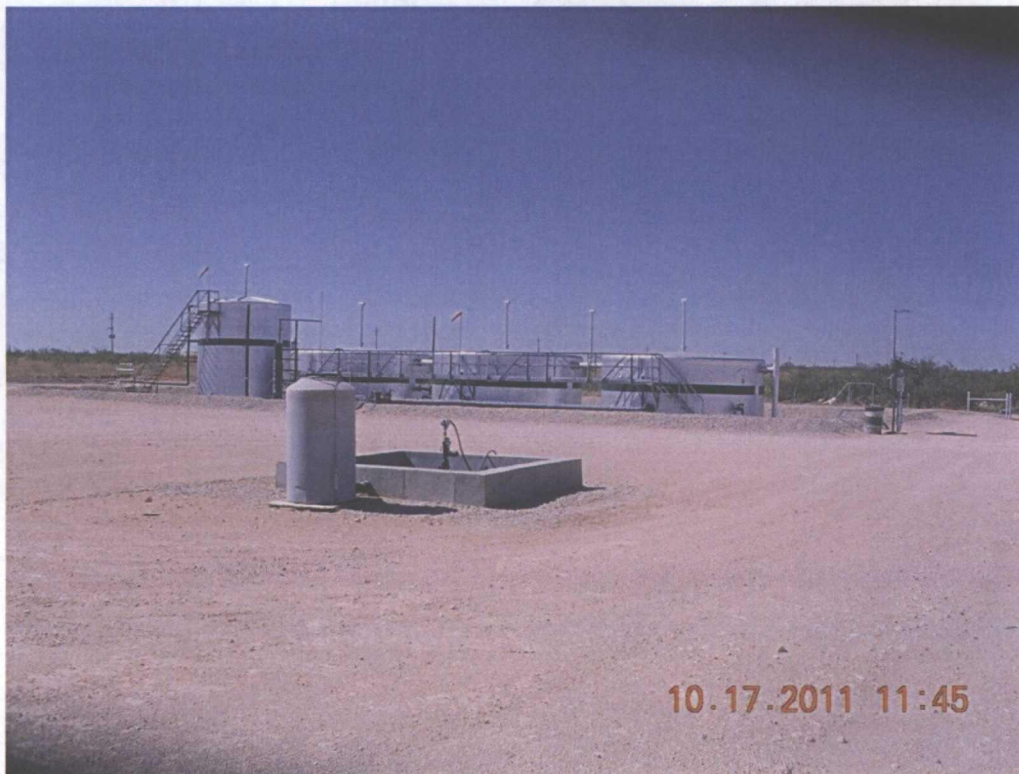
10/17/2011

Site photo of new facility
