**RE: Termination Request
for the Rice Operating Company's
Vacuum Jct L-29 Site
Unit Letter L, Section 29, T17S, R35E, NMPM, Lea County, New Mexico
Remediation Plan (1R425-90) Termination**

RE: Termination Request
Vacuum Jct. L-29 (1R425-90): UL/L, Sec. 29, T17S, R35E
RICE Operating Company – Vacuum SWD System

**RICE OPERATING COMPANY
JUNCTION BOX FINAL REPORT**

Vacuum Jct. L-29

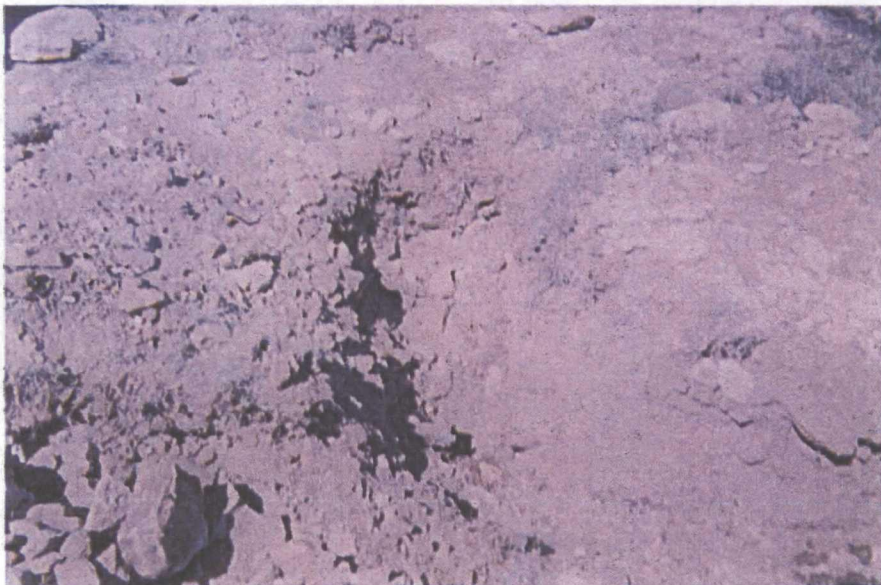
Site prior to delineation

6/22/2010

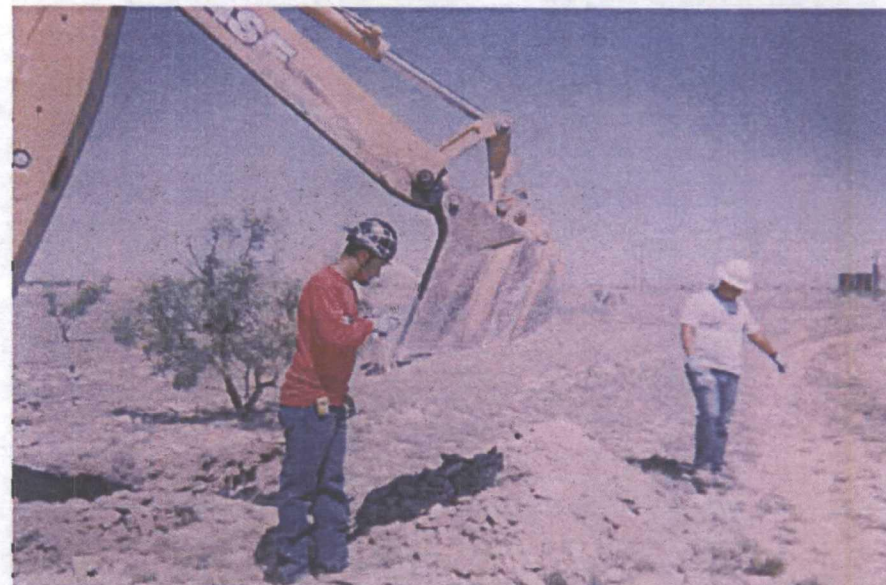
Collecting sample

6/22/2010

General Description of Remedial Action: This junction box was addressed during the Vacuum SWD System abandonment. After the former junction box was removed an investigation was conducted using a backhoe to collect soil sample at regular intervals creating a 5x3x7-ft deep excavation. Each sample was field tested for chlorides and organic vapors which yielded low concentrations similar to that of the background sample.

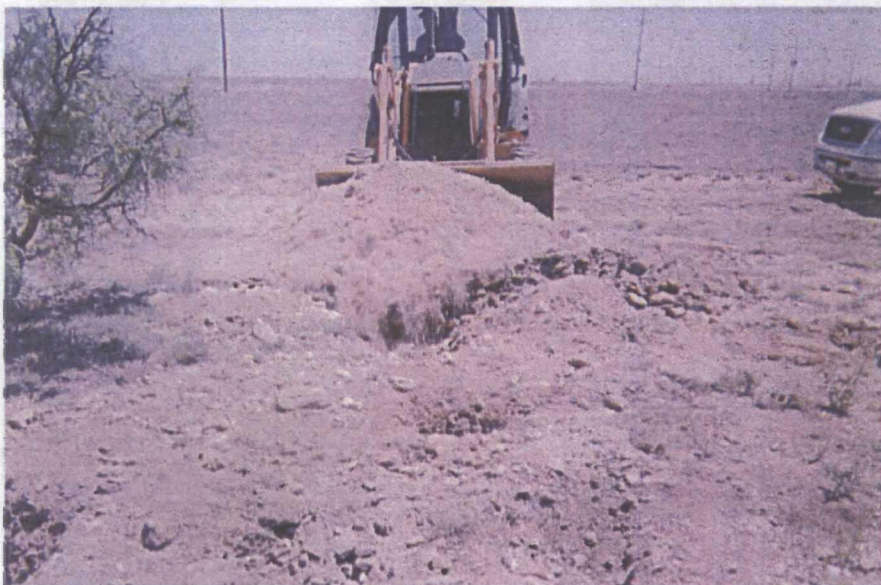
Backfilling excavation

6/22/2010

The excavated soil was returned to the excavation to ground surface and contoured to the surrounding area. On 6/22/2010, the site was seeded with a blend of native vegetation and is expected to return to a productive capacity at a normal rate.

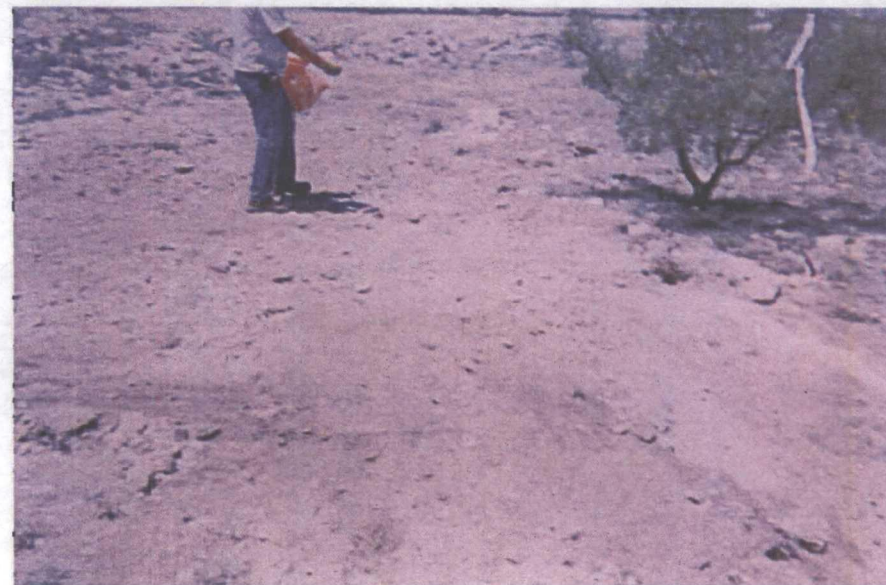
Seeding excavation

6/22/2010
