**RE: Termination Request
for the Rice Operating Company's
Vacuum E-29 EOL Site
Unit Letter E, Section 29, T17S, R35E, NMPM, Lea County, New Mexico
Remediation Plan (1R425-79) Termination**

RE: Termination Request
Vacuum E-29 EOL (1R425-79): UL/E, Sec. 29, T17S, R35E
RICE Operating Company – Vacuum SWD System

RICE OPERATING COMPANY
JUNCTION BOX FINAL REPORT

Vacuum E-29 EOL

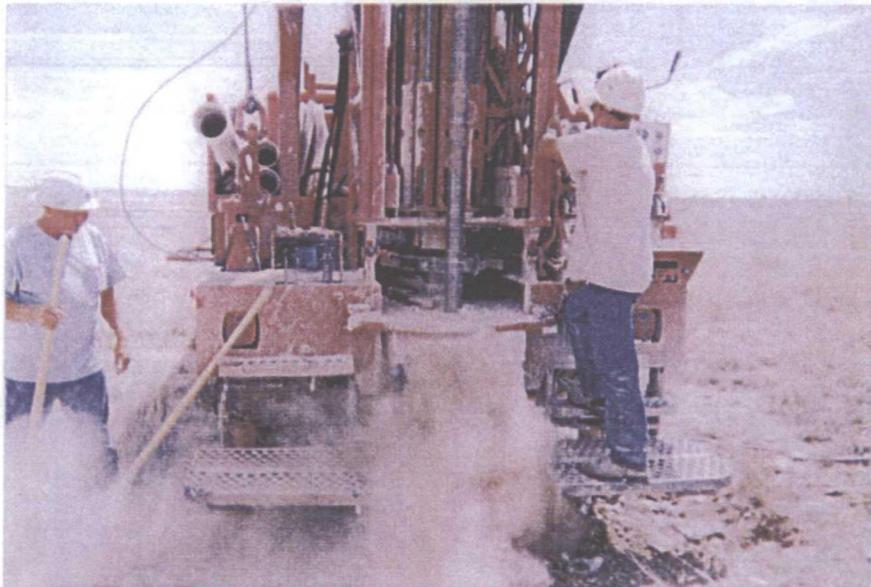
6/18/2009

drilling SB #1 at the former junction box site

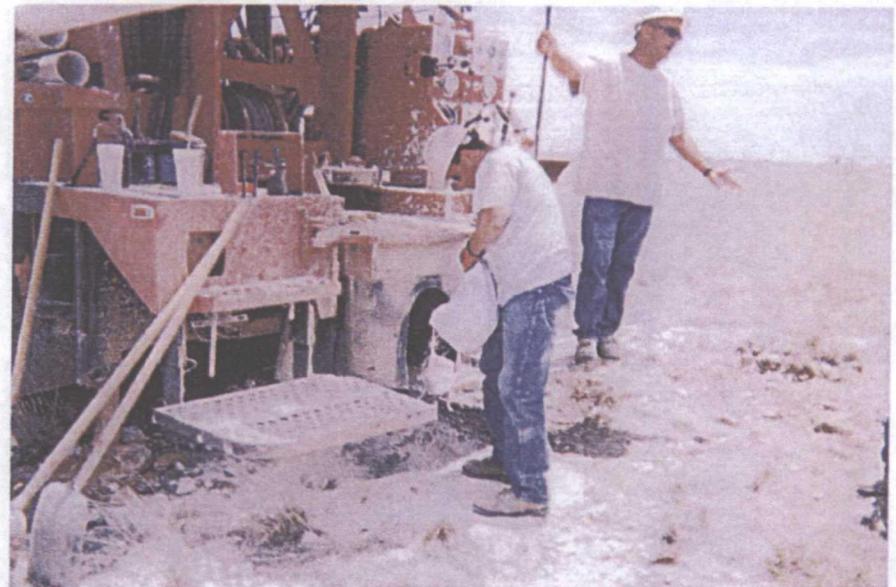
6/18/2009

plugging SB #1 with bentonite

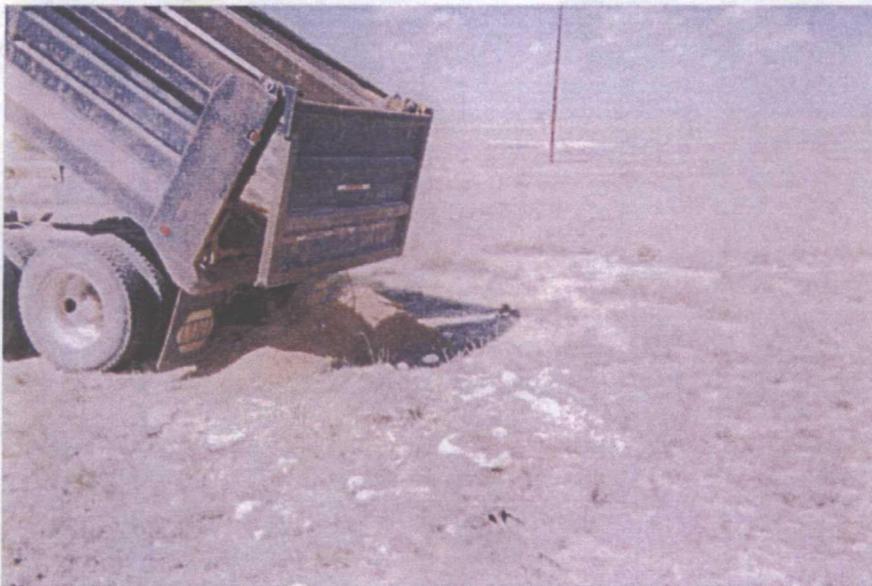
6/24/2009

importing clean soil to the site
