**RE: CAP Report and Termination Request
Rice Operating Company – EME SWD System
EME H-7 EOL (1R427-351): UL/H sec. 7 T20S R37E
(formerly EME I-7 EOL)**

EME H-7 EOL

Liner Installation Documentation

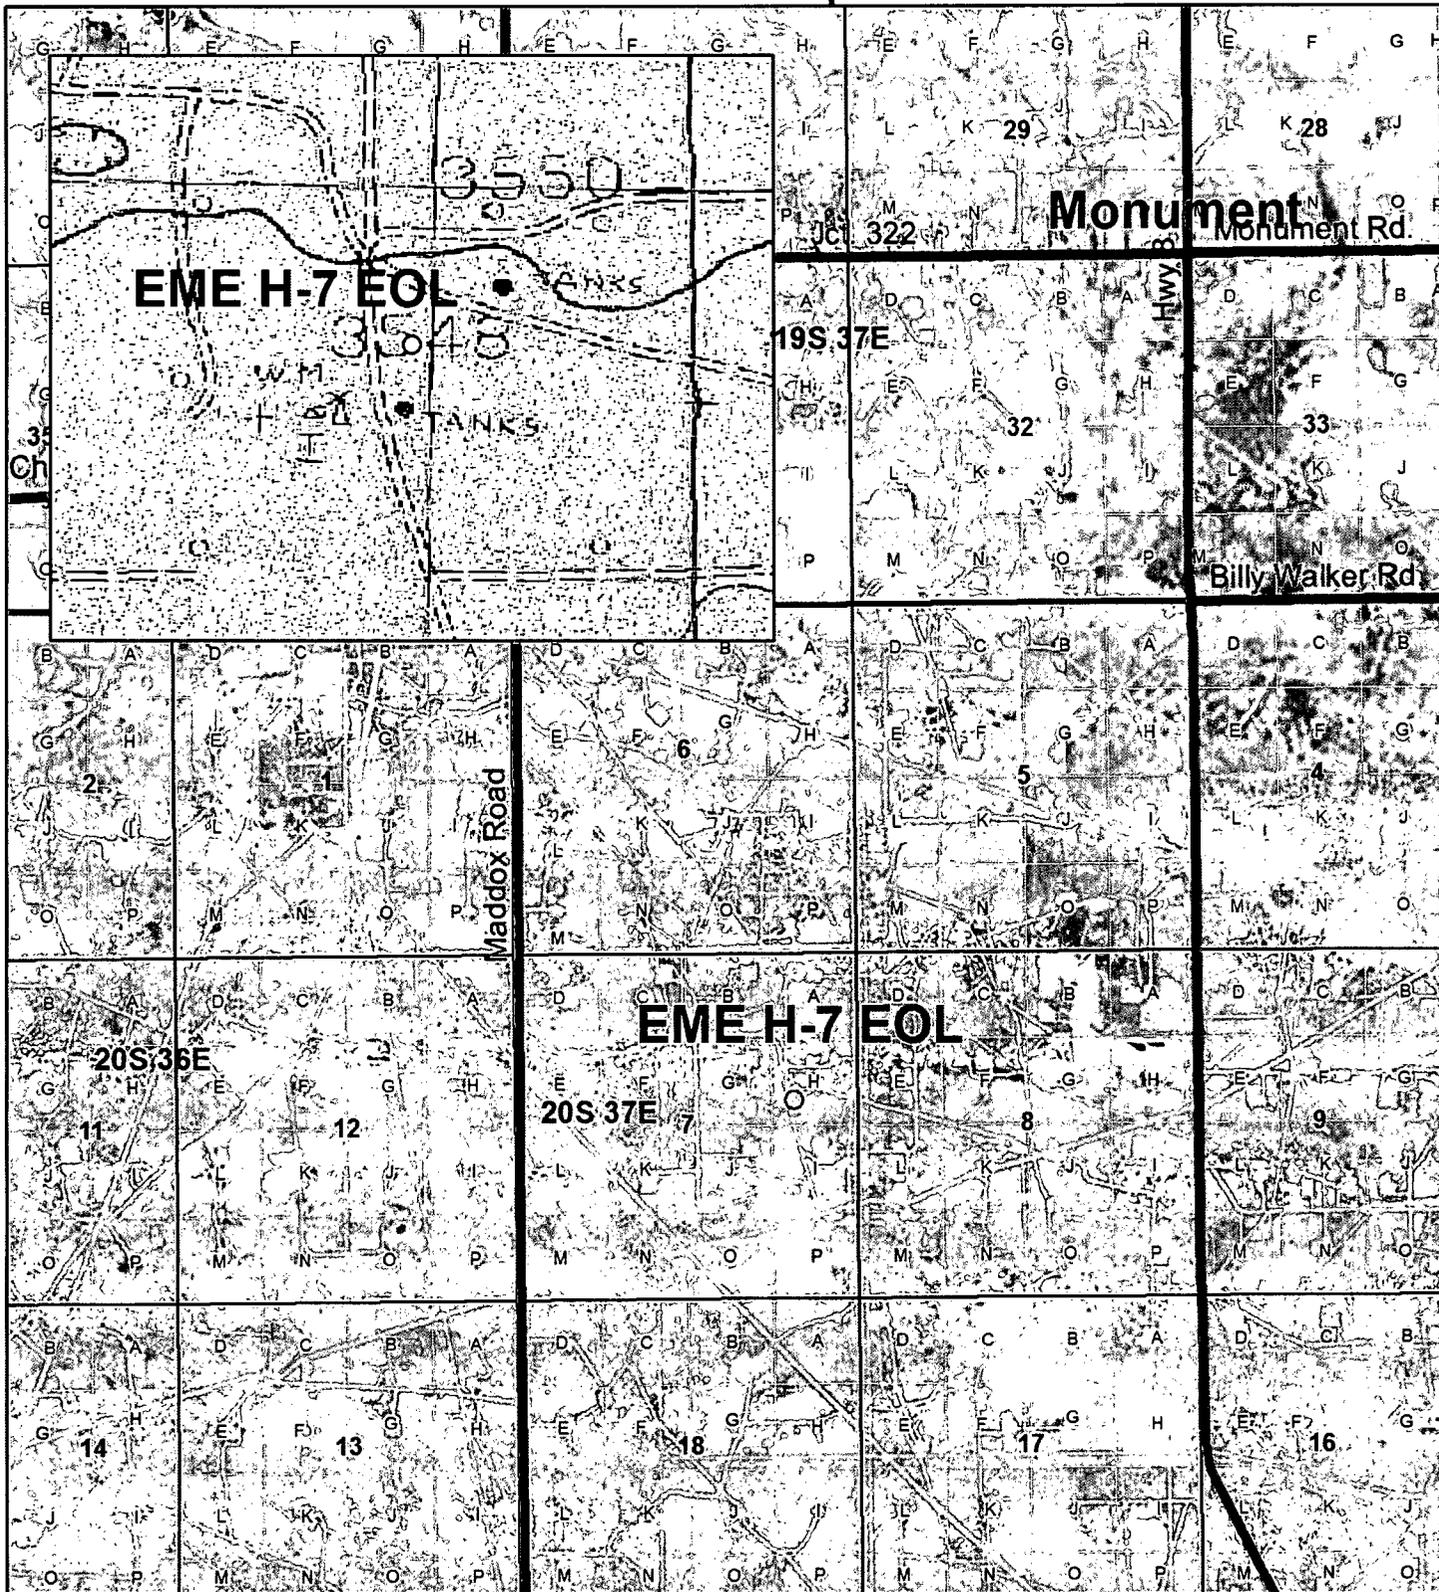
Figure 1

The site is located approximately 2.5 miles southwest of Monument, New Mexico at UL/H sec. 7 T20S R37E as shown on the Site Map (Figure 1). Monitor well sampling at the site indicates that groundwater is located at 29 ft bgs.

Site Map

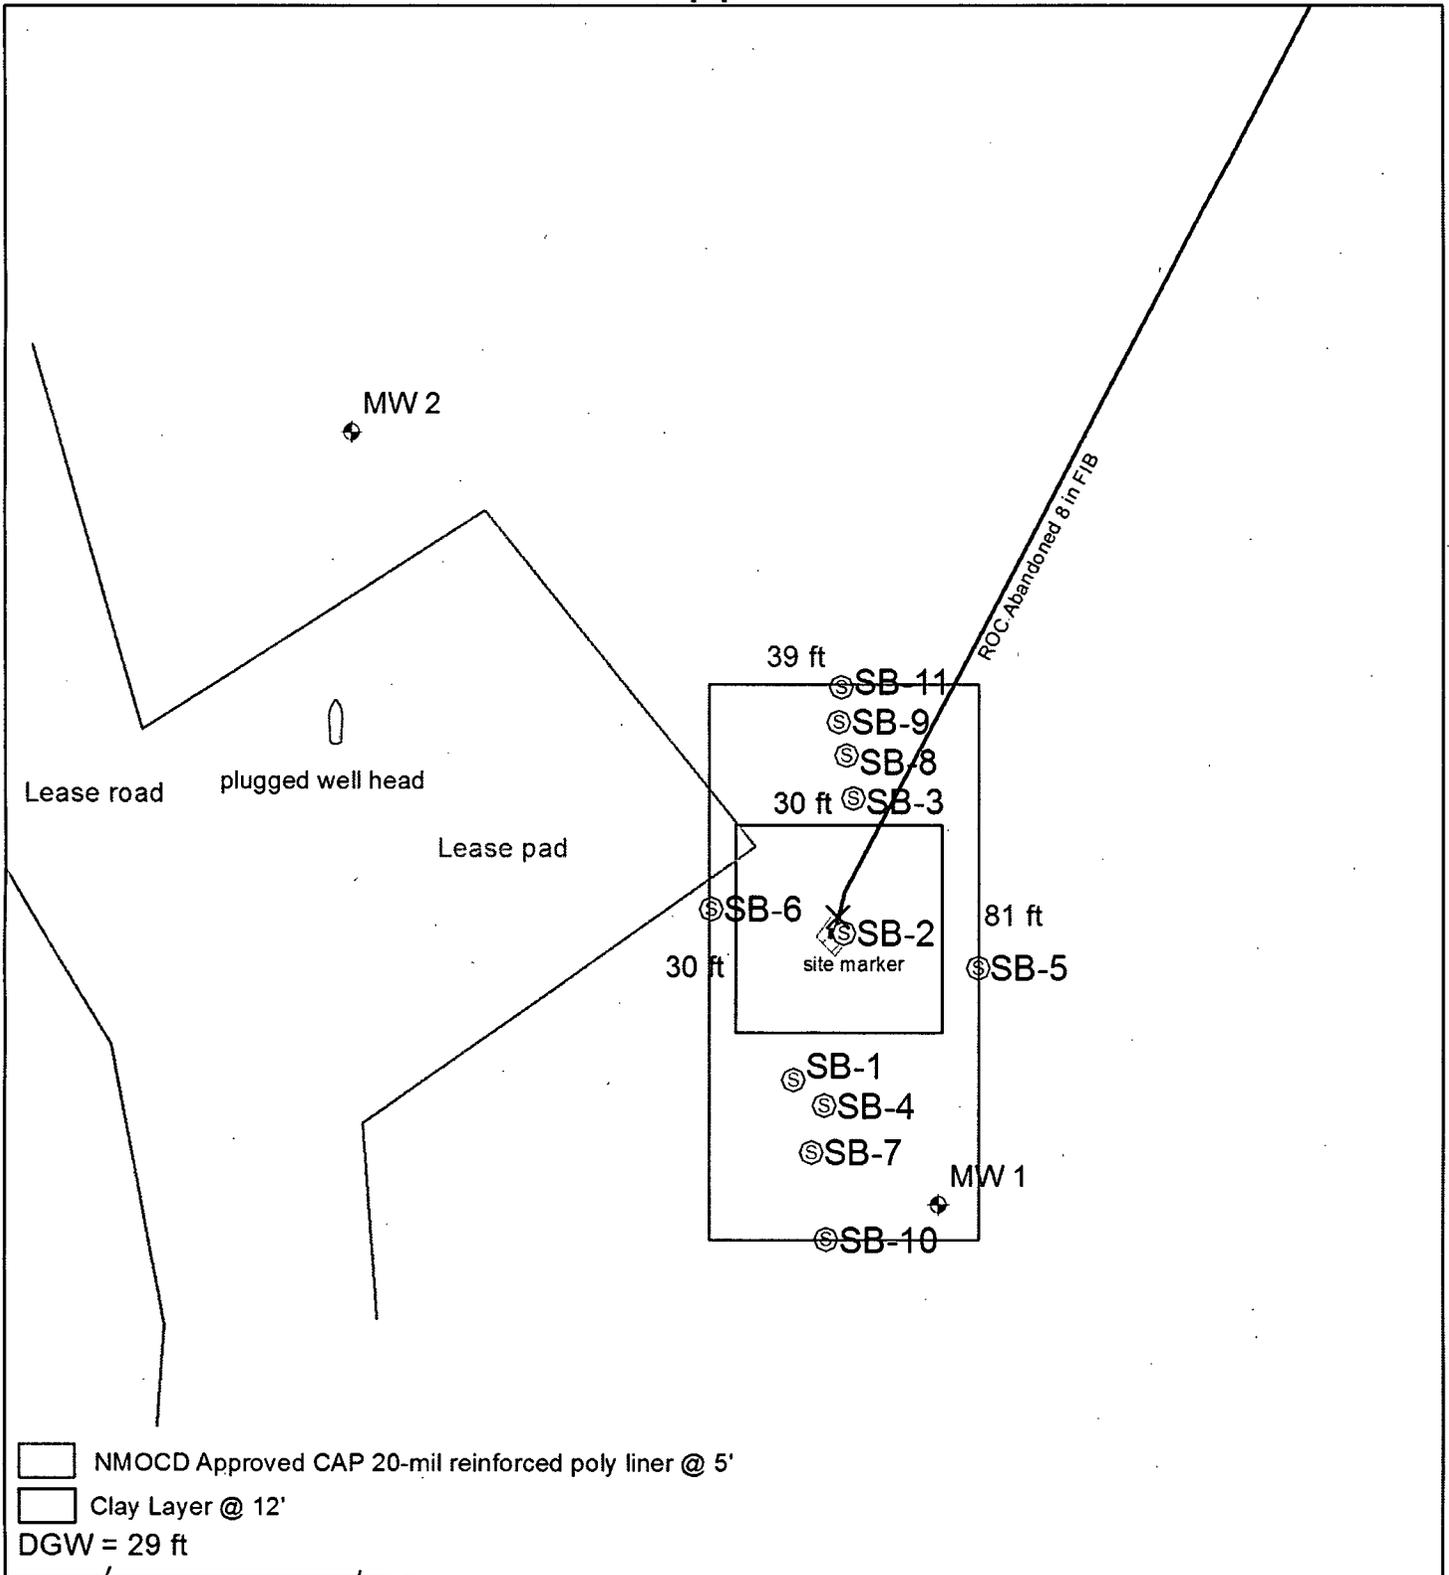
NMOCD Approved Liner

On May 11th, 2012, RECS personnel were on site to begin the excavation for liner installation. The site was excavated to 39 ft x 81 ft x 5 ft deep (Figure 2). 60 yards of the

ROC has completed the corrective actions as approved by NMOCD in the CAP by installing and properly seating a 20-mil reinforced poly liner measuring 39 ft x 81 ft at 5 ft deep over the existing clay layer measuring 30 ft x 30 ft at 12 ft deep and by removing the necessary 179 kg of chlorides the site contributed to groundwater. Therefore, ROC requests 'remediation termination' status of the regulatory file.

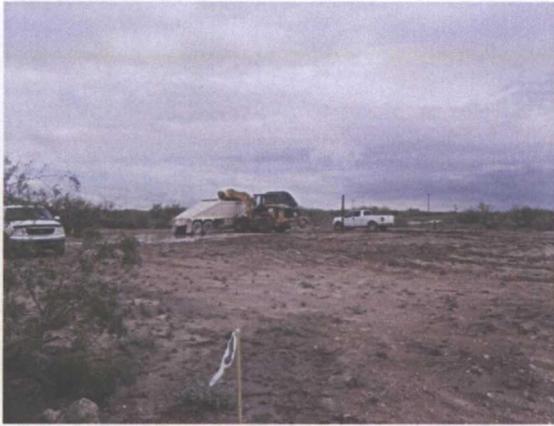
Exporting soil, facing northwest 5/11/12

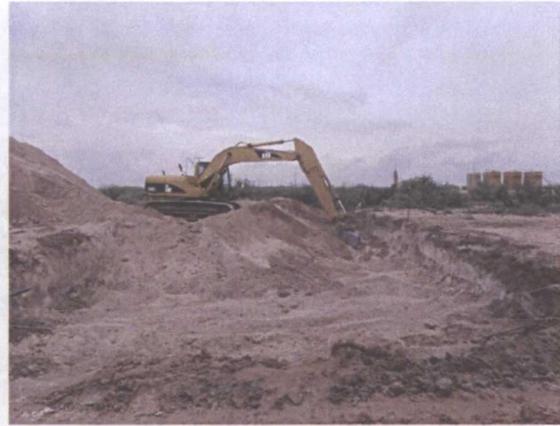
Excavating site, facing north 5/14/2012

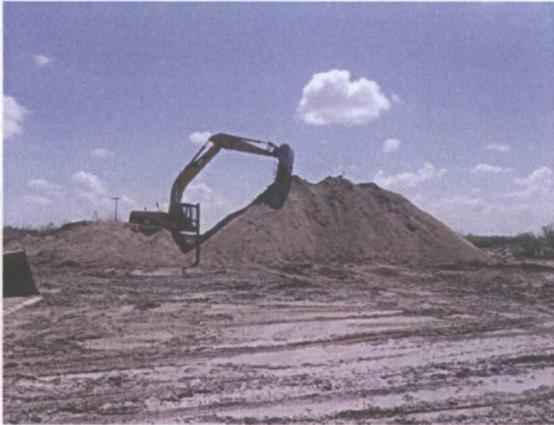
Blending excavated soil, facing east 5/15/2012

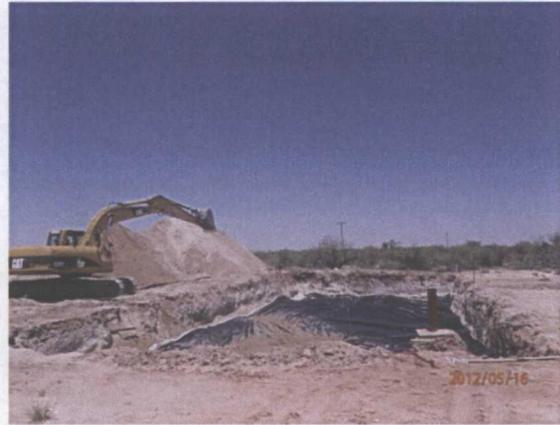
Backfilling above installed 39' x 81' 20-mil reinforced plastic liner, facing north 5/16/2012

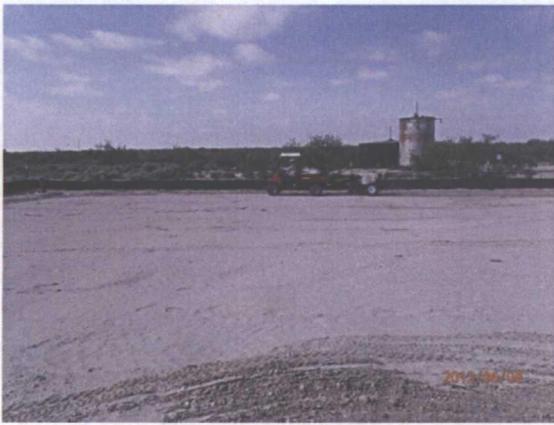
Seeding and tilling site, facing south 6/8/2012

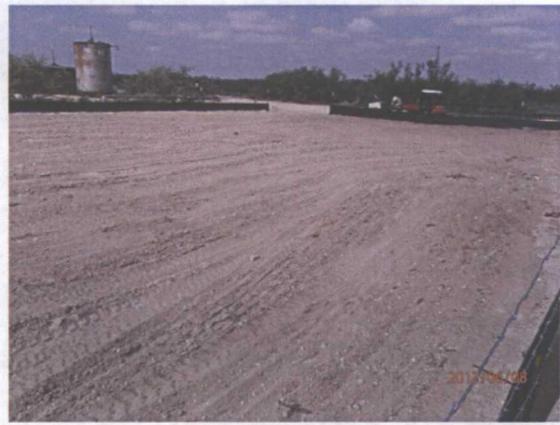
Site complete, facing southwest 6/8/2012
