# WORKPLANS

**INVESTIGATION & CHARACTERIZATION PLAN (ICP)  
EME I-18 EOL  
Unit I, SEC. 18, T19S, R37E, Monument, Lea County, New Mexico  
NMOCD CASE # 1R427-367**

## **EME I-18 EOL**

# EME P-18 EOL

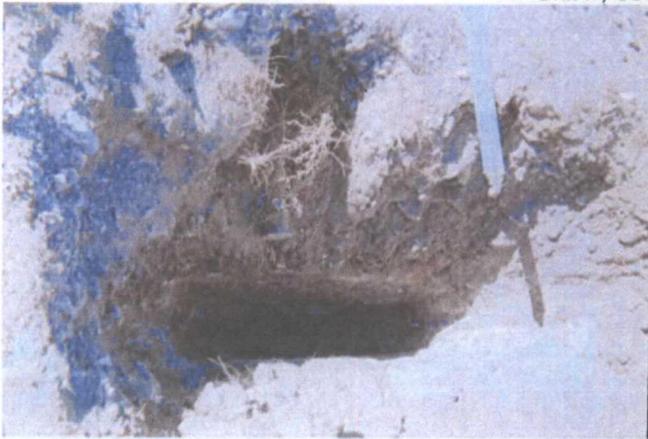
1.26.11

A backhoe was used to excavate soils from an excavation measuring 10 feet by 10 feet by 12 feet deep around the former junction box. Soil samples were collected at regular intervals and analyzed in the field for chlorides using field-adapted Standard Method 4500-Cl<sup>-</sup>B and screened in the field using a photoionization detector (PID).

Excavating site

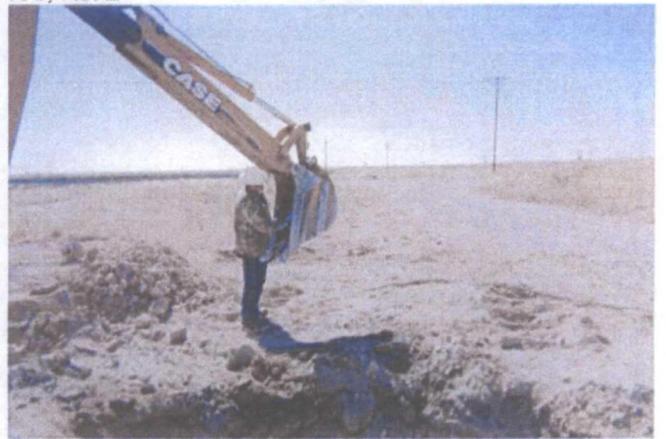
2.14.11

A five-point wall composite sample was collected from each of the four walls and combined to make a representative four-wall composite sample; and a five-point composite sample was collected from the bottom of the excavation and submitted to Cardinal Laboratories for gasoline range organics (GRO), diesel range organics (DRO) and chloride analysis. DRO was detected at a concentration of 1,100 milligrams per kilogram (mg/kg) in the four-wall composite sample and 1,780 mg/kg in the five-point bottom composite sample. GRO was detected at a concentration of 82.3 mg/kg in the four-wall composite sample and 76 mg/kg in the five-point bottom composite sample. Chlorides were detected at a concentration of 16 mg/kg in both the four-wall composite sample and the five-point composite bottom sample.

Collecting sample

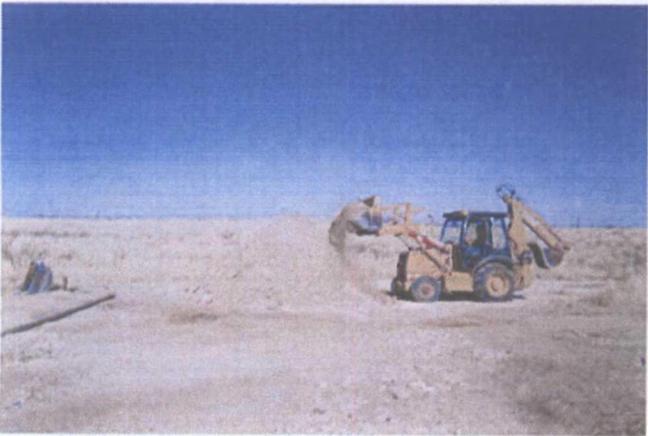
2.14.11

Excavated soils were blended on site and backfilled into the excavation to ground surface. The area was contoured to the surrounding landscape and seeded with a blend of native vegetation.

A sample of the blended backfill material was submitted to Cardinal Laboratories for GRO, DRO and chloride analysis. DRO was detected at a concentration of 1,080

mg/kg and GRO was detected at a concentration of 76.3 mg/kg. Chlorides were detected at a concentration of 16 mg/kg.

Blending backfill

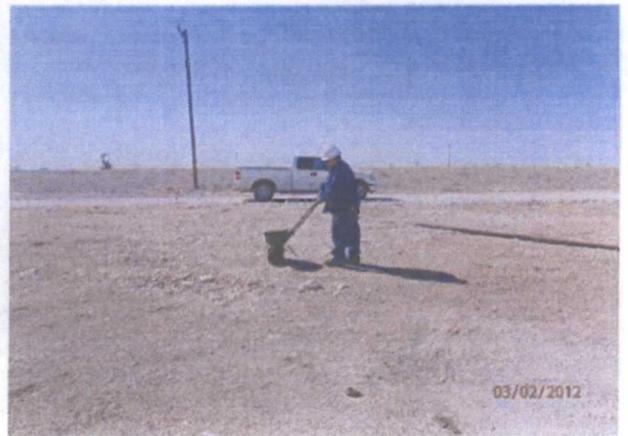
3.2.12

Seeding site

Custom seed mix <input checked="" type="checkbox"/>	Prescribed mix <input type="checkbox"/>	Seed mix name: 2 lbs blue grama	Seedingdate: 3-2-11
Broadcast <input checked="" type="checkbox"/>			
Method: Portable seeder			
Soil conditions during seeding: Dry <input checked="" type="checkbox"/> Damp <input type="checkbox"/> Wet <input type="checkbox"/>			
Photos attached <input checked="" type="checkbox"/>	Observations:		
Number of photos:

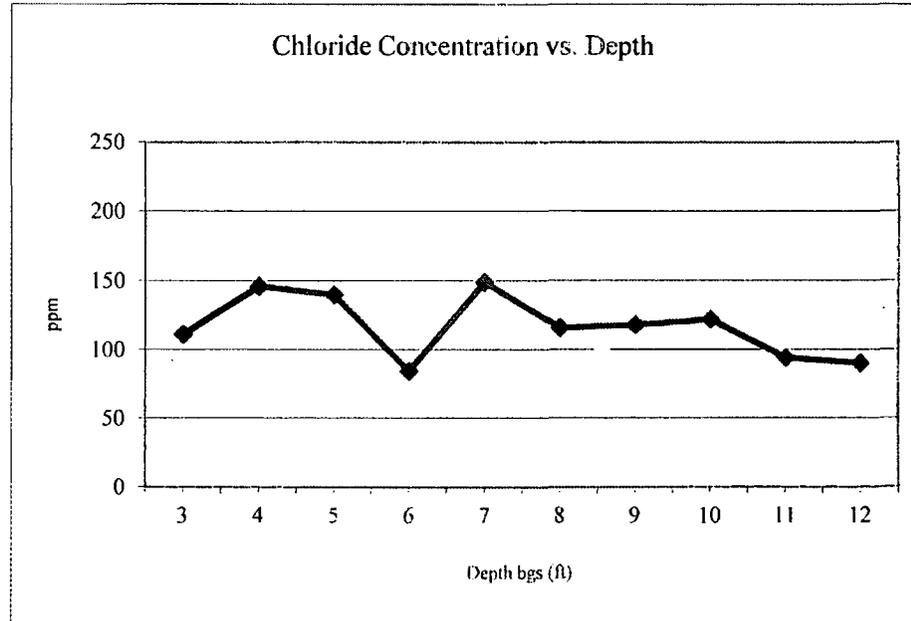
CHLORIDE CONCENTRATION CURVE

*Backhoe samples at junction (source)*

Depth bgs (ft)	[Cl <sup>-</sup> ] ppm
3	111
4	146
5	140
6	84
7	149
8	116
9	118
10	122
11	94
12	90

Groundwater = 35 ft
