**RE: Termination Request  
for the Rice Operating Company's  
Vacuum Jct C-7 Site  
Unit Letter C, Section 7, T18S, R35E, NMPM, Lea County, New Mexico  
Remediation Plan (1R425-75) Termination**

RE: Termination Request  
Vacuum Jct. C-7 (1R425-75): UL/C, Sec. 7, T18S, R35E  
RICE Operating Company – Vacuum SWD System

## Vacuum Jct. C-7

Unit C, Section 7, T18S, R35E

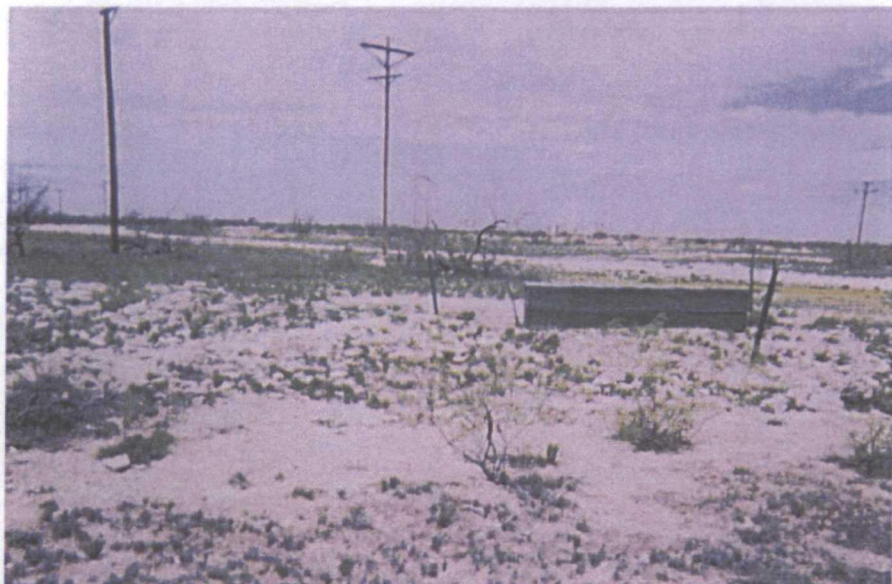
4/18/2002

former junction box site

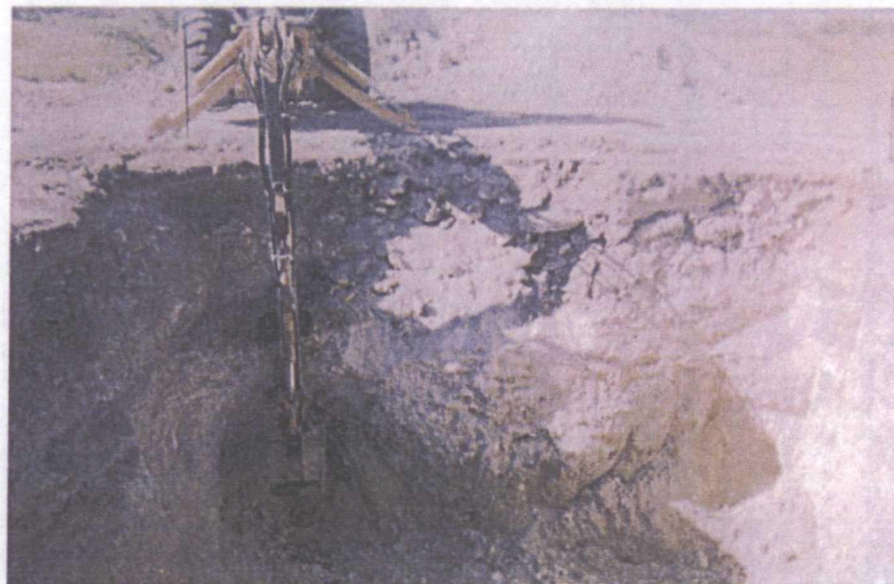
10/4/2006

excavating the former junction box site

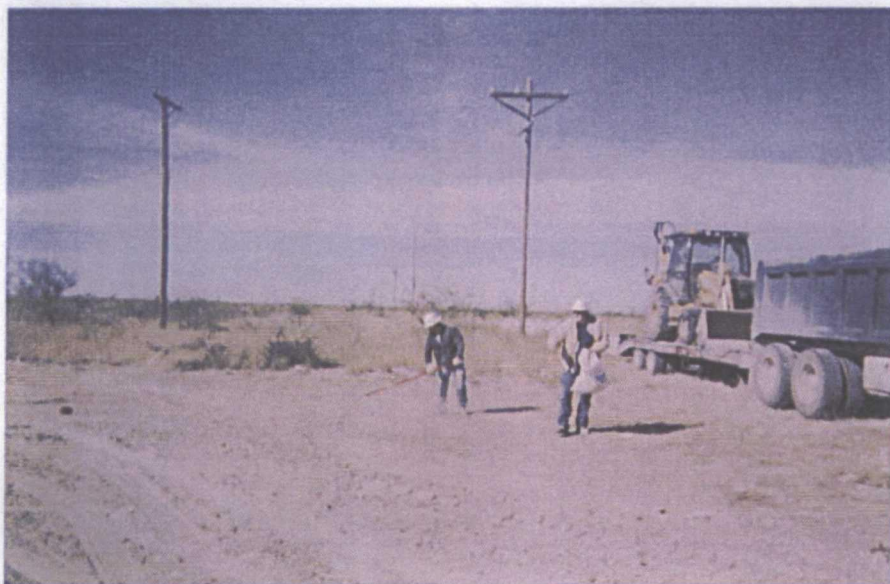
11/6/2006

seeding backfilled site

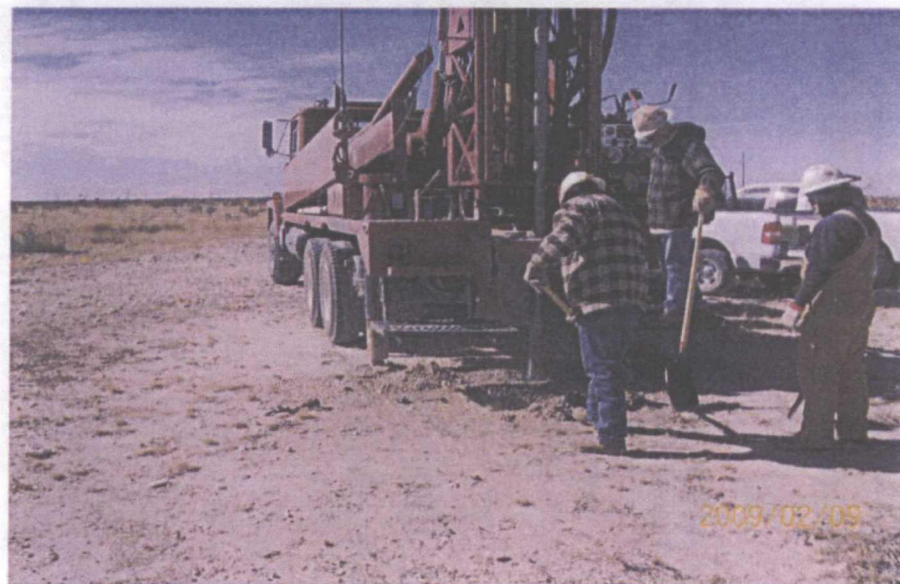
soil boring the former junction box site

To further investigate the depth of TPH presence, a soil boring was initiated on 2/9/2009 at the former junction box site. The boring was advanced to a total depth of 30 ft BGS with soil samples collected every 5 ft and field tested for chlorides and organic vapors. The 30 ft sample was sent to a laboratory for analysis of chloride and TPH, resulting in a chloride concentration of 16 mg/kg, and GRO and DRO concentrations below detectable limits. The entire bore hole was plugged with bentonite to ground surface. The junction box final report, photo documentation, laboratory analysis, PID sheet, and boring log are attached.

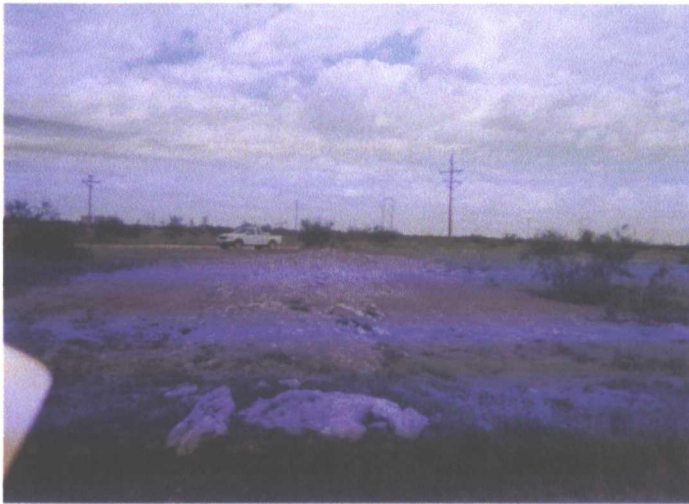
3/3/2006

Facing northwest

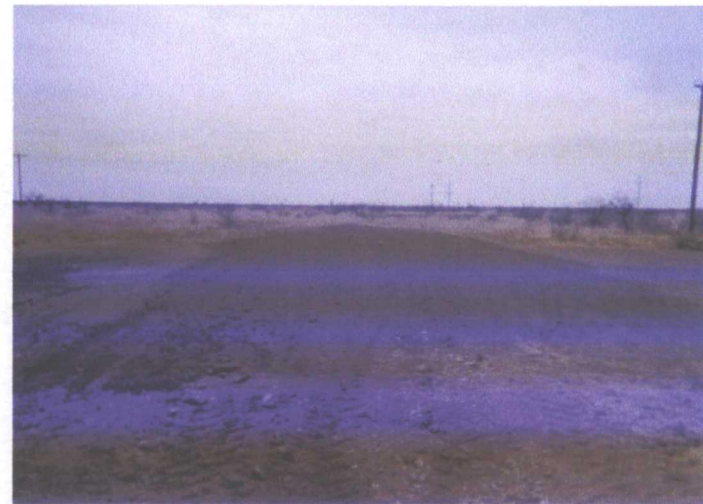
3/6/2006

Facing north

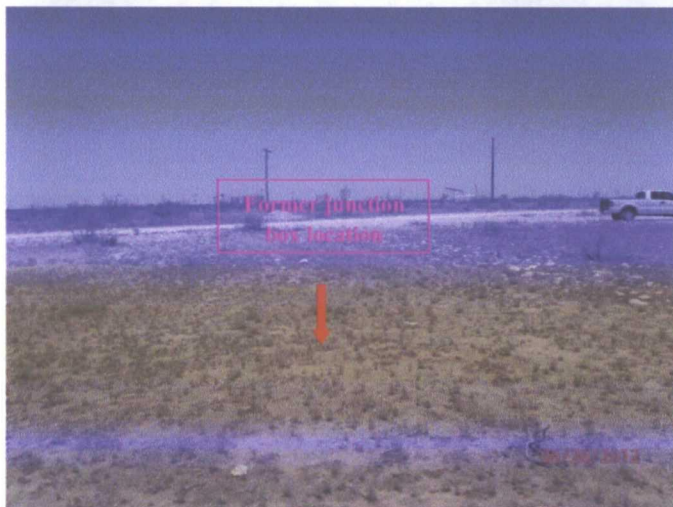
6/26/2012

Facing northwest

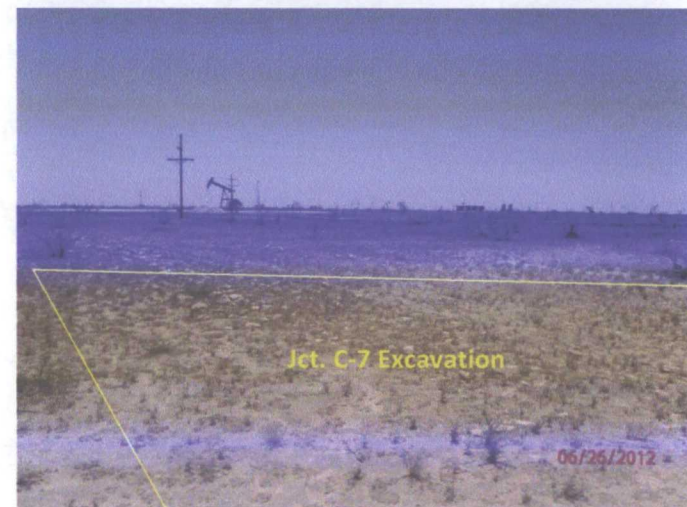
6/26/2012

Facing southeast
