1R - 426-09

Re: Corrective Action Plan (CAP) Report and Termination Request, Rice Operating Company, Blinebry Drinkard (BD) Saltwater Disposal System (SWD) H-19 Vent, Unit H, Section 19, T-21-S, R-37-E, Lea County, New Mexico, NMOCD CASE #1R0426-09

**BD H-19 vent (1R426-09)
Unit H, Section 19, T21S, R37E**

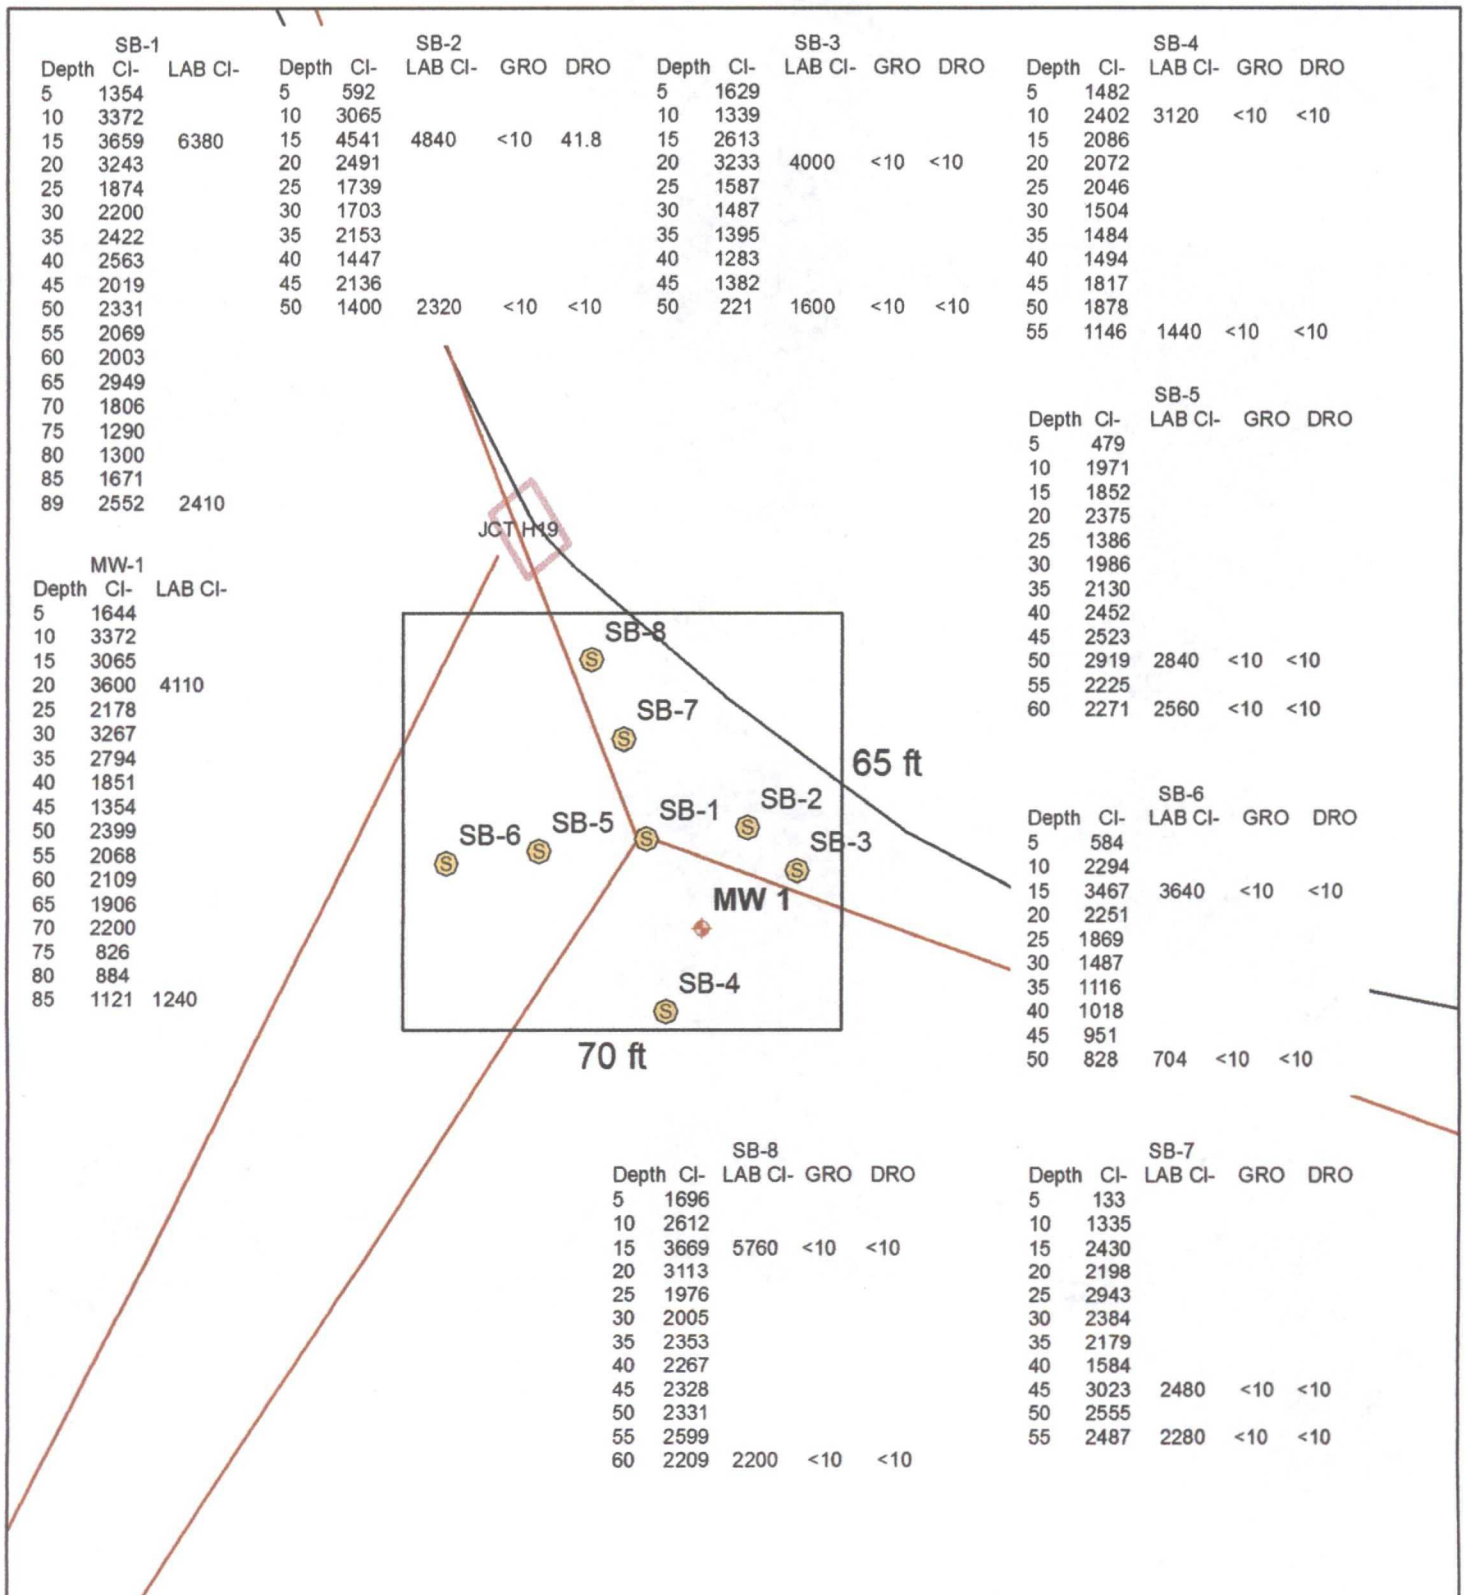
Figure 3

Soil Bore Information and Proposed Infiltration Barrier

Liner Dimensions

A CAP was submitted to the NMOCD on January 5, 2011 with an addendum to the CAP submitted on April 11, 2011. The CAP, which was approved by the NMOCD on April 13, 2011, proposed the installation of a 20-mil polyethylene liner at a depth of 4 feet bgs with measurements of 65 feet by 70 feet. In addition, with the impacted groundwater up-gradient at the site indicating a regional impact, a chloride mass calculation removal of 13,405 gallons or 355 kilograms (kg) was proposed for the site. Since there is a relatively negligible impact to monitor well MW-1, the water was to be pumped from recovery systems located at the nearby sites BD O-23 vent and BD O-23-1.

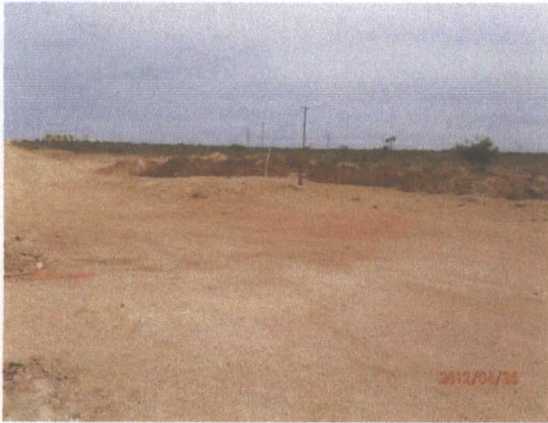
Exporting soil, facing northeast 4/26/12

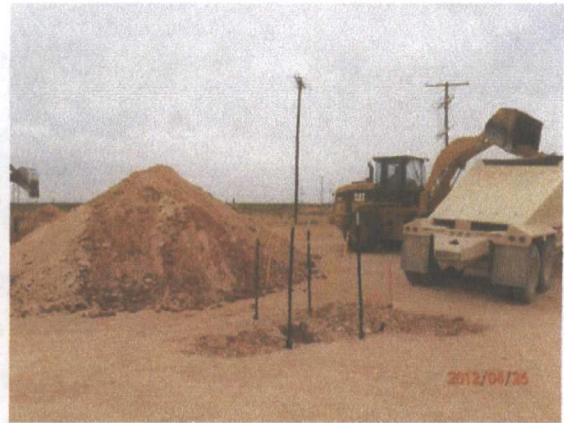
Exporting soil, facing east 4/26/2012

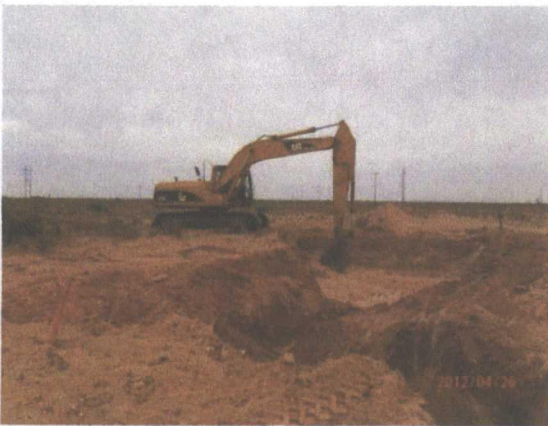
Excavating site, facing east 4/26/2012

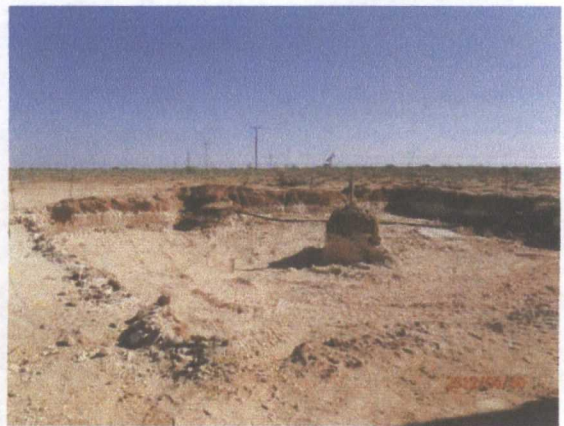
Completed excavation, facing northeast
4/30/2012

As per the approved CAP and addendum, dated January 5 and April 11, 2011, ROC was onsite between April 26 and June 15, 2012 to oversee the site field activities. As part of the activities, an area measuring approximately 70 feet by 65 feet by 5 feet deep was excavated in the vicinity of the former junction box. Upon completion of the excavation, a 6-inch layer of clean sand was backfilled within the area prior to placement of a 20-mil polyethylene liner of the same measurements. See Figure 3 for liner location and dimensions. Once the liner was installed at 4.5 feet bgs, a second 6-inch layer of clean sand was placed over the liner. Above the sand was placed 3 feet of clean caliche and capped with 1 foot of sand. A laboratory sample of the imported caliche and imported blow sand returned a chloride concentration result of 64 mg/kg in the imported caliche and a chloride concentration result of 16 mg/kg in the imported blow sand (See Appendix A). The top layer of sand was then contoured to match the surrounding topography, amendments were added and the soils seeded with a mixture of Race Horse Oats and Lea County Seed Mix. See Photographs for site restoration activities. Approximately 1,040 cubic yards of chloride impacted soils were transported offsite for disposal at a NMOCD approved facility.

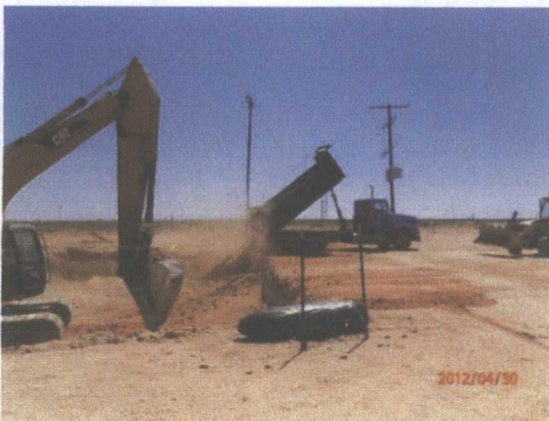
Importing sand, facing southeast 4/30/2012

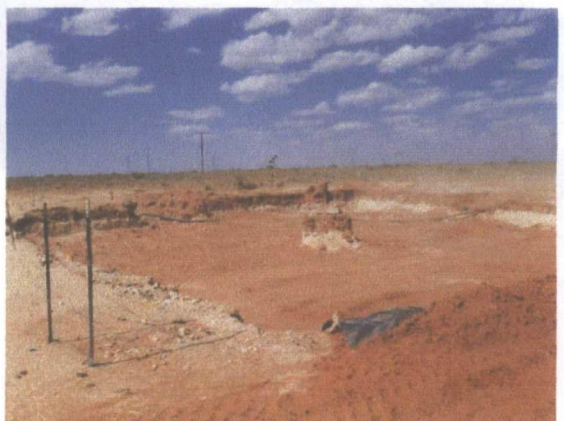
Installed bottom 6" sand pad, facing northeast
4/30/2012

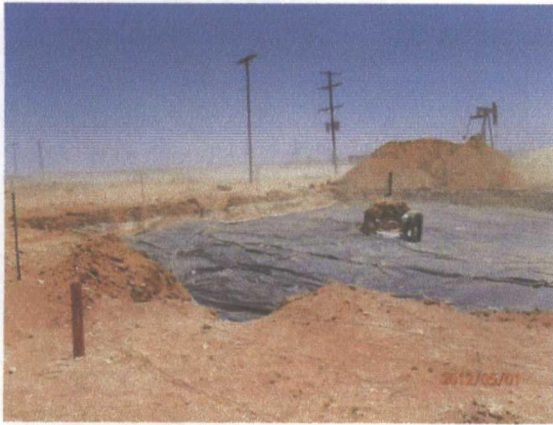
Installing a 70' x 65', 20-mil reinforced liner at 4.5' bgs, facing southeast 5/1/12

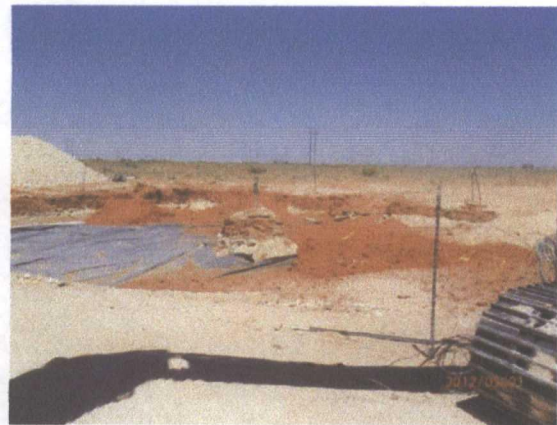
Installing 6" sand pad above liner, facing northeast 5/1/2012

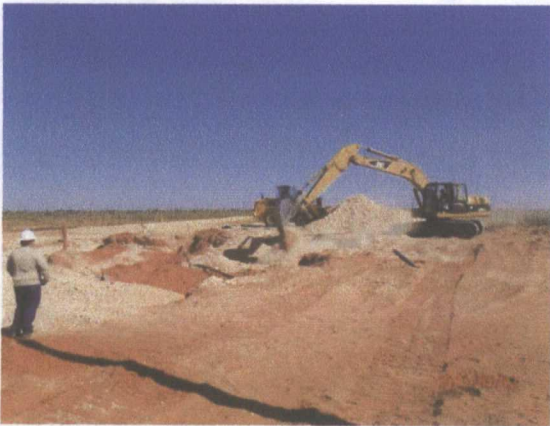
Backfilling site with caliche up to 1' bgs, facing northwest 5/2/2012

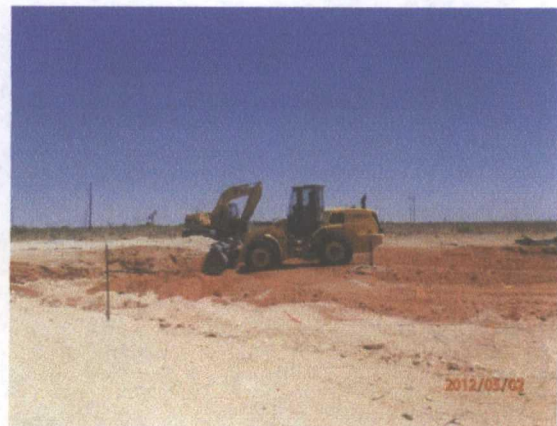
Backfilling site from 1' bgs to ground surface with sand, facing northeast 5/2/2012

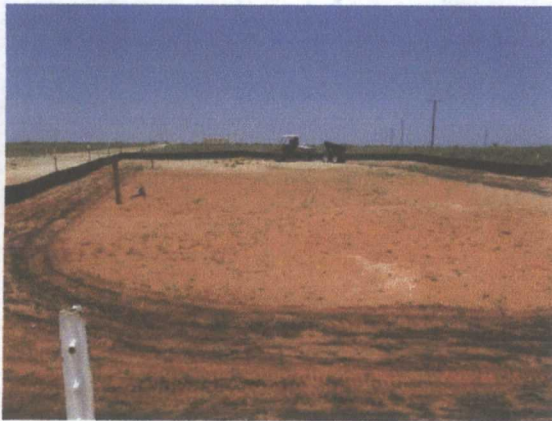
Spreading amendments, facing north 6/15/2012

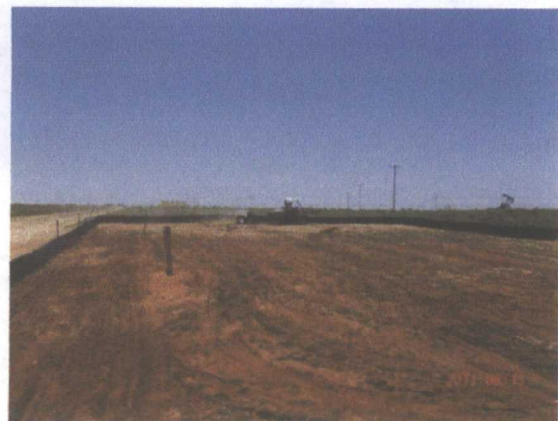
Seeding site, facing north 6/15/2012
