**RE: Corrective Action Plan (CAP) Report – Plug and Abandon MW-1 and
Replace with MW-1R
Rice Operating Company – Vacuum SWD System
Vacuum L-26 vent (1R425-66): UL/L sec. 26 T17S R35E**

CAP Report – Plug and Abandon MW-1 and Replace with MW-1R

Vacuum L-26 vent
Unit Letter L, Section 26, T-17-S, R-35-E

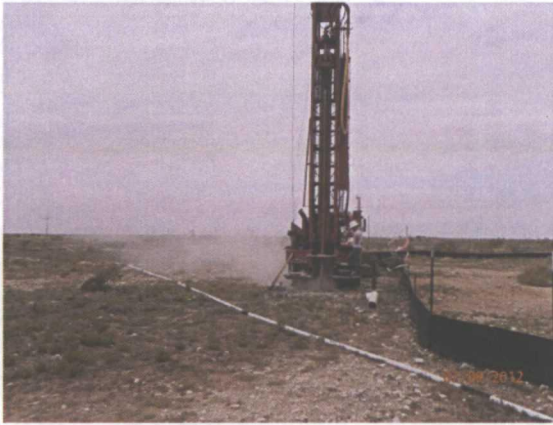
Drilling MW-1R, facing west 7/9/12

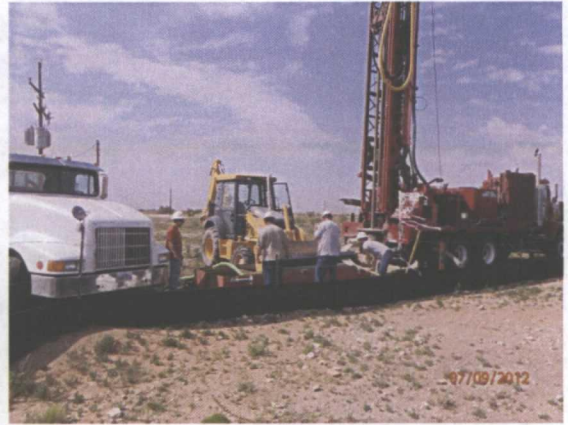
Mudding in MW-1R, facing southwest 7/9/12

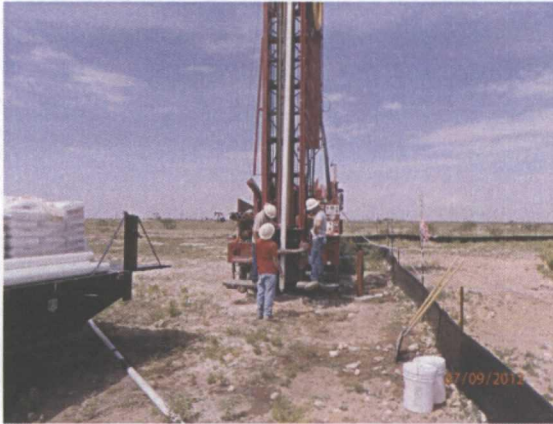
Installing the casing, facing west 7/9/12

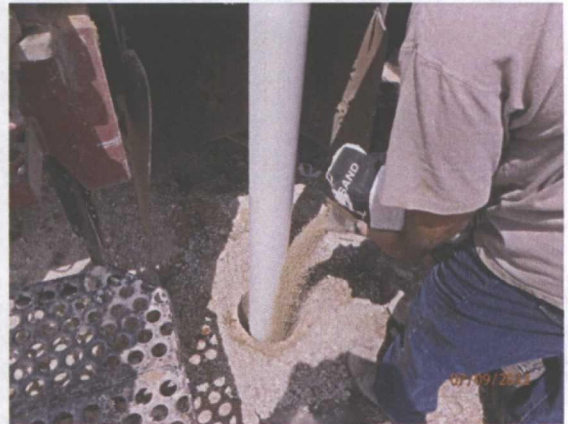
Installing the sand pack 7/9/12

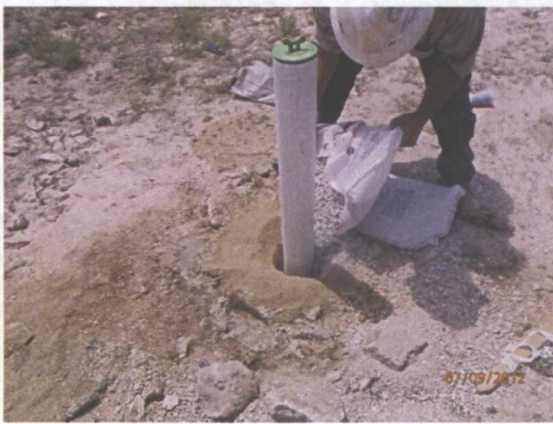
Installing the bentonite seal 7/9/12

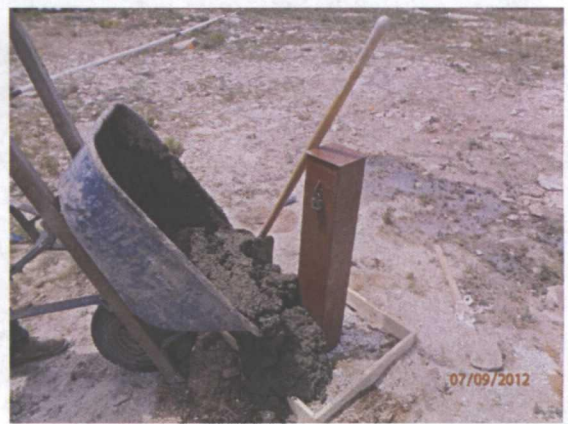
Concreting the well in 7/9/12

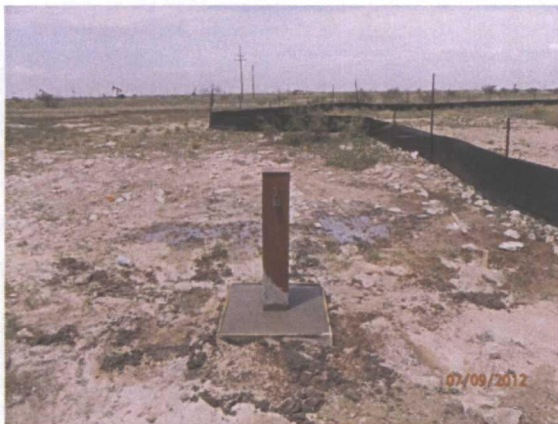
Completed MW-1R, facing west 7/9/12

RECS personnel were on site on July 9th, 2012 to plug and abandon MW-1 and install MW-1R. MW-1 was plugged using a 1-3% bentonite/concrete slurry and a three foot concrete cap. MW-1R was installed six feet southeast of the former monitor well (Figure 2) and samples were not taken as the well was advanced (Appendix B).

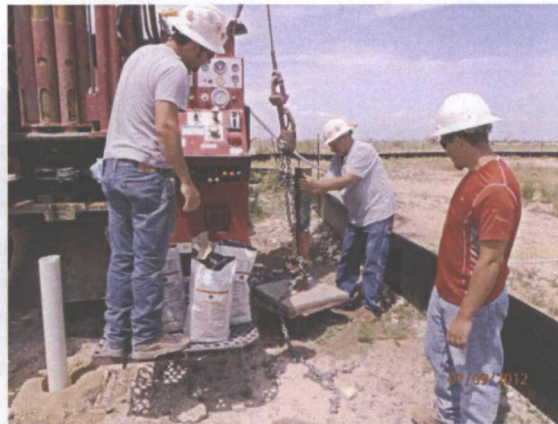
Pulling MW-1, facing west 7/9/12

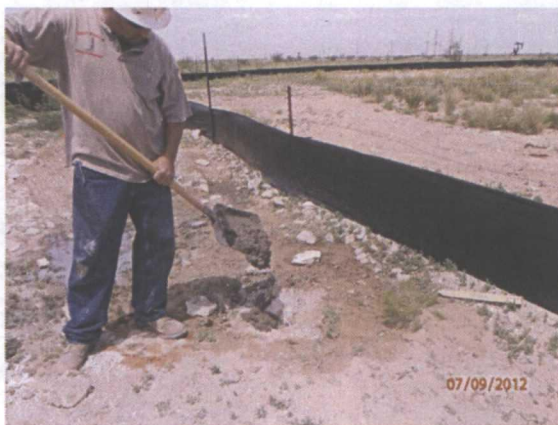
Plugging MW-1 with 1-3% bentonite/concrete slurry, facing west 7/9/12

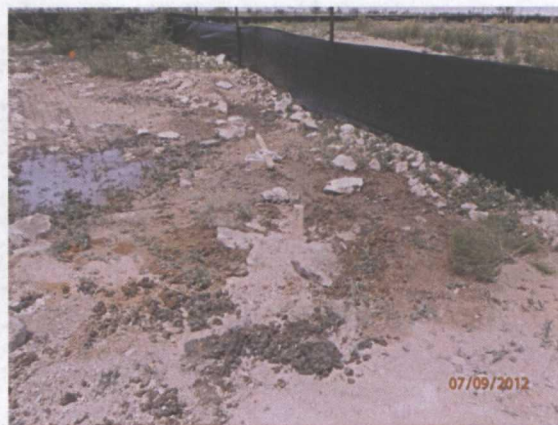
Plug and abandon of MW-1 complete 7/9/12

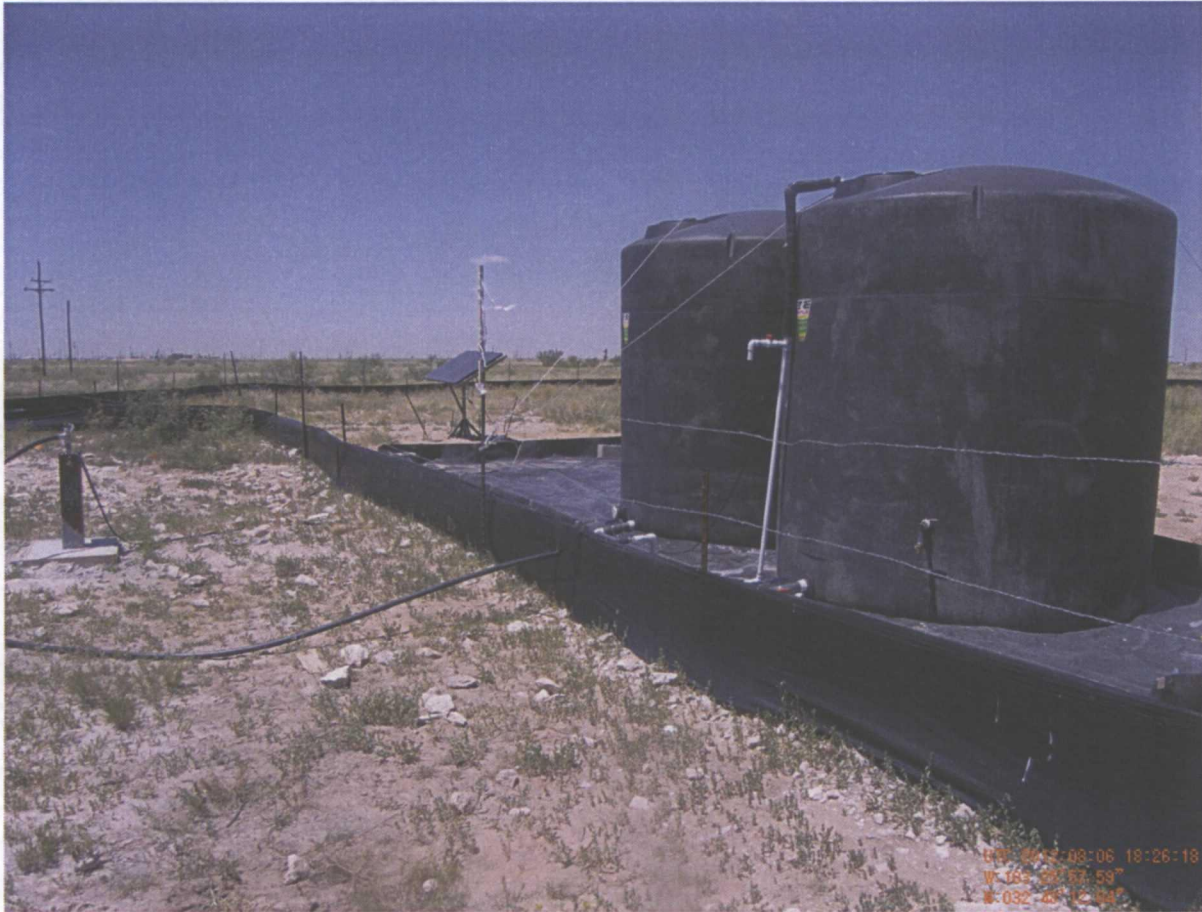
On-Site Recovery System

Facing west

A recovery system was installed in MW-1R and the groundwater source removal and pumping program began on July 26th, 2012 (Appendix C). RECS recommends that ROC continue the pumping program at the site to evaluate groundwater restoration methods. Once the pumping program is completed, ROC will submit either a 'CAP for Groundwater' with our estimate for chloride mass removal or a request for 'remediation termination'.
