RE: Termination Request
Vacuum I-29 EOL (1R425-101): UL/I, Sec. 29, T17S, R35E
RICE Operating Company – Vacuum SWD System

**RICE OPERATING COMPANY
JUNCTION BOX FINAL REPORT**

Vacuum I-29 EOL

Unit I, Section 29, T17S, R35E

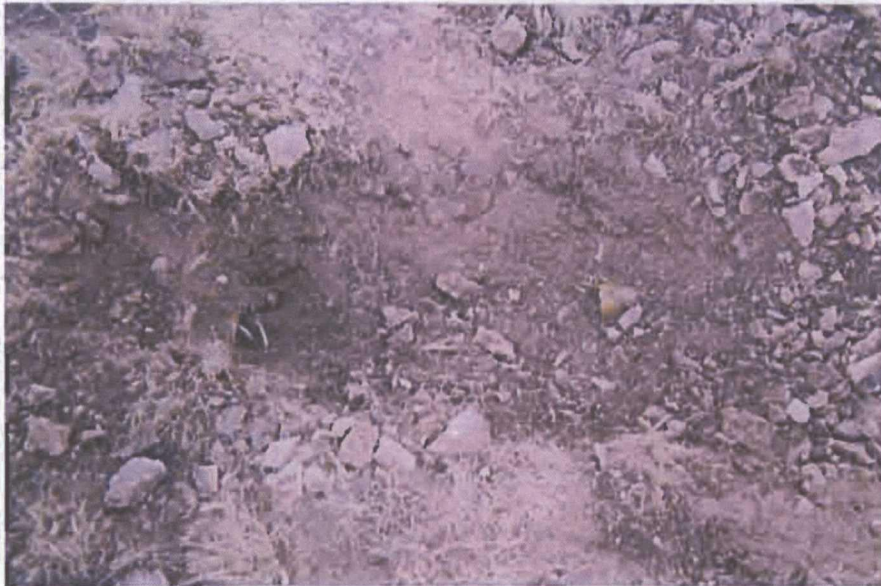
6/29/2010

Site prior to delineation

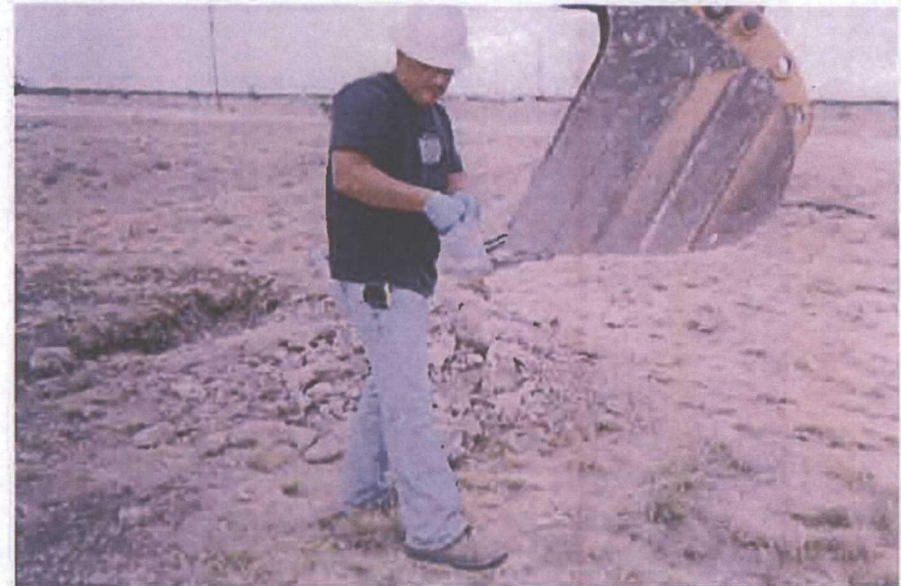
6/29/2010

Collecting sample

General Description of Remedial Action: This junction box was addressed during the Vacuum SWD System abandonment. After the former junction box was removed an investigation was conducted using a backhoe to collect soil sample at regular intervals creating a 3x5x6-ft deep excavation. Each sample was field tested for chlorides and organic vapors which yielded low concentrations similar to that of the background sample.

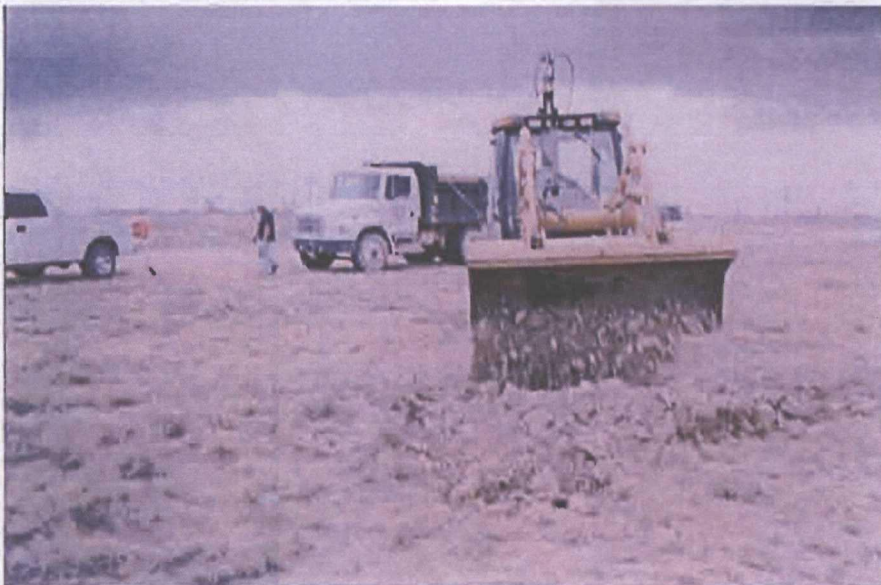
6/29/2010

Backfilling excavation

The excavated soil was returned to the excavation to ground surface and contoured to the surrounding area. On 6/29/2010, the site was seeded with a blend of native vegetation and is expected to return to a productive capacity at a normal rate.

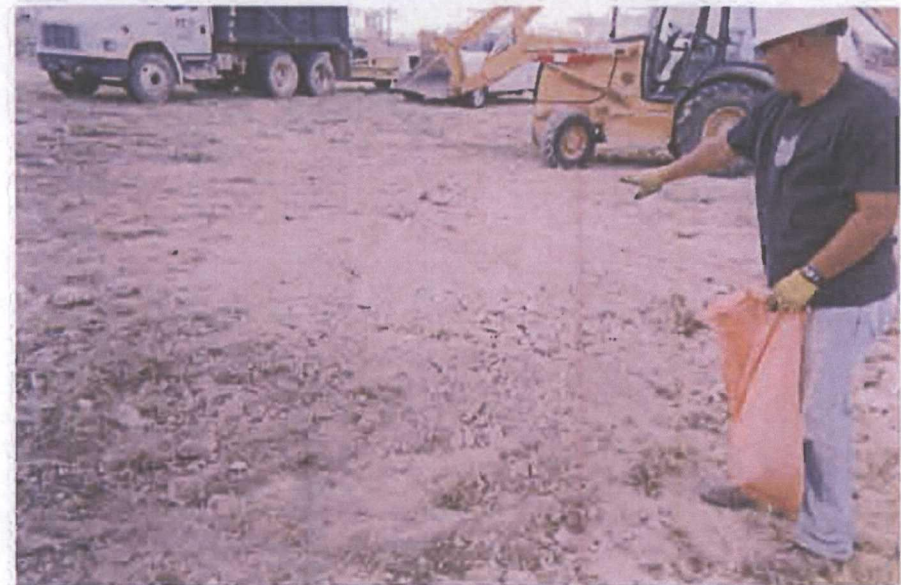
6/29/2010

Seeding excavation
