**EPWM - 010**

**GENERAL  
CORRESPONDENCE**

RE: C-144 Closure Report for the Poseidon Modular Impoundment.  
Operator: XTO Energy. API #: 30-015-29434.  
Unit Letter J Section 13 T23S R29E.

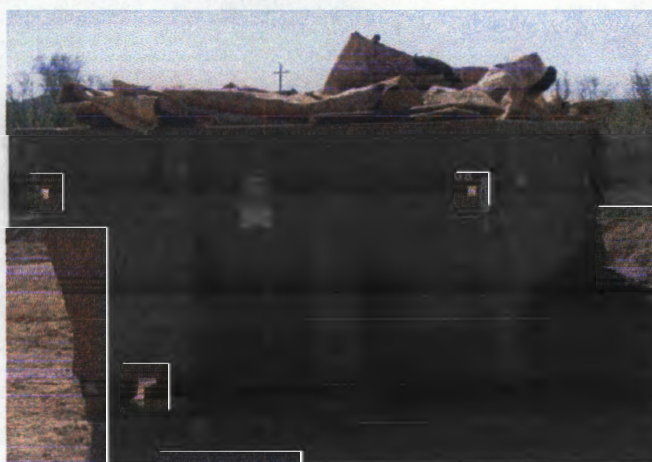
Figure 1: One of the four roll-offs containing liner material that was transported to R360.

On October 15, 2012 Poseidon Concepts began the disassembly of the Poseidon tank. Due to the oily nature of remaining fluid in the

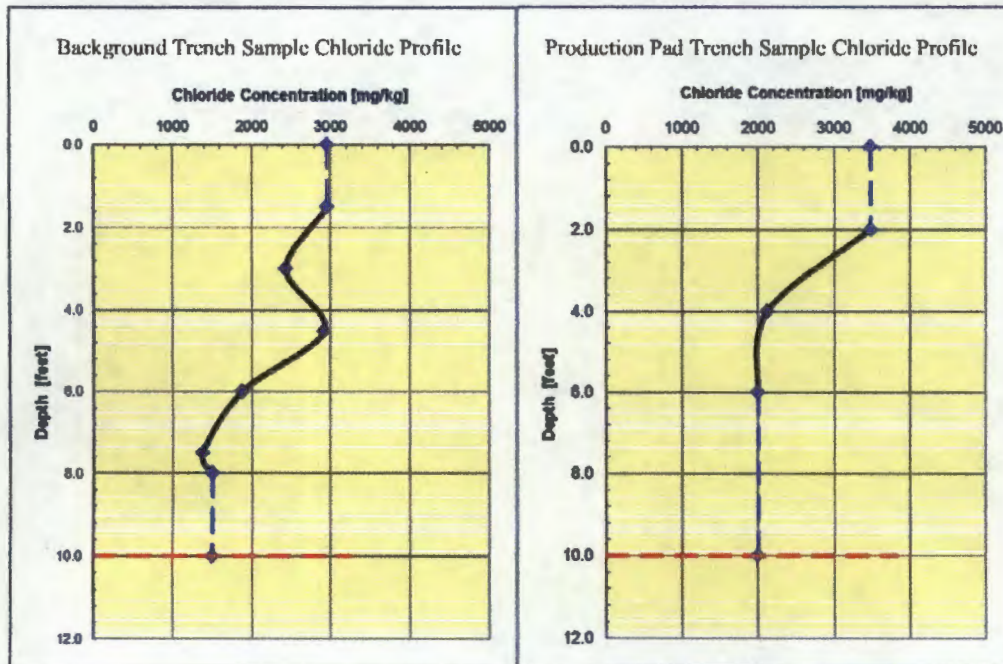
Graphic 1, below, shows the chloride concentration data from Table 1 plotted at the appropriate depth for both the Background Sample trench and the Trench Sample located on the production pad (locations shown on Plate 3). From the ground surface to the depth of 10-feet, the mass of chloride per unit area can be calculated from these chloride concentration profiles.

**Graphic 1 : Concentrations for samples closest to the surface and at greatest depth are assumed as constant to both the ground surface and to a depth of 10 feet**

Multiplying each sample concentration by a moist soil density and a centered depth interval for each sample depth yields a chloride mass per area for that depth interval. The calculation is shown below:

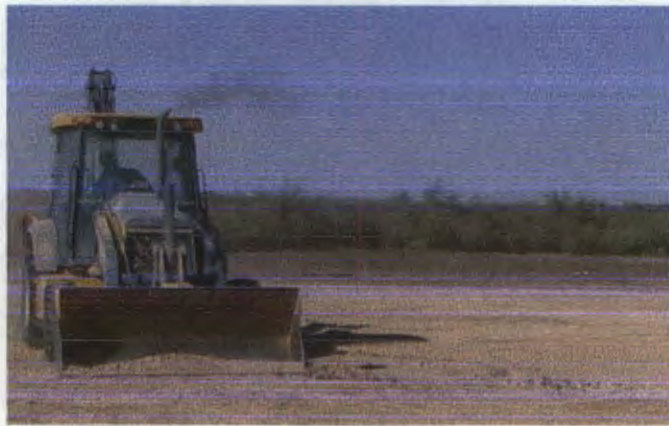
**Figure 2: Backfilling a "Y" shaped trench with caliche.**

The location is currently an active well site. To return the site to pre-existing conditions, the three "Y" shaped trenches associated with the modular impoundment were backfilled with caliche (Figure 2) and graded even with the existing production pad (Figure 3).

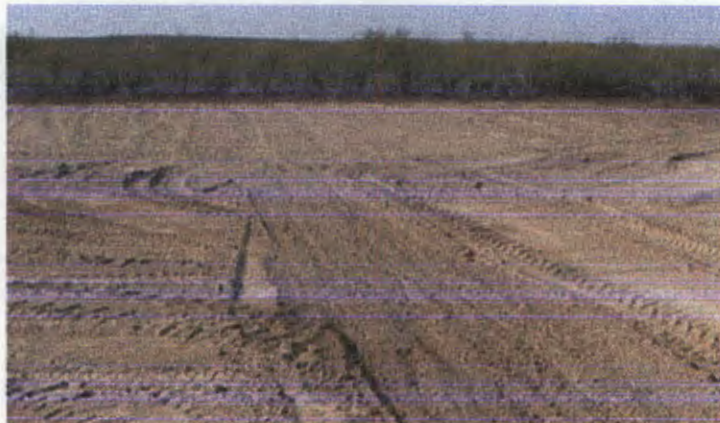
**Figure 3: Location reclaimed to pre-existing conditions graded even with the active production pad.**

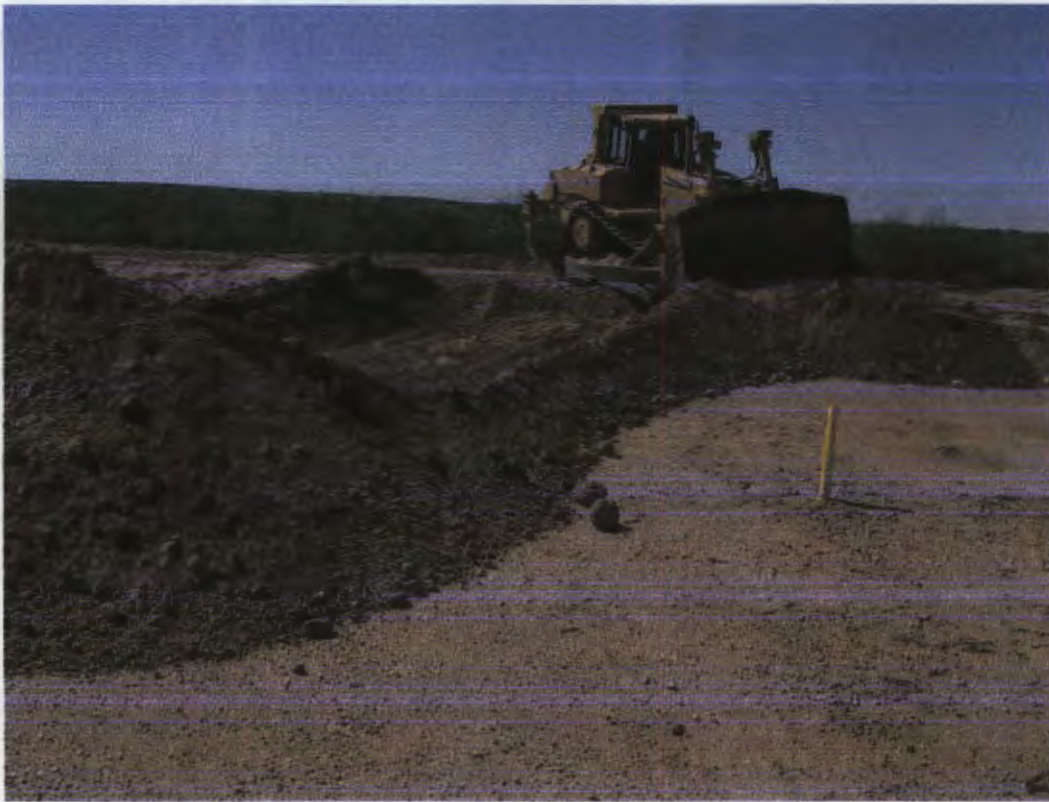
**Figure 1: Stockpiling chloride impacted caliche near western 1/3 of location pad.**

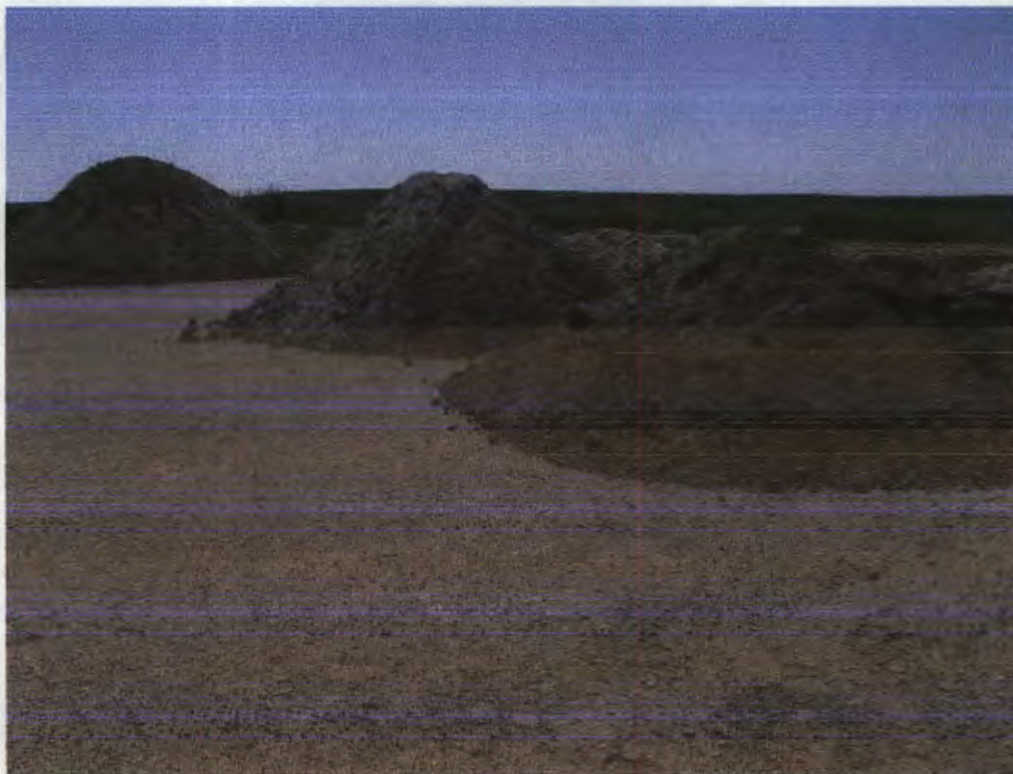
**Figure 2: Stockpiled impacted caliche (two right soil piles) waiting transport to R360. The far left soil pile (background) is clean soil to be used for BLM interim reclamation activities.**

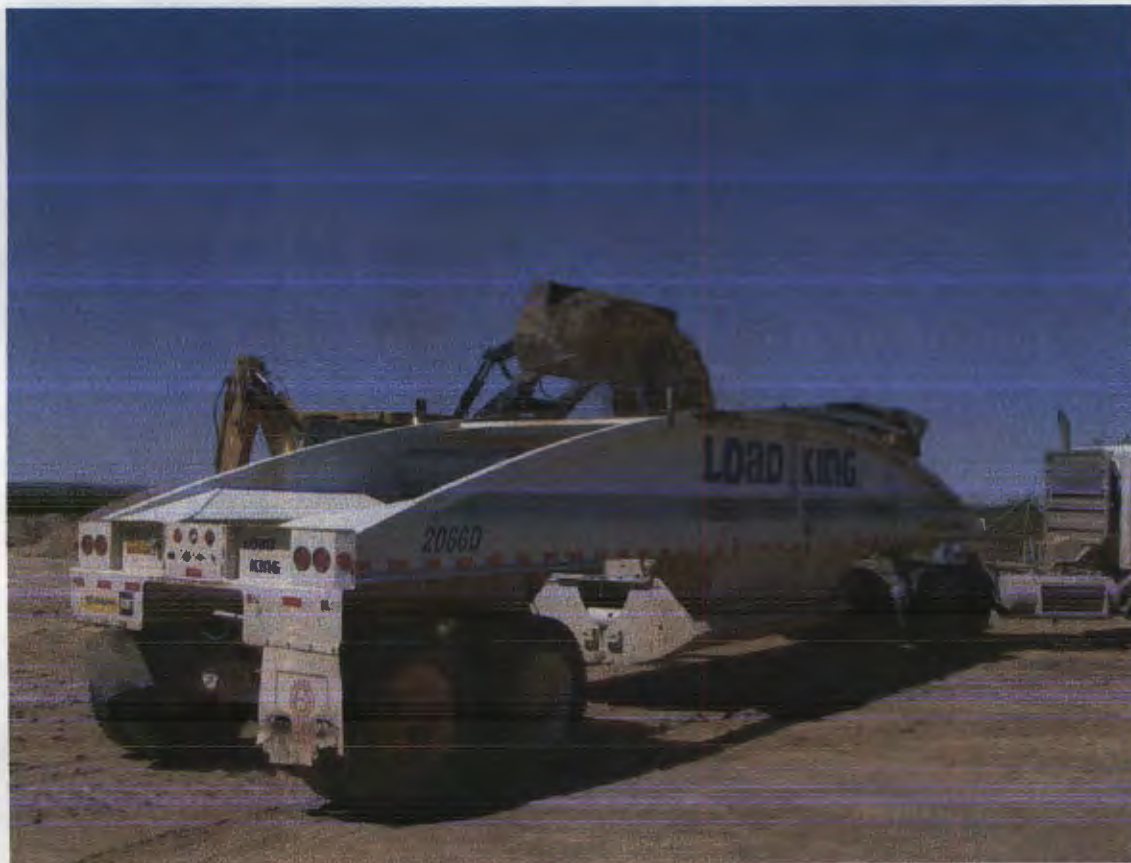
Figure 3: Stockpiled chloride impacted caliche being loaded for transport to R360.

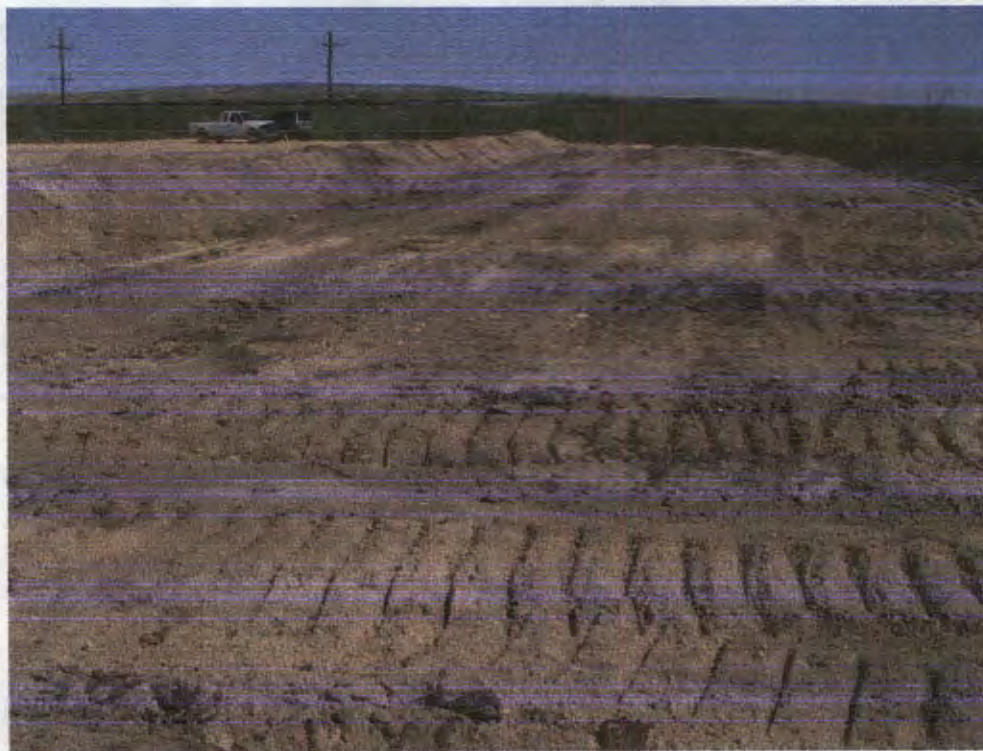
Figure 4: Western 1/3 of caliche pad removed and ready for ripping and seeding. Portions of the caliche pad were included in BLM interim reclamation activities.

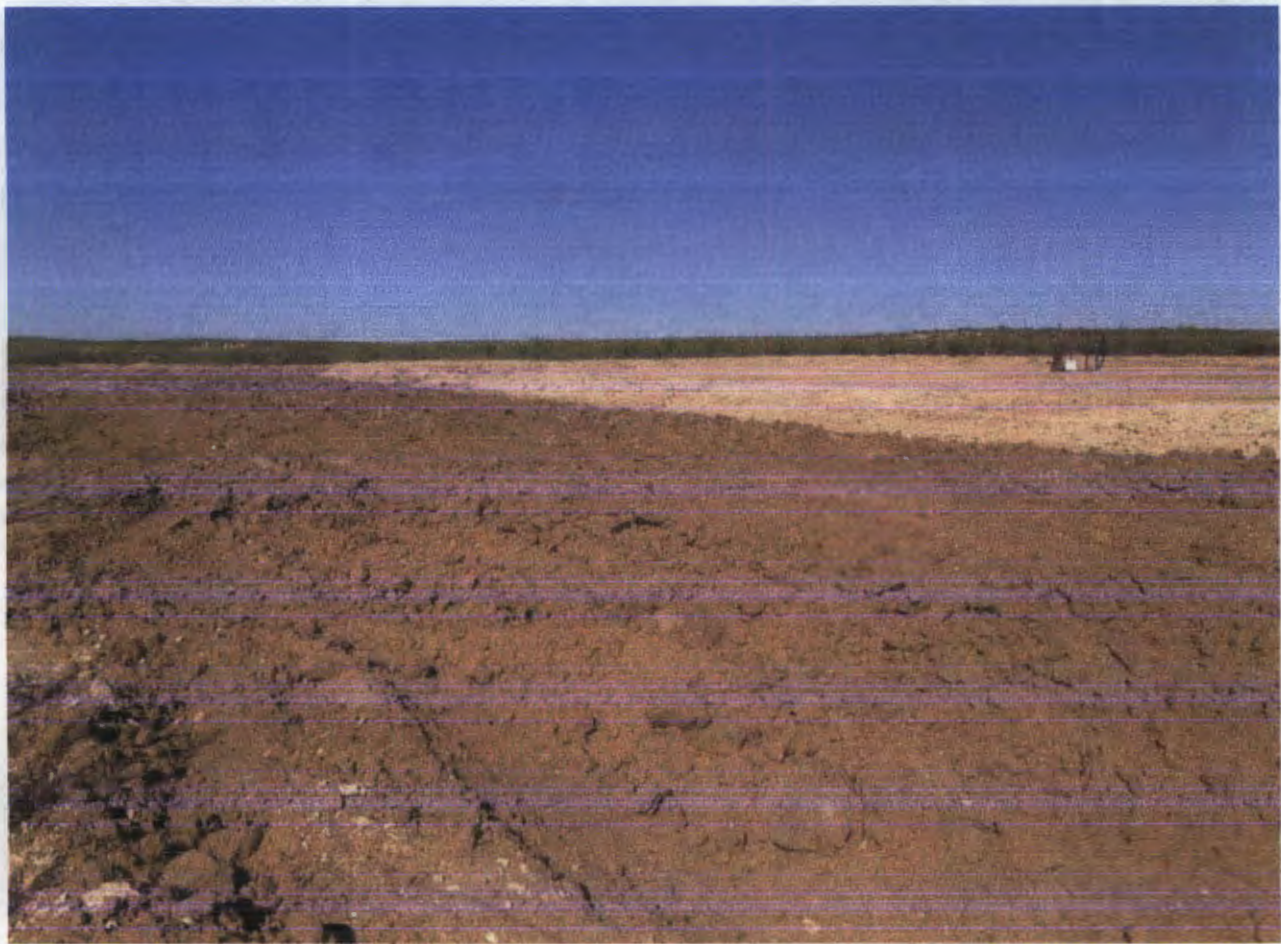
**Figure 5: Photo of remediated western 1/3 of caliche pad, viewing north. Area was ripped and seeded with BLM seed mixture #4 and Alkali Sacaton.**
