2RA-881 & 891

Report Type: Closure Report

Re: Closure Report for the Alamo Permian Resources LLC., Berry A #33, Tank Battery, Unit K, Section 24, Township 17 South, Range 27 East, Eddy County, New Mexico.

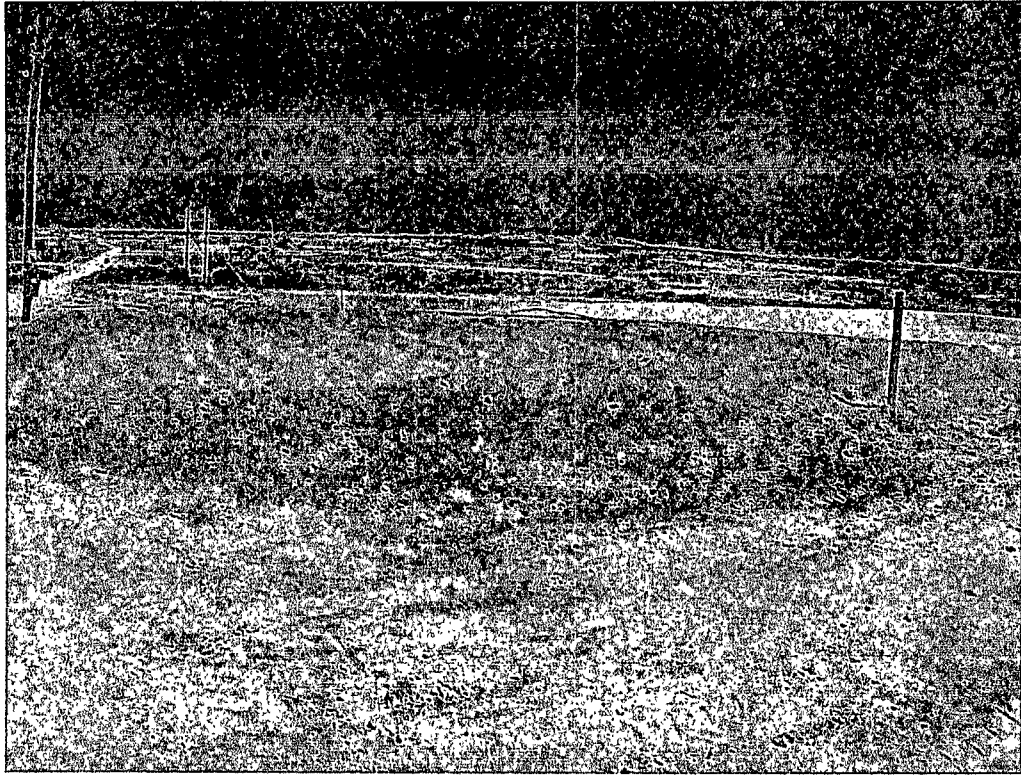
Reserve pit and north area - backfilled with 2.0' to 3.0' top soil

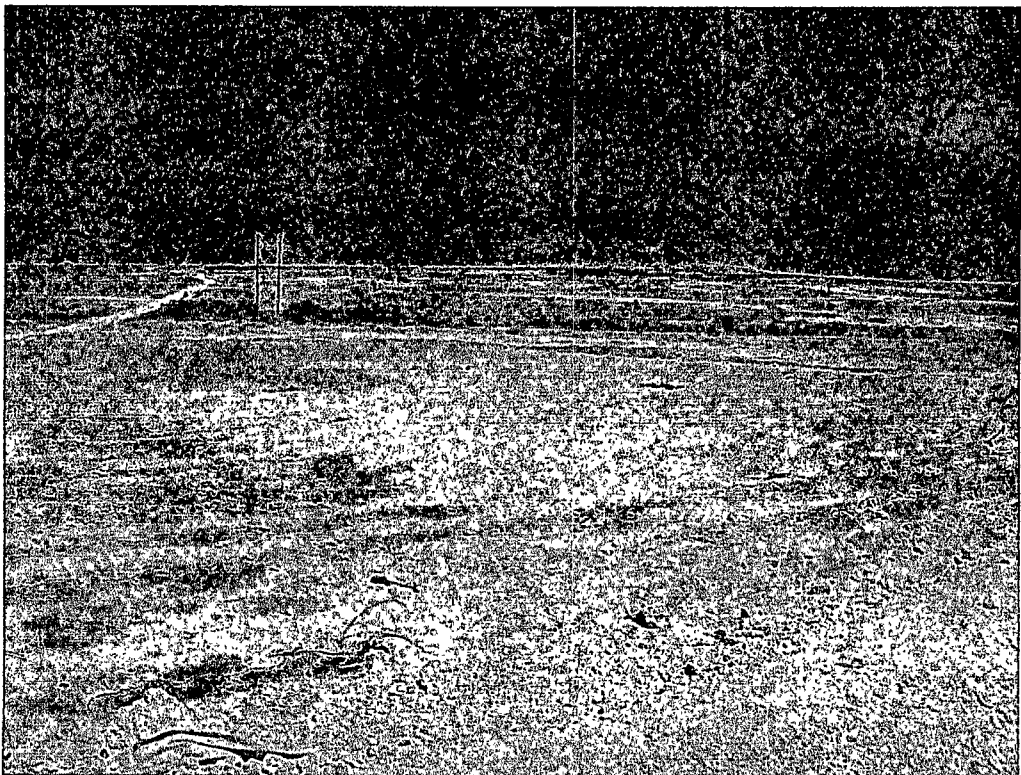
Reserve pit and north area - backfilled with 2.0 to 3.0' of clean topsoil

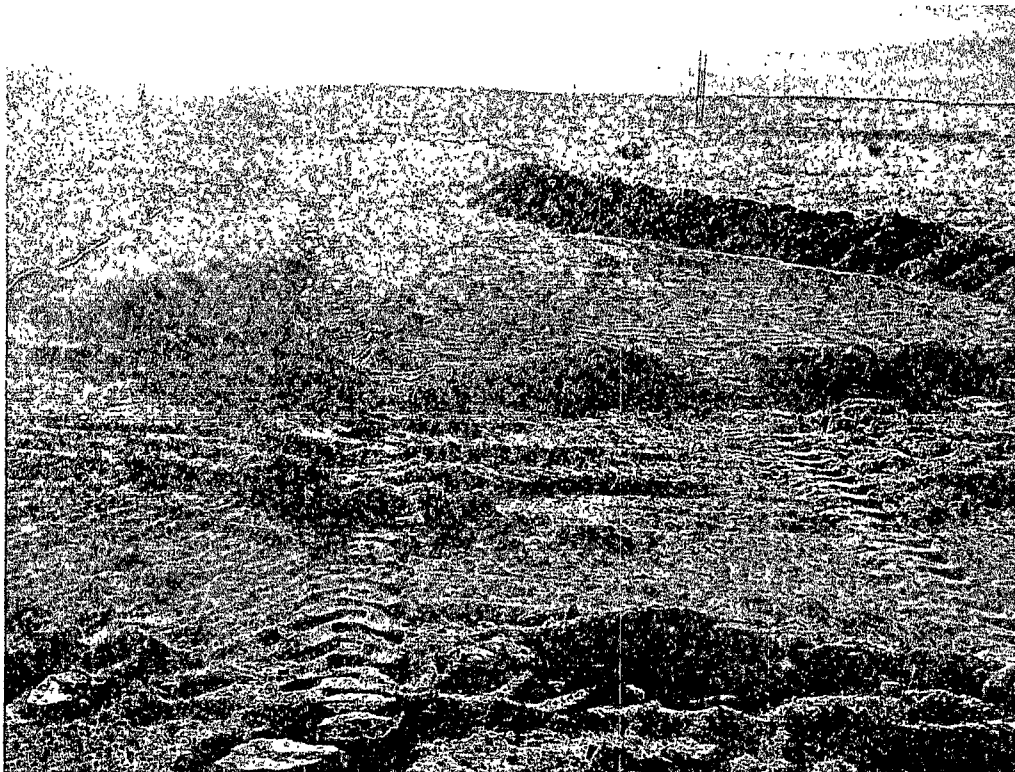
East view - excavation south of pad - 1.0' excavation

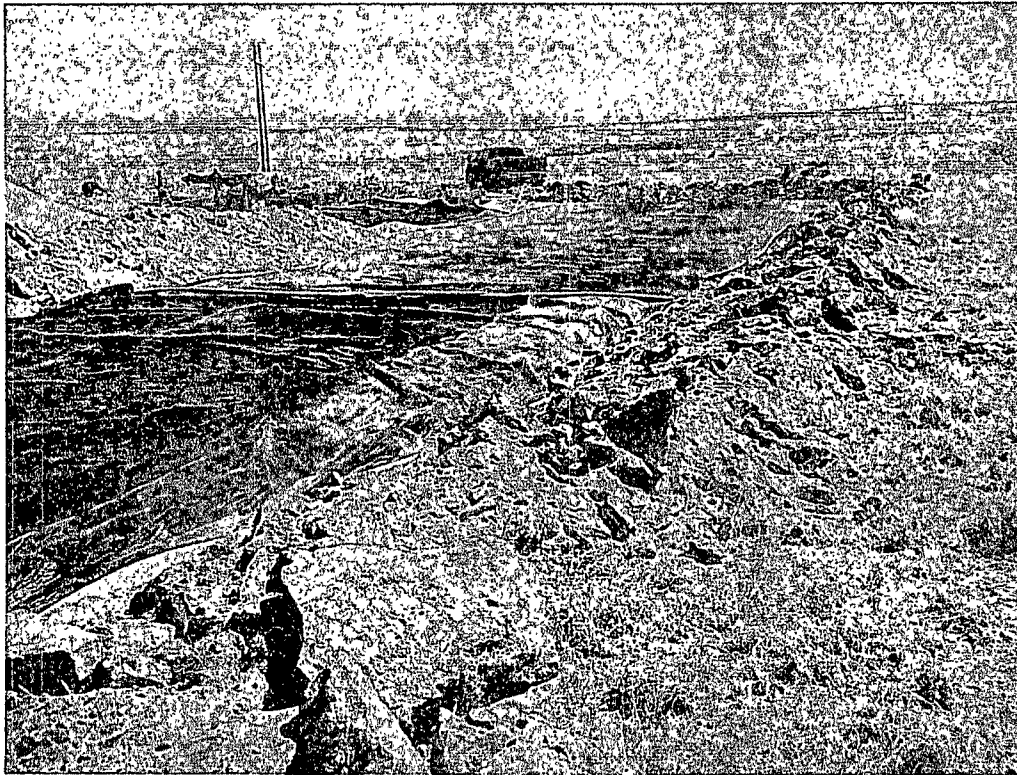
Area south of pad - liner installation

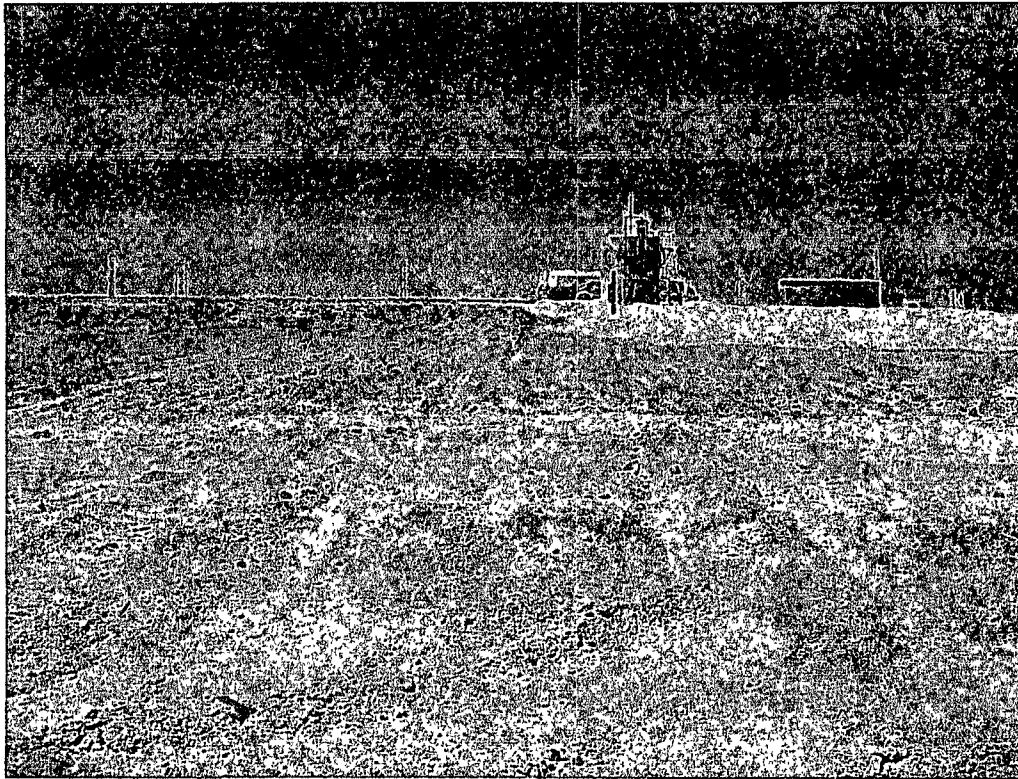
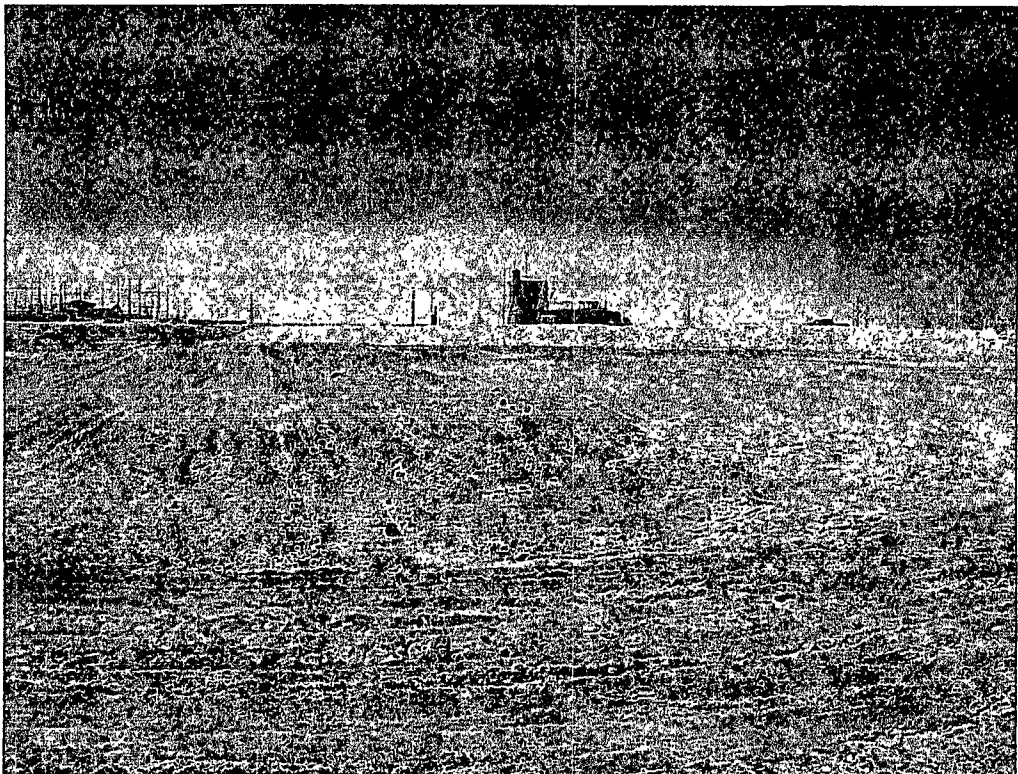
View of backfilled area south of pad

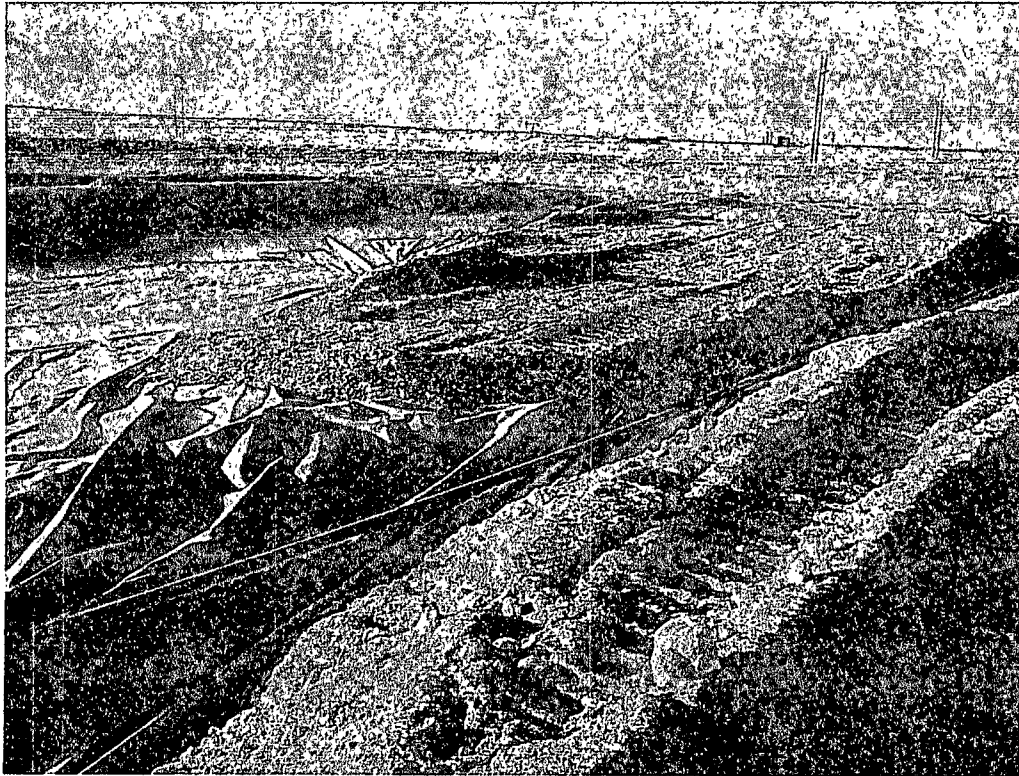
Pad area - 1.0' of caliche material top of liner
