From: Hansen, Edward J., EMNRD
Sent: Tuesday, January 22, 2013 12:40 PM
To: Hack Conder (hconder@riceswd.com)
Cc: Leking, Geoffrey R, EMNRD; Laura Pena (lpena@riceswd.com); Katie Jones <kjones@riceswd.com> (kjones@riceswd.com); Scott Curtis (scurtis@riceswd.com); Jeff.Kindley@tetrattech.com
Subject: Remediation Plan (1R427-288) Termination - ROC EME C-8 Vent Site

RE: **CAP REPORT AND TERMINATION REQUEST
EME C-8 VENT (1R427-288)
UNIT "C", SEC. 8, T20S, R37E
LEA COUNTY, NEW MEXICO**

**EME C-8 vent (1R427-288)
Unit C, Section 8, T20S, R37E**

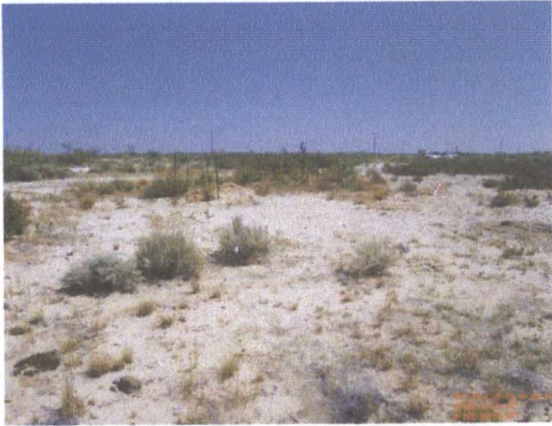
site prior to excavation, facing east
9/19/2012

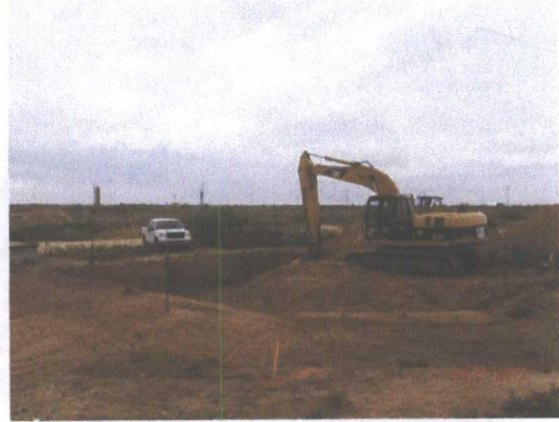
excavating the site, facing northeast
9/27/2012

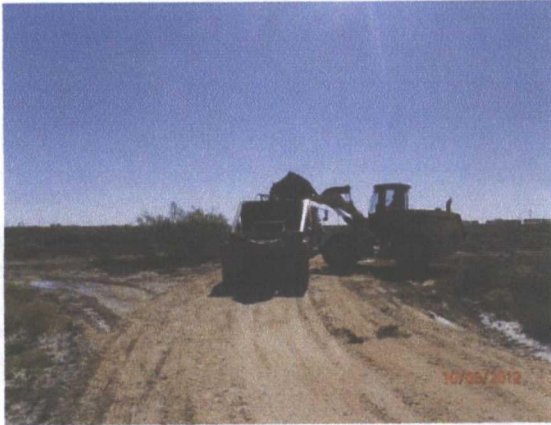
exporting excavated soil, facing east
10/3/2012

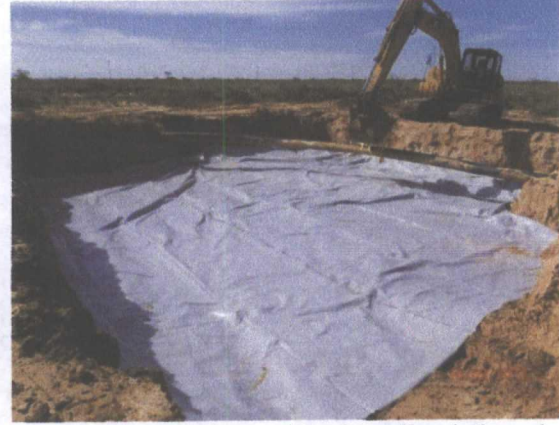
excavation complete, with a 20-mil, reinforced
liner installed, facing southwest 10/9/2012

As per the approved *ICP Report and CAP*, ROC was onsite between September 25 and October 12, 2012 to oversee the excavation and installation of a 20-mil reinforced polyethylene liner at a depth of 5 feet bgs (See attached Photographs). The excavation and liner dimensions measured 45 feet by 40 feet and covered the initial junction box and all soil borings. Approximately 420 yds³, of excavated soils from the site were removed and transported offsite for disposal at Sundance Services of Eunice, New Mexico. Approximately 520 yds³, of blow sand was brought in from offsite to backfill the location and bring it up to surface grade. Prior to backfilling, a sample of the blow sand was collected and submitted to Cardinal Labs of Hobbs, New Mexico for analysis of chlorides using EPA Method 4500-CL B and TPH using 8015M. Laboratory analysis in-

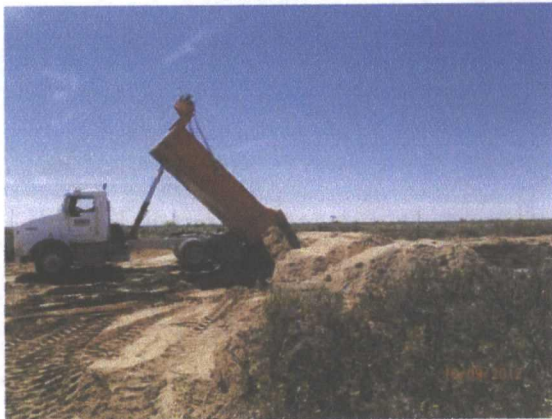
importing blow sand, facing south
10/9/2012

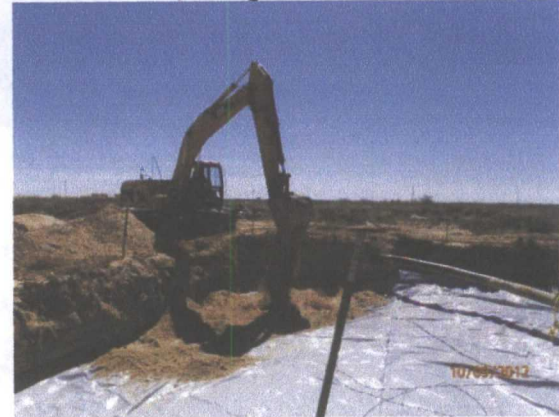
backfilling the excavation with blow sand,
facing south 10/9/2012

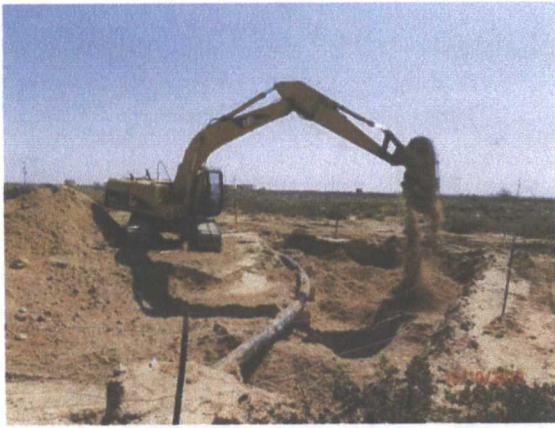
backfilling the excavation, facing south
10/10/2012

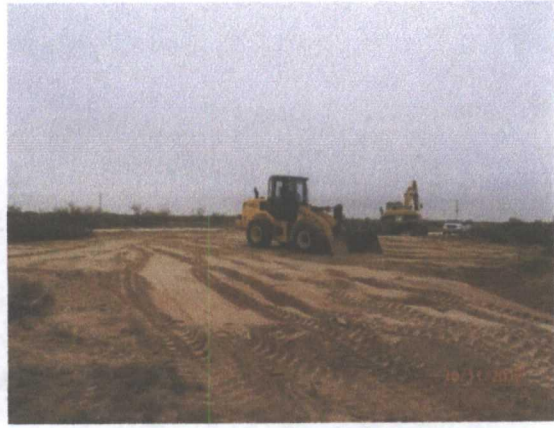
contouring the site, facing east
10/11/2012

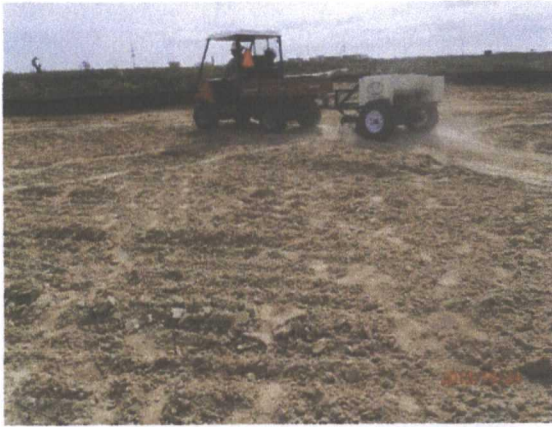
seeding the backfilled site, facing east
10/24/2012

icates results of <16.0 mg/kg chlorides, TPH DRO/GRO of <10.0 mg/kg, with a PID reading of 3.2 ppm (See attached Laboratory Analysis). Upon completion of the liner and backfilling, the site was reseeded with 10 lbs. of BLM #2 seed.

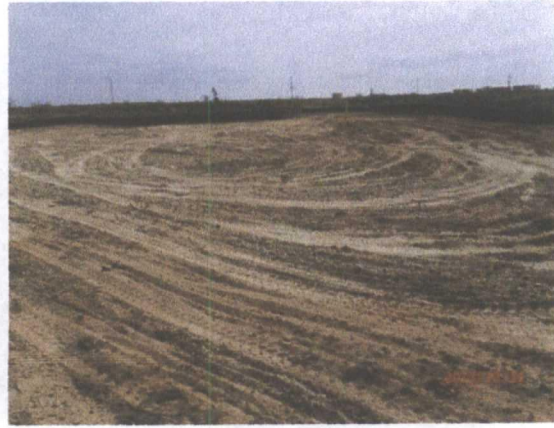
site complete, facing east
10/24/2012
