1R - 427-30

**RE: Termination Request
for the Rice Operating Company's
EME F-1 Site
Unit Letter F, Section 1, T21S, R35E, NMPM, Lea County, New Mexico
Remediation Plan (1R427-30) Termination**

RE: Termination Request
EME F-1 (1R427-30): UL/F Sec. 1, T21S, R35E
RICE Operating Company – Eunice Monument Eumont SWD System.

**RICE OPERATING COMPANY
JUNCTION BOX FINAL REPORT**

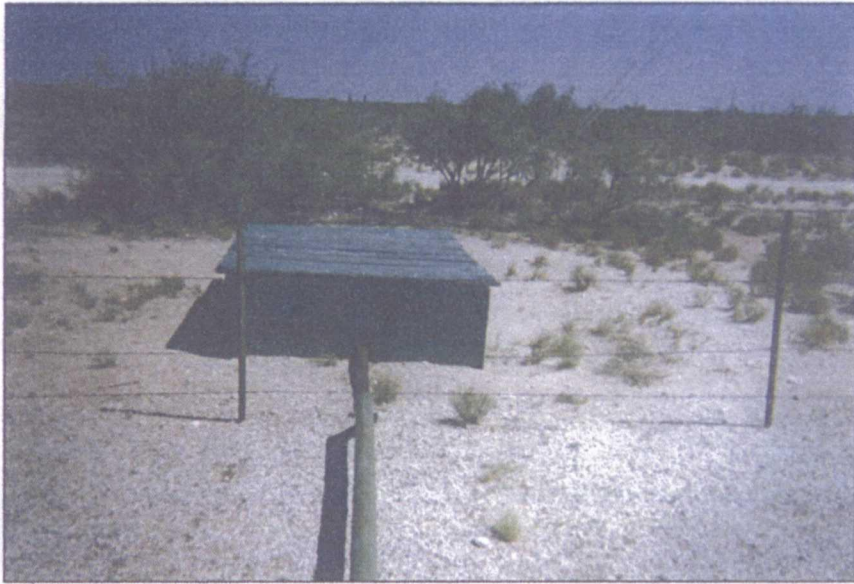
Wooden Junction Box Before NORM Removal 7/25/2003

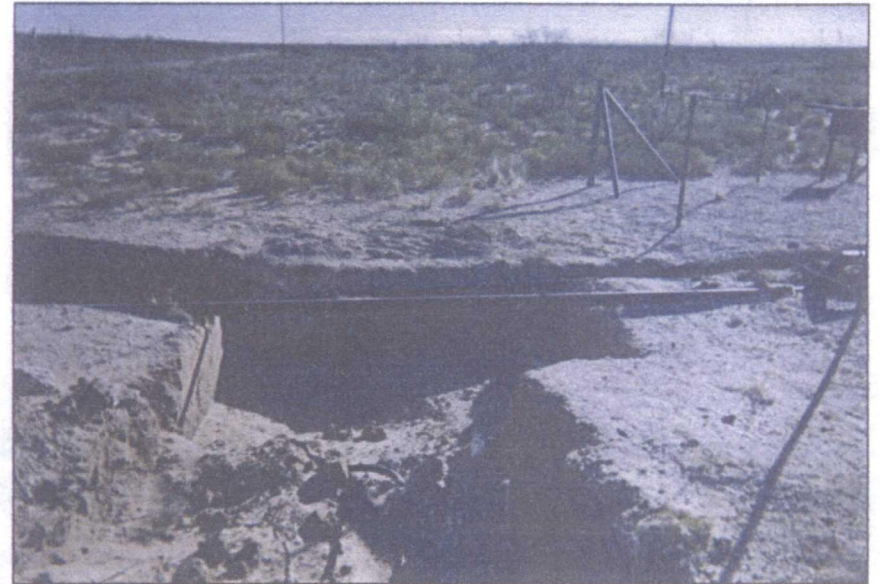
After Wood and NORM Removal 11/18/2003

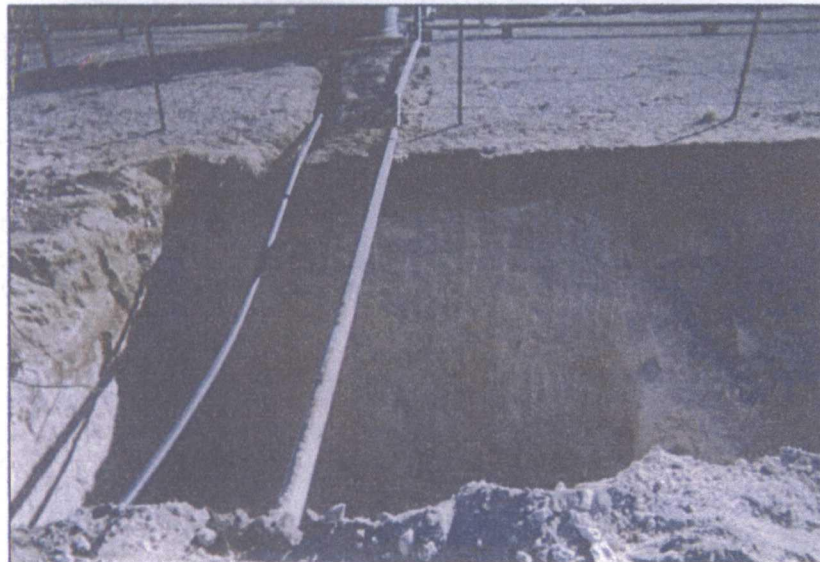
10 x 10 x 9 ft Excavation 11/19/2003

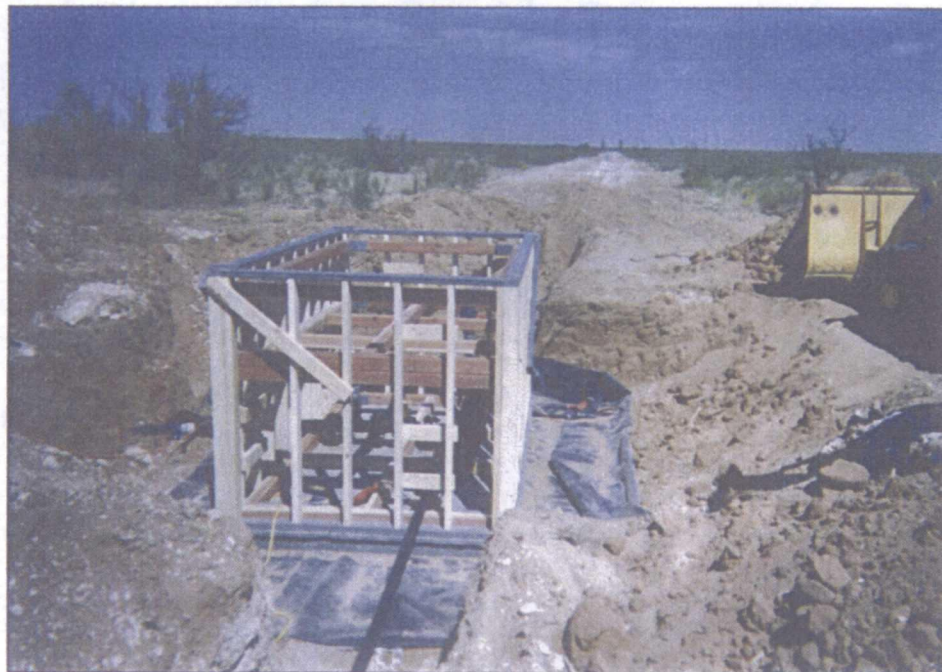
New Junction Box Construction 80 ft North

new, water-tight junction box was built 80 ft north of this site. The former junction box was located next to a lease road and pad; therefore, seeding was not necessary.

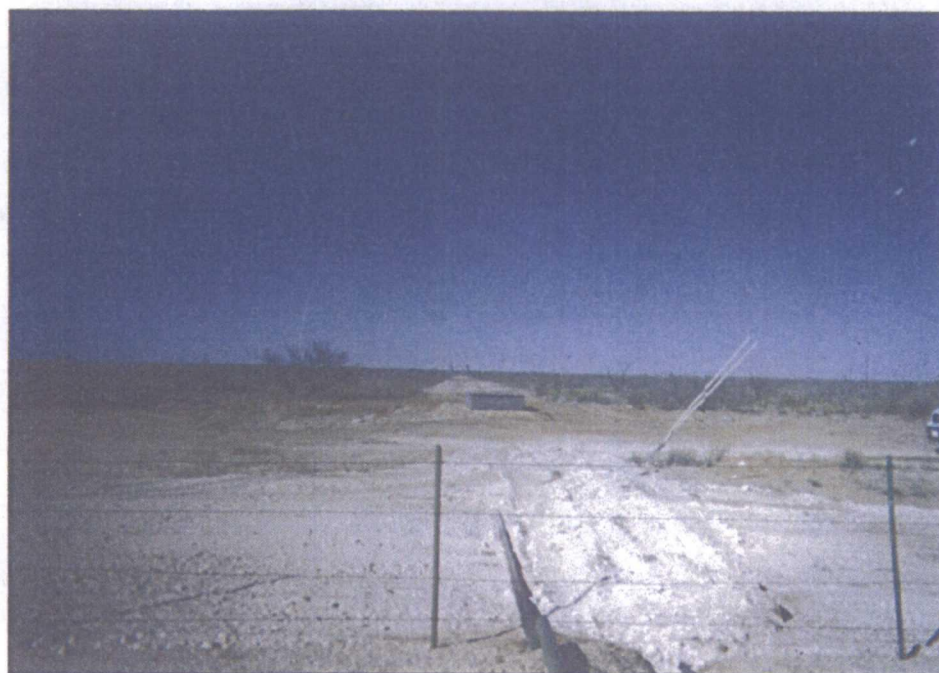
**Backfilled Excavation in Foreground
New Junction Box 80 ft North in Background**
