RE: Termination Request
EME Jct. P-20 (1R427-329): UL/P, Sec. 20, T19S, R37E
RICE Operating Company – Eunice Monument Eumont SWD System

EME Jct. P-20 (1R427-329)

RICE OPERATING COMPANY
JUNCTION BOX FINAL REPORT

EME Jct. P-20
UL/P, Section 20, T19S, R37E

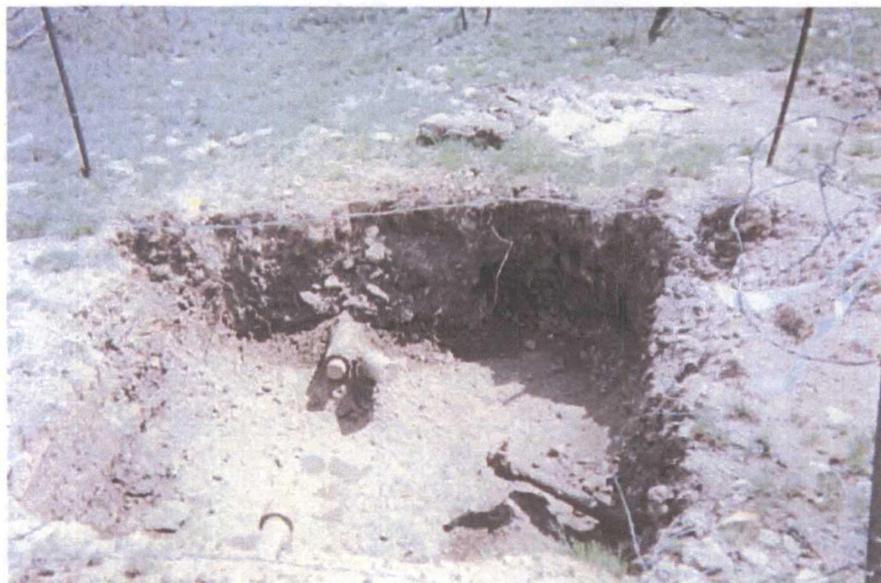
4/20/2010

Site prior to excavation

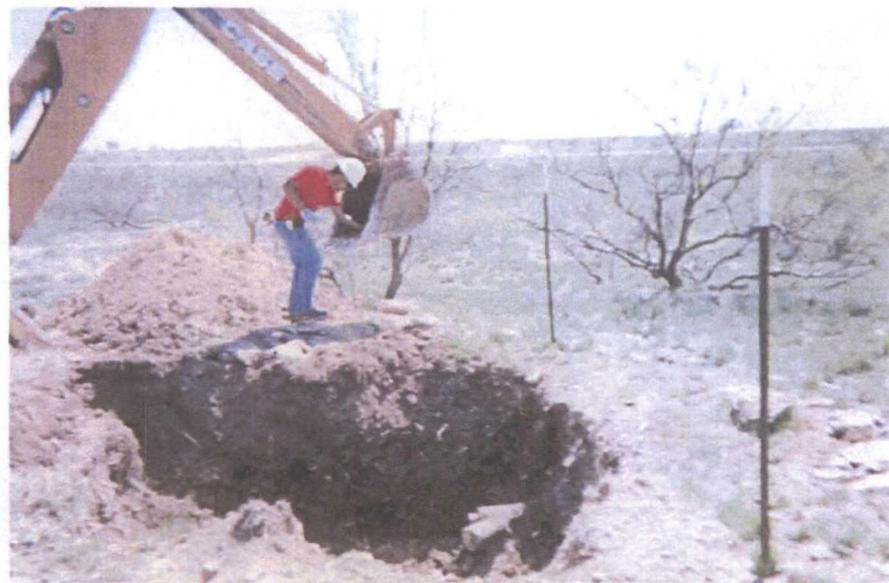
4/21/2010

Taking sample

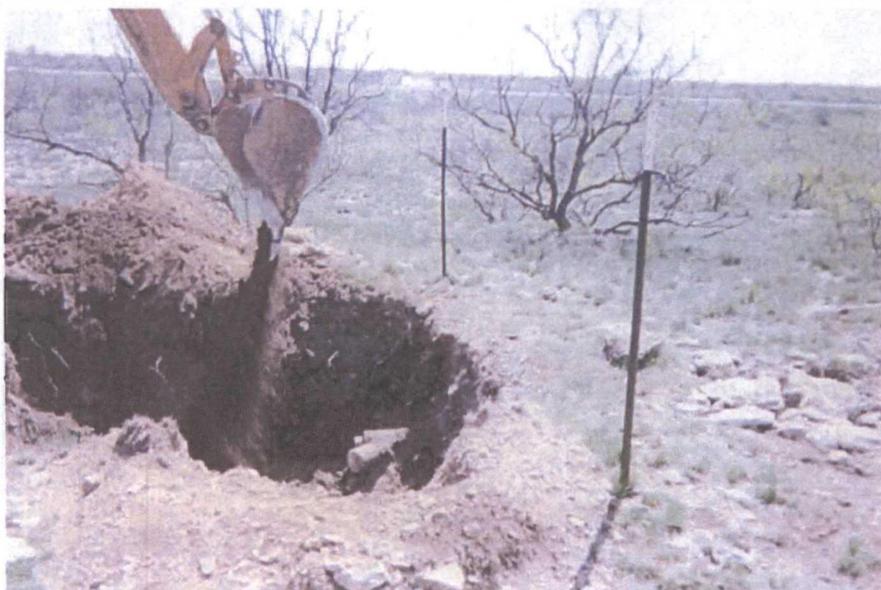
4/21/2010

Backfilling excavation

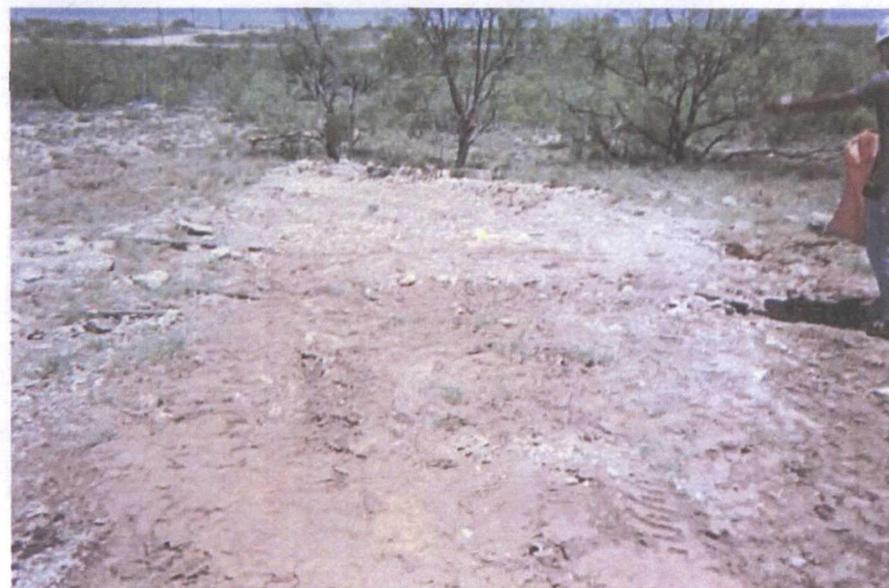
5/21/2010

Seeding excavation

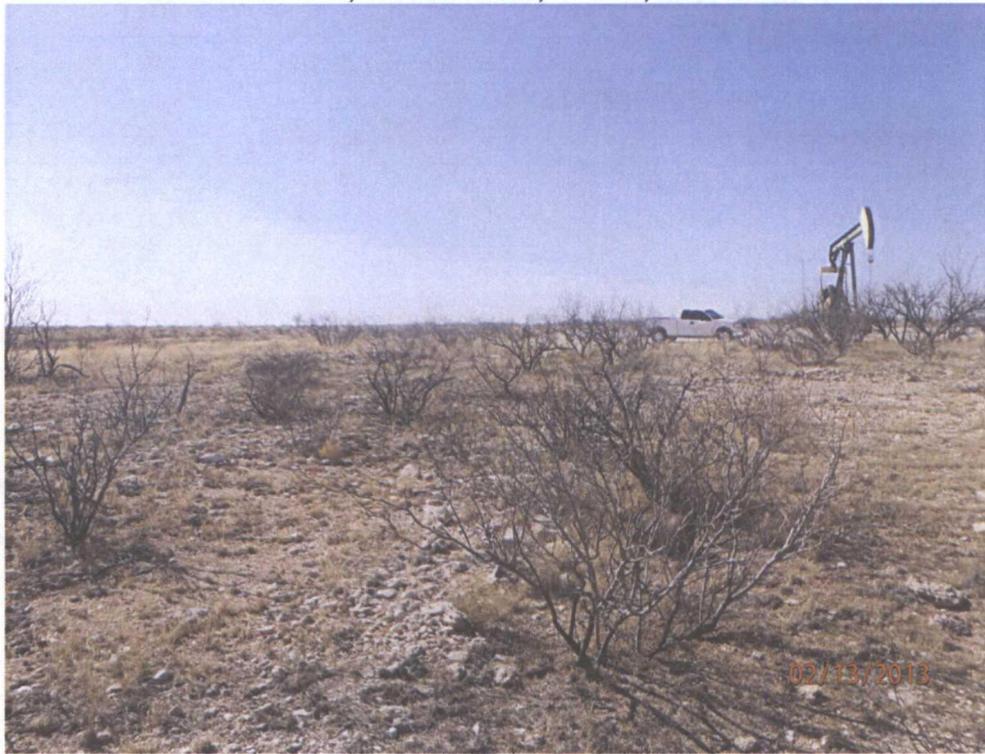
2/13/2013

Facing west

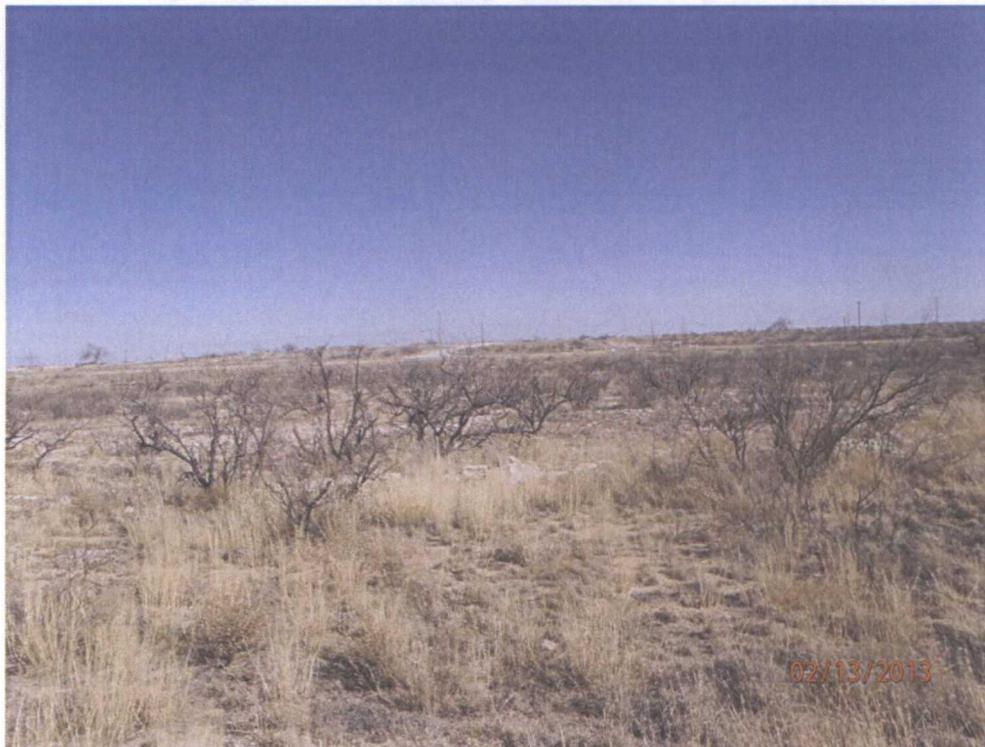
2/13/2013

Facing east
