From: Hansen, Edward J., EMNRD
Sent: Tuesday, March 12, 2013 4:47 PM
To: Hack Conder (hconder@riceswd.com)
Cc: Leking, Geoffrey R, EMNRD; Laura Pena (lpna@riceswd.com); Katie Jones <kjones@riceswd.com> (kjones@riceswd.com); Scott Curtis (scurtis@riceswd.com)
Subject: Remediation Plan (1R427-330) Termination - ROC EME Jct O-25 Site

RE: Termination Request
EME Jct. O-25 (1R427-330): UL/O, Sec. 25, T20S, R36E
RICE Operating Company – Eunice Monument Eumont SWD System

**RICE OPERATING COMPANY
JUNCTION BOX FINAL REPORT**

EME Jct. O-25

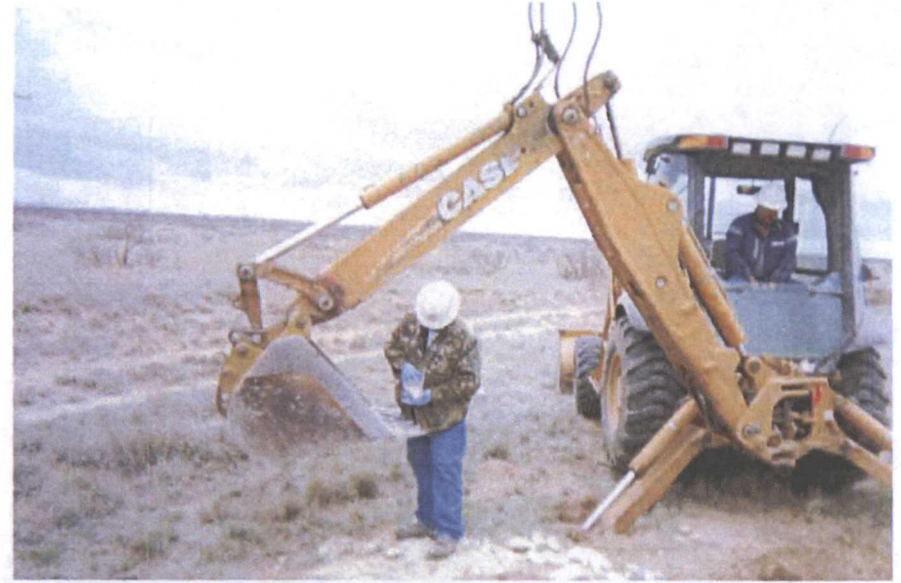
Collecting a soil sample

4/13/2010

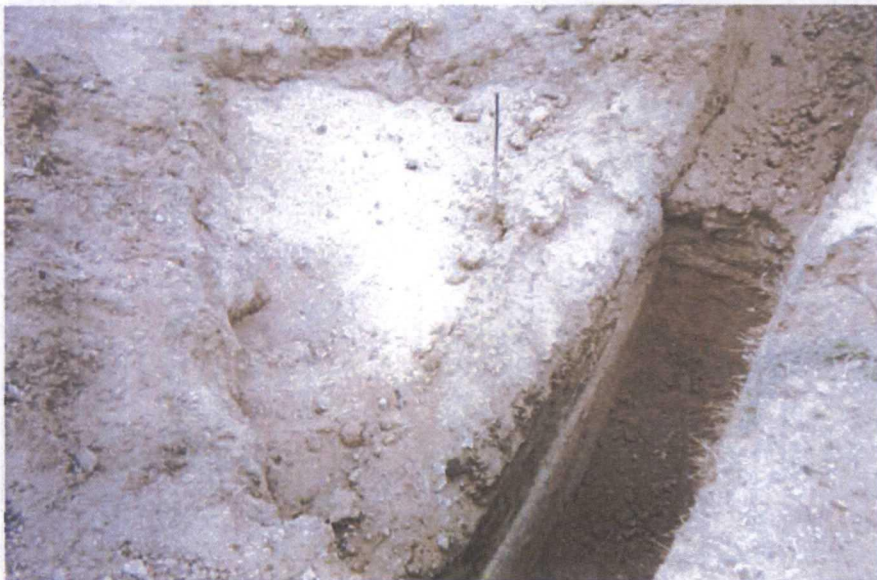
Final excavation 5x3x7 4/13/2010

General Description of Remedial Action: This junction box and line were eliminated during the pipeline replacement/upgrade program. After the former junction box was removed, an investigation was conducted using a backhoe to collect soil samples at regular intervals producing a 5x3x7-ft-deep excavation. Chloride field tests performed on each sample yielded low concentrations similar to that of the background. Organic vapors were measured using a PID and also yielded low concentrations. The deepest sample, 7 ft. BGS was analyzed by a commercial laboratory which confirmed low concentrations. The excavated soil was returned to the excavation to ground surface and contoured to the surrounding area. On 4/13/2010, the site was seeded with a blend of native vegetation and is expected to return to a productive capacity at a normal rate.

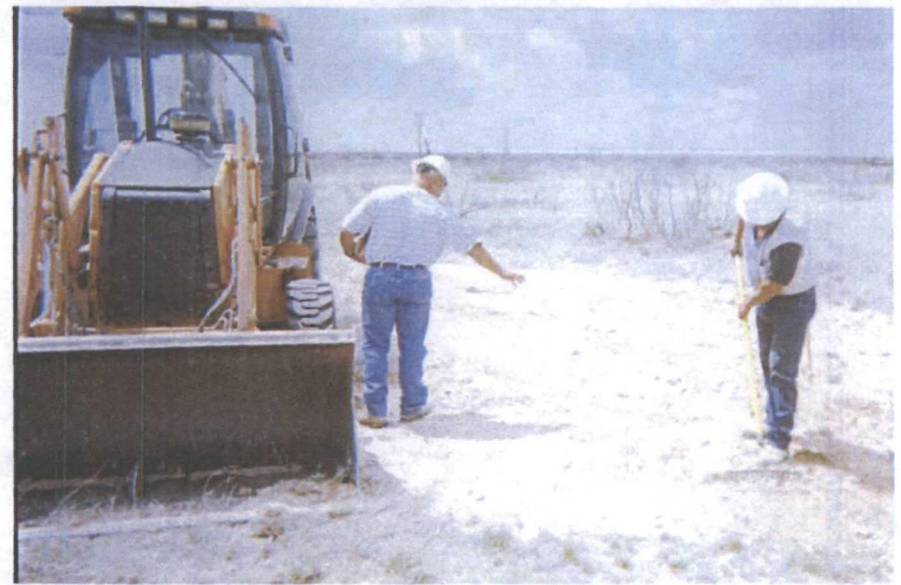
Seeding site 4/13/2010

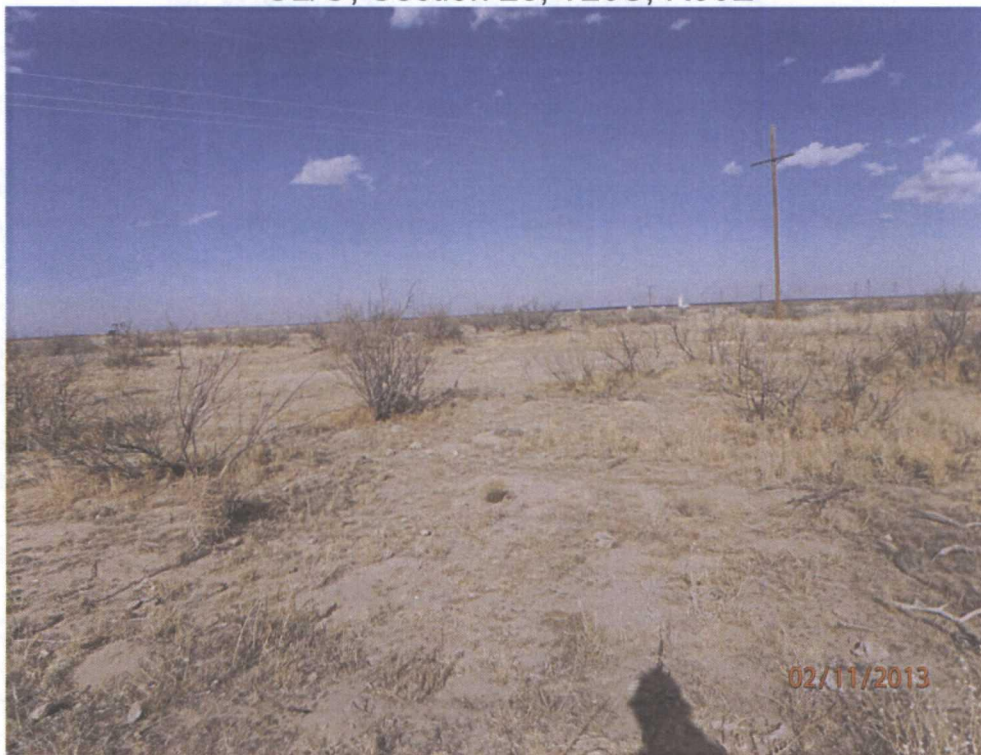
Facing northeast

2/8/2013

In 2010, ROC initiated work on the former O-25 junction box. The site is located in UL/O, Sec. 25, T20S, R36E. NM OSE records indicate that groundwater would likely be encountered at a depth of approximately 106 +/- feet. The site was delineated using a backhoe to collect soil samples at regular intervals, creating a 5x3x7 ft deep excavation. Each sample was field titrated for chlorides and field screened using a PID for hydrocarbons, resulting in low chloride concentrations. The 7 ft sample was sent to a commercial laboratory for analysis of chloride and TPH, resulting in a chloride, gasoline range organics (GRO) and diesel range organics (DRO) concentration below detectable limits. The excavated soil was returned to the excavation and contoured to the surrounding area. On 4/13/2010, the site was seeded with a blend of native vegetation. A junction box is no longer needed at the site. Vegetation has rebounded at the site, so no re-vegetation efforts are needed.

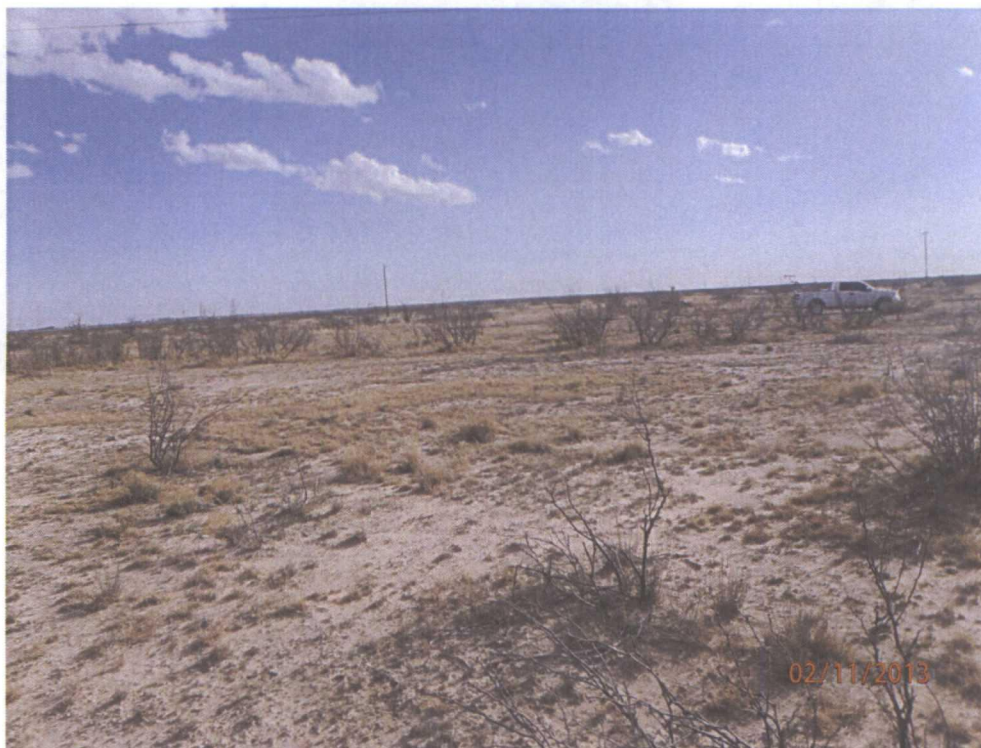
Facing south

2/8/2013
