1R - 427-363

**RE: Excavation Summary and Initial Corrective Action Plan (CAP) Report
Rice Operating Company – EME SWD System
EME I-35 EOL (1R427-363): UL/P sec. 35 T19S R36E**

Vadose Zone Remediation Documentation

EME I-35 EOL (1R427-363)
Unit Letter P, Section 35, T-19-S, R-36-E

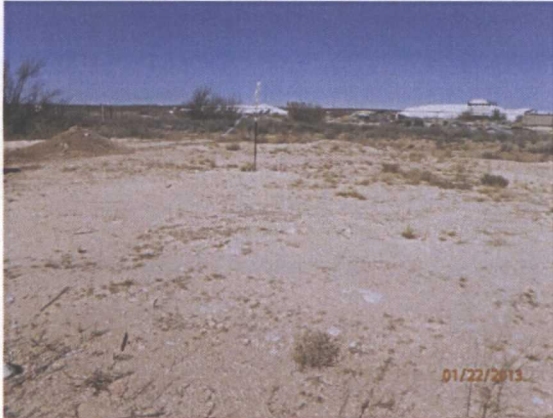
Site prior to excavation, facing southeast 1/22/13

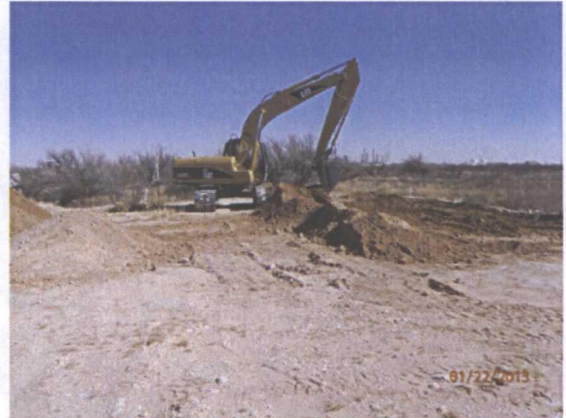
Scraping caliche to 1'6", facing west 1/22/13

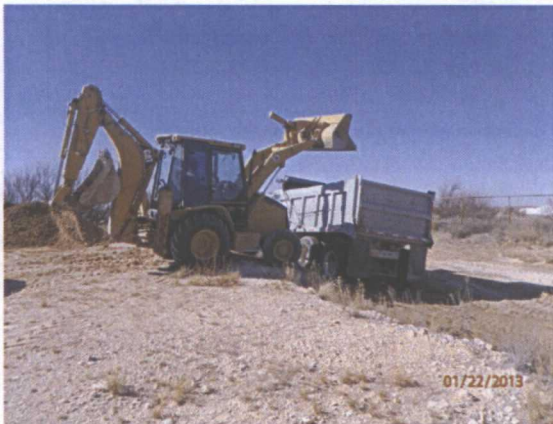
Exporting caliche, facing north 1/22/13

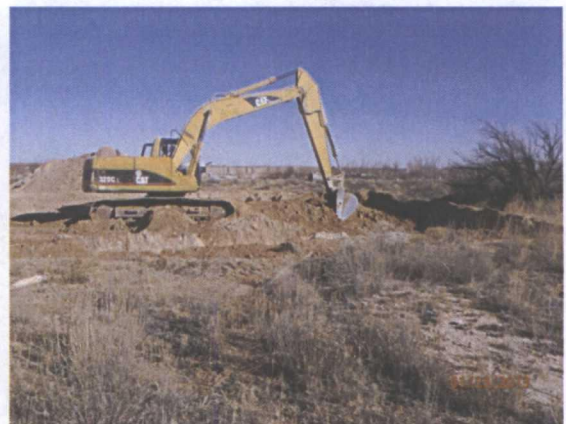
Excavating the site down 4'6", facing north
1/23/13

On January 22nd, 2013, RECS personnel were on site to begin excavating for liner installation. The site was then excavated to 105 ft x 60 ft x 4.5 ft. Based on the soil bore chloride concentrations, the soil with low chloride concentrations was stockpiled on site to use as backfill and the soil with higher chloride concentrations was sent to a NMOCD approved facility for disposal. A total of 588 yards of contaminated soil was disposed of at a NMOCD approved facility. Three samples of the stockpiled soil were field tested for hydrocarbons and returned results of 7.2 ppm, 11.2 ppm and 5.4 ppm. The samples were then taken to a commercial laboratory for analysis of chlorides and returned results of 320 mg/kg, 416 mg/kg and 496 mg/kg.

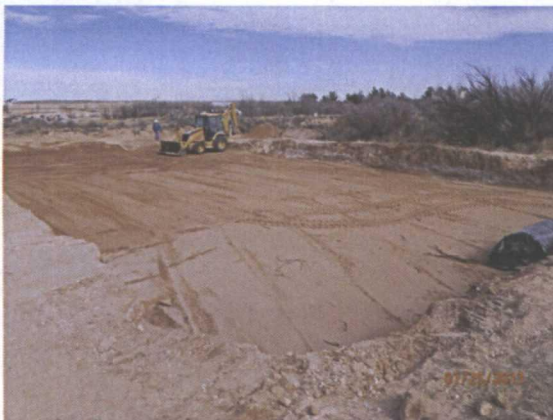
Installing sand pad below liner, facing northeast
1/25/13

A total of 288 yards of blow sand was imported to the site to serve as padding for the liner. A sample of the imported blow sand was field tested for hydrocarbons and returned a result of 2.8 ppm. The sample was then taken to a commercial laboratory for analysis of chlorides and returned a result of 32 mg/kg. The liner was padded below with the blow sand, properly seated into the excavation and then padded above. The site was then backfilled with the stockpiled soil. Top soil was imported onto the site to bring the excavation to the surface and contour it to the surrounding location. A sample of the top soil was field tested for hydrocarbons and returned a result of 0.2 ppm. The sample was then taken to a commercial laboratory for analysis of chlorides and returned a result of non-detect.

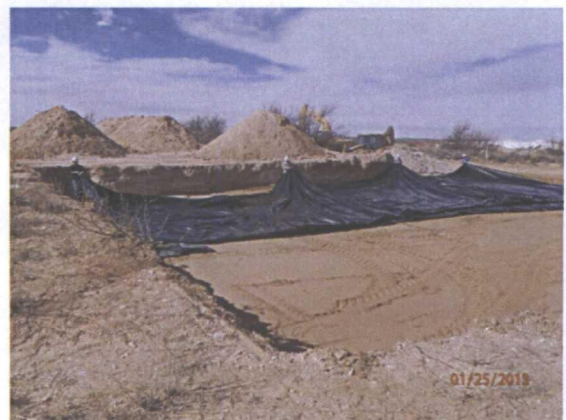
Installing liner, facing northwest 1/25/13

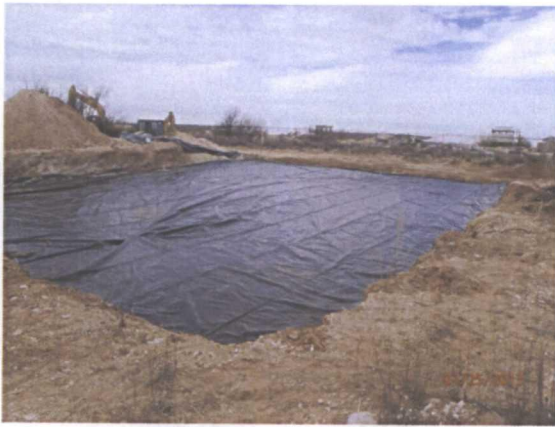
Liner installation completed, facing northwest
1/25/13

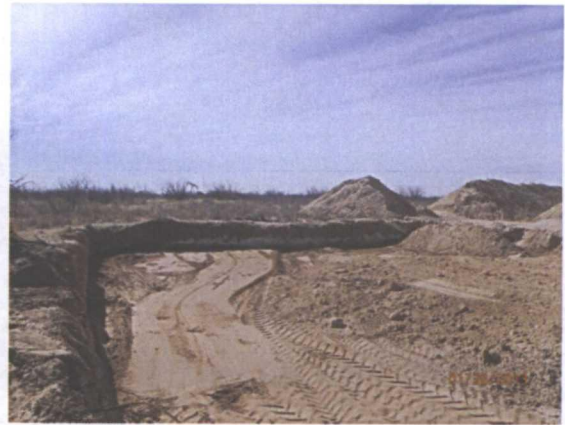
Padding above liner completed, facing
southwest 1/28/13

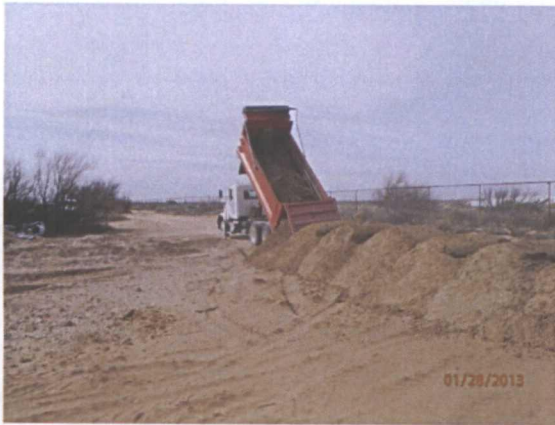
Importing soil, facing northwest 1/28/13

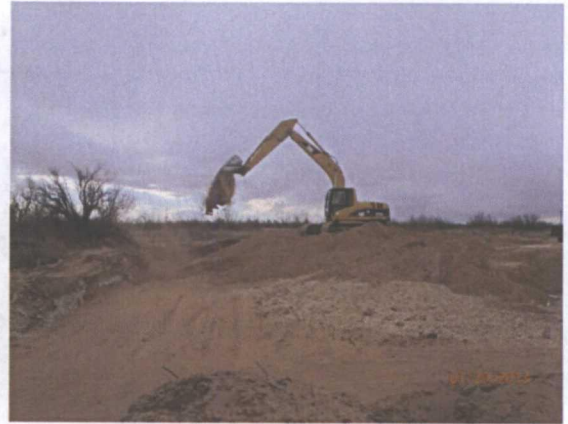
Backfilling excavation, facing south 1/29/13

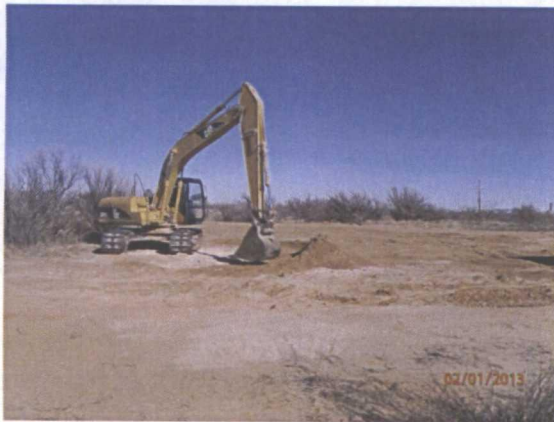
Spreading top soil over site, facing east 2/1/13

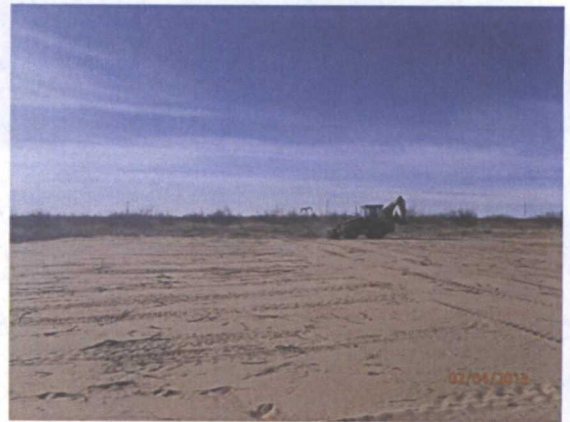
Excavation completed, facing south 2/4/13

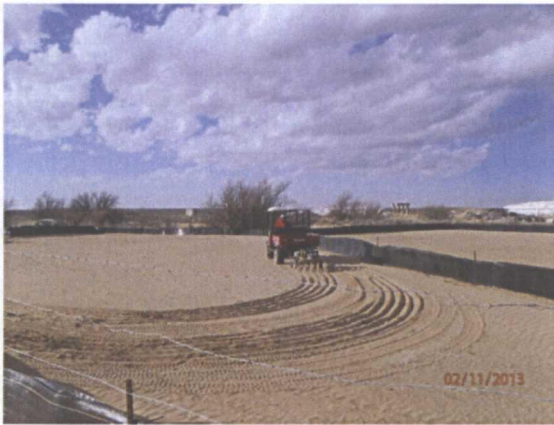
Tilling the site, facing northwest 2/11/13

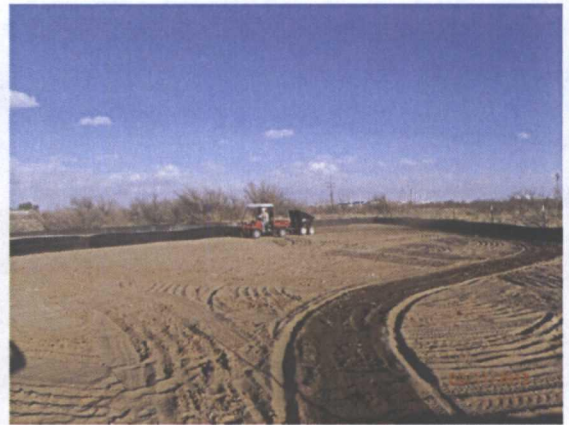
Spreading soil amendments, facing east 2/11/13

Silt net fencing was installed around the excavated area. Soil amendments were added to the top soil and the site was seeded with a blend of native vegetation. Documentation of Corrective Actions for the Vadose Zone can be found in Appendix A.

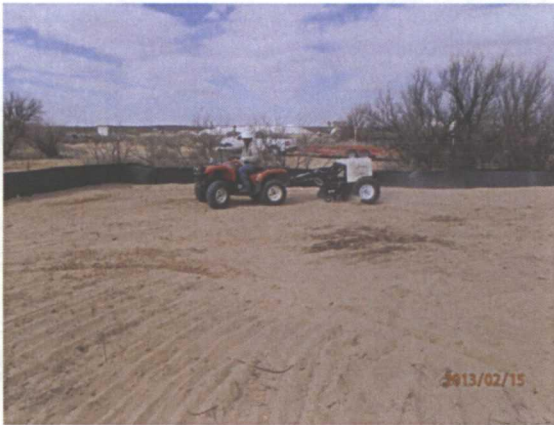
Seeding site, facing north 2/15/13

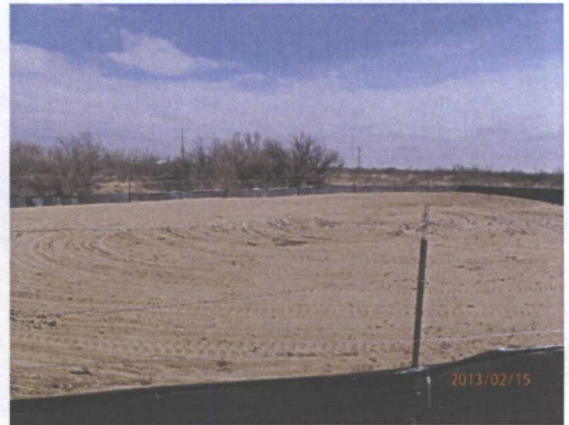
Site completed, facing east 2/15/13

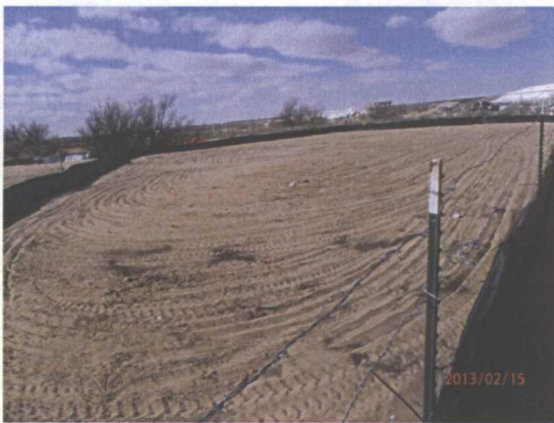
Site completed, facing north 2/15/13

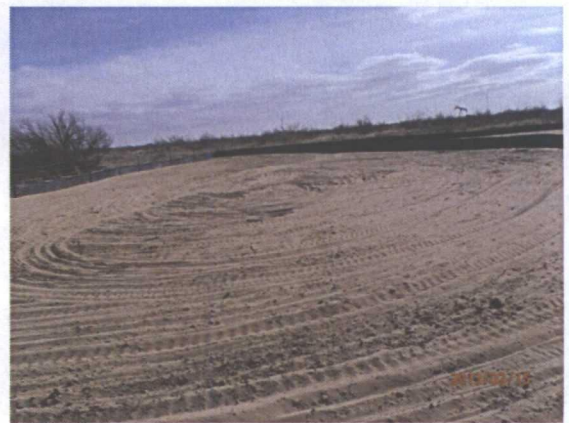
Site completed, facing south 2/15/13
