From: Hansen, Edward J., EMNRD
Sent: Tuesday, April 09, 2013 3:56 PM
To: Hack Conder (hconder@riceswd.com)
Cc: Leking, Geoffrey R, EMNRD; Laura Pena (lpena@riceswd.com); Katie Jones <kjones@riceswd.com> (kjones@riceswd.com); Scott Curtis (scurtis@riceswd.com)
Subject: Remediation Plan (1R427-339) Termination - ROC EME Jct E-33-1 Site

RE: Termination Request
EME Jct. E-33-1 (1R427-339): UL/E, Sec. 33, T19S, R37E
RICE Operating Company – Eunice Monument Eumont SWD System

RICE OPERATING COMPANY
JUNCTION BOX FINAL REPORT

EME Jct. E-33-1

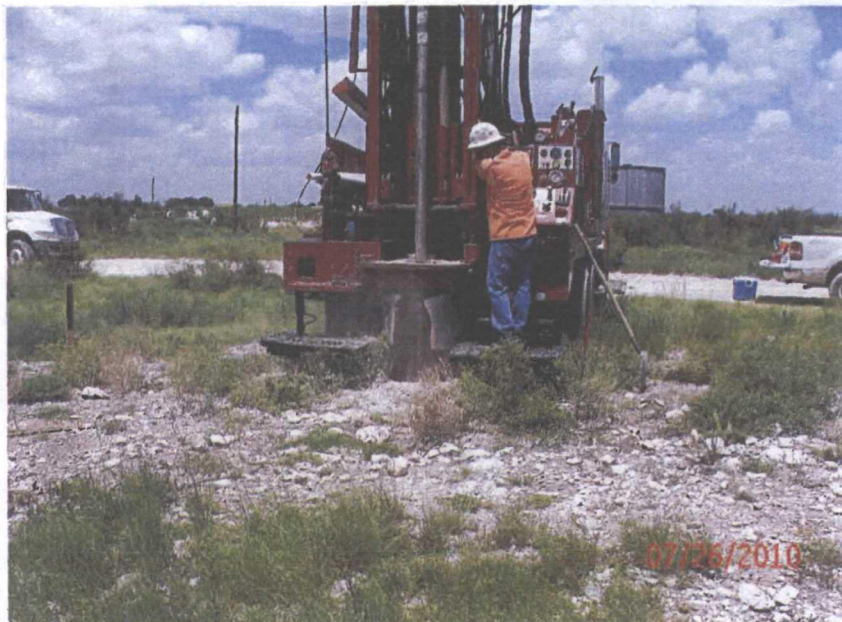
Drilling Soil bore

7/26/2010

General Description of Remedial Action: This junction was eliminated during the pipeline replacement/upgrade program. After the junction box was removed, an investigation conducted with a soil bore due to the inability to excavate through the rock formation. Chloride field test were performed on each sample taken at regular intervals, which yielded low concentrations. Organic vapors were measured using a PID, which yielded low concentrations. The deepest sample, 8 ft BGS, was sent to a commercial laboratory for analysis of chloride and TPH, which confirmed low concentrations of each. The entire bore hole was plugged with bentonite to ground surface. The site was not seeded due to the vegetation at the location was intact.

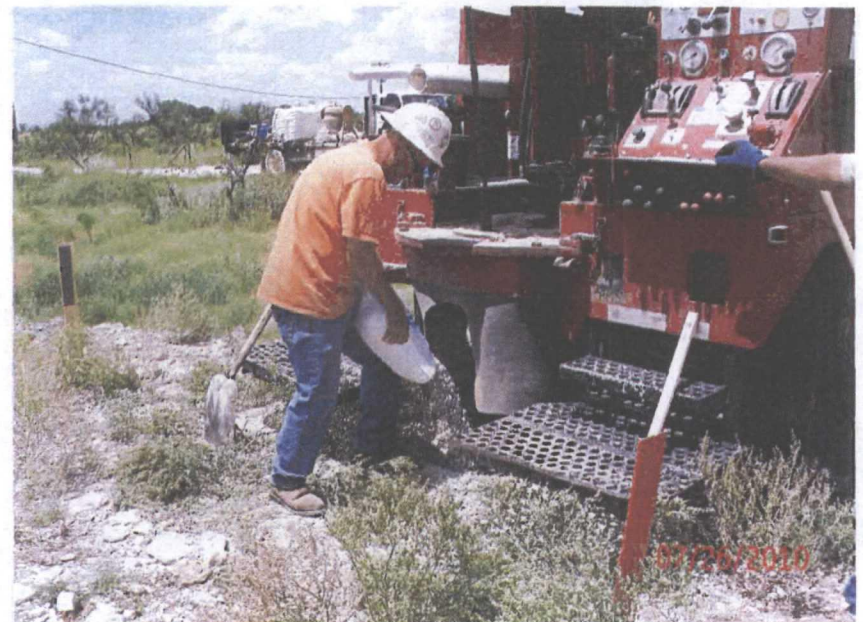
Soil Bore plugged with bentonite

7/26/2010

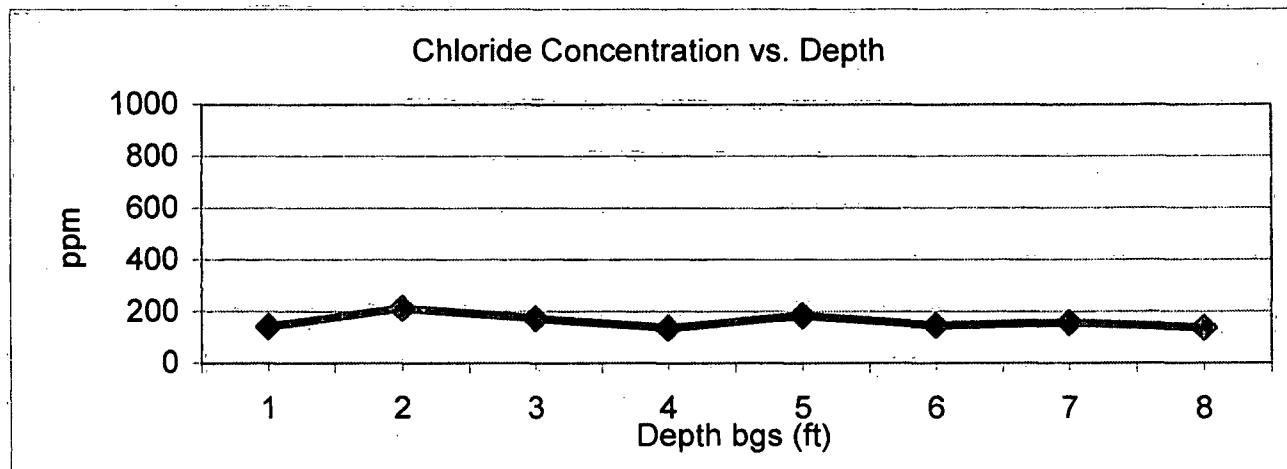
Soil Bore at junction (source)

Depth bgs (ft)	[Cl] ppm
1	143
2	213
3	174
4	136
5	185
6	146
7	157
8	138

Groundwater = 31 ft.

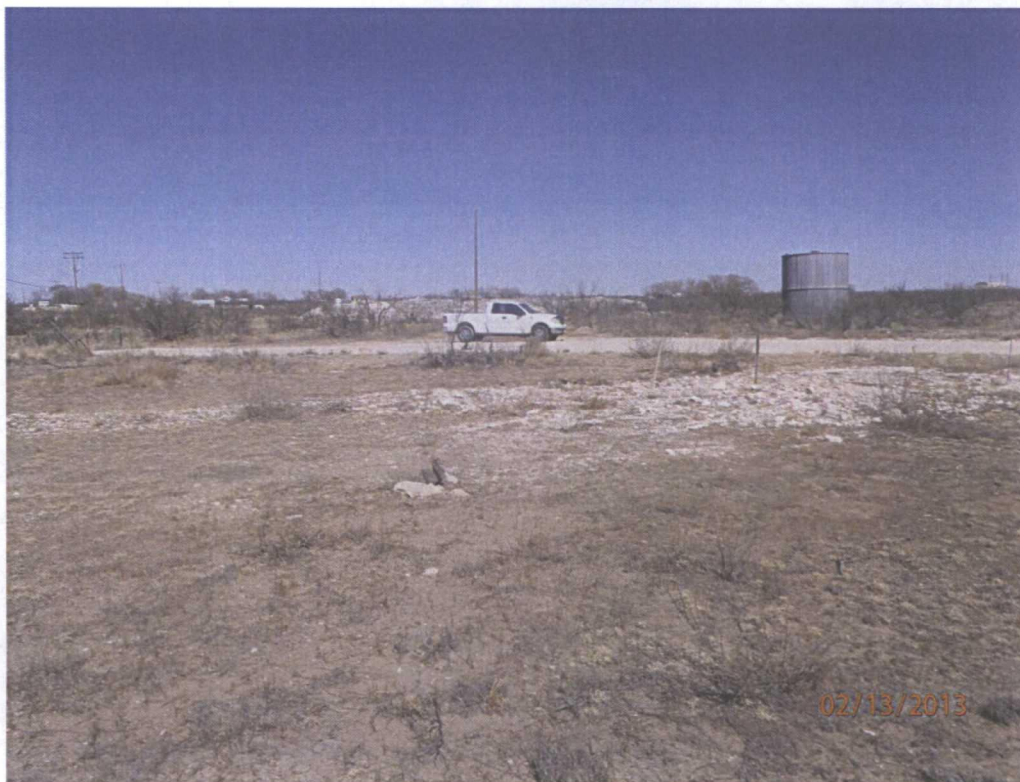
Facing north

2/13/2013

In 2010, ROC initiated work on the former E-33-1 junction box. The site is located in UL/E, Sec. 33, T19S, R37E. NM OSE records indicate that groundwater would likely be encountered at a depth of approximately 31 +/- feet. After the junction box was eliminated, a boring was installed to investigate the depth of chloride presence due to the inability to excavate through the rock formation. Each sample was field titrated for chlorides and field screened using a PID for hydrocarbons, resulting in low concentrations of each. The 8 ft sample was sent to a commercial laboratory for analysis of chloride and TPH, resulting in a chloride concentration of 112 mg/kg, and concentrations of gasoline range organics (GRO) and diesel range organics (DRO) below detectable limits. The boring was plugged in total with bentonite. A junction box is no longer needed at the site. The site is adjacent to an active right of way. Vegetation is occurring naturally and is expected to return to a productive capacity at a normal rate.

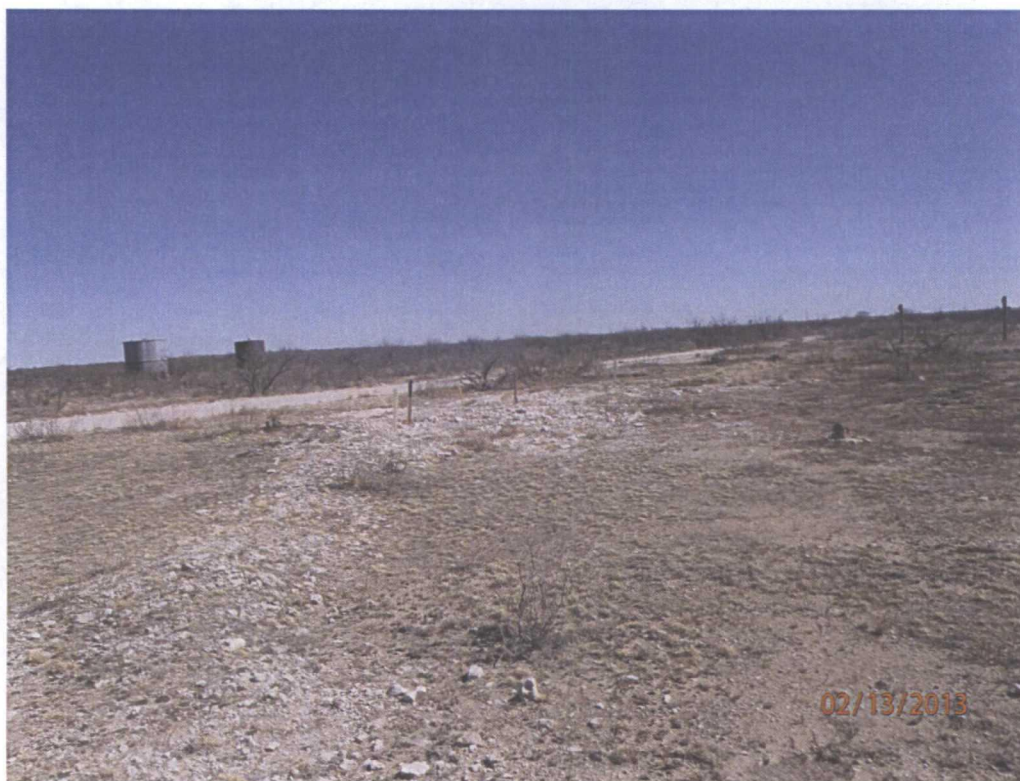
Facing east

2/13/2013
