RICE OPERATING COMPANY JUNCTION BOX DISCLOSURE* REPORT

BOX LOCATION							BOX DIMENSIONS* FEET		
SWD SYSTEM	JUNCTION	UNIT	SECTION	TOWNSHIP	RANGE	COUNTY	Length	Width	Depth
Eunice Monument Eumont (EME)	N-28 EOL	N	28	20S	36E	Lea	Eliminated

EME N-28 EOL

UL/N SECTION 28
T-20-S R-36-E
LEA COUNTY, NM

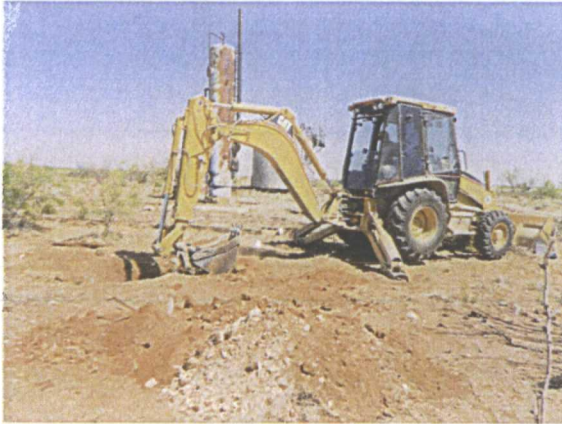
4/17/2012

Excavating site, facing north

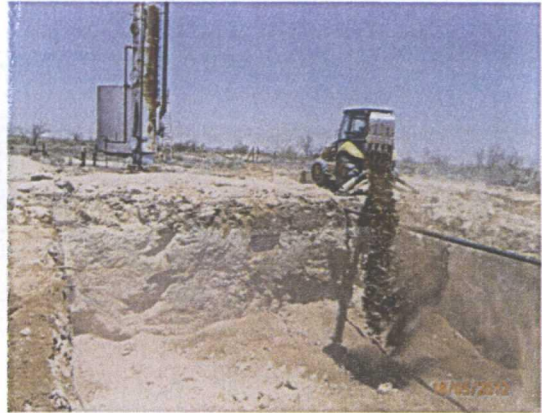
5/18/2012

Installing 6' sand pad below liner, facing north

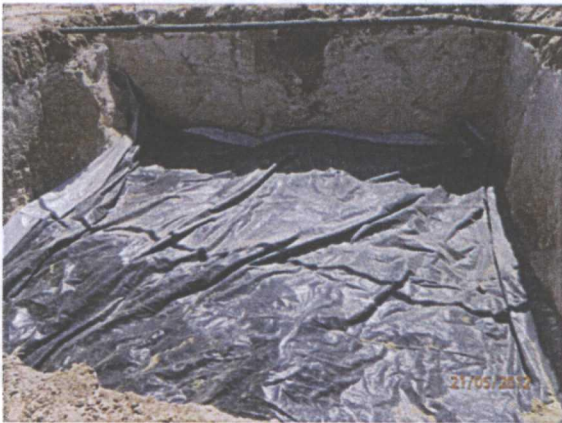
5/21/2012

Installed 25'x20' liner @ 12' bgs, facing west

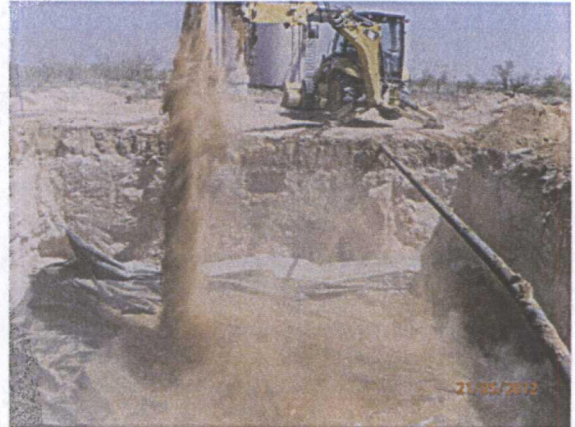
5/21/2012

Installing 6' sand pad above liner, facing east

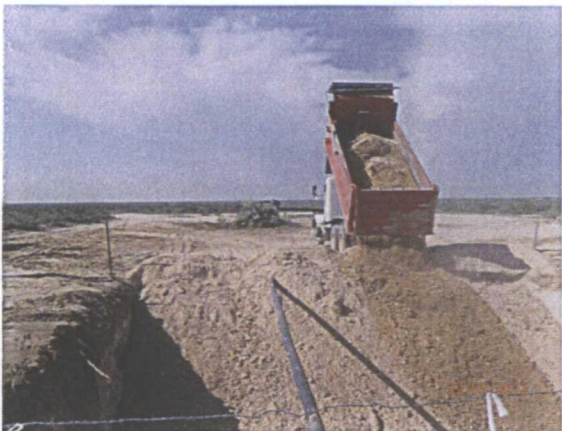
5/22/2012

Backfilling with imported soil facing south

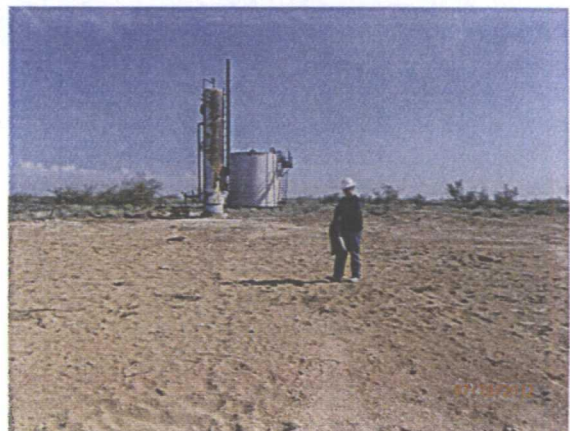
7/18/2012

Seeding site, facing north
