EME J-29 EOL

RE: Termination Request
EME J-29 EOL: UL/J, Sec. 29, T21S, R36E
RICE Operating Company – Eunice Monument Eumont SWD System

**RICE OPERATING COMPANY
JUNCTION BOX FINAL REPORT**

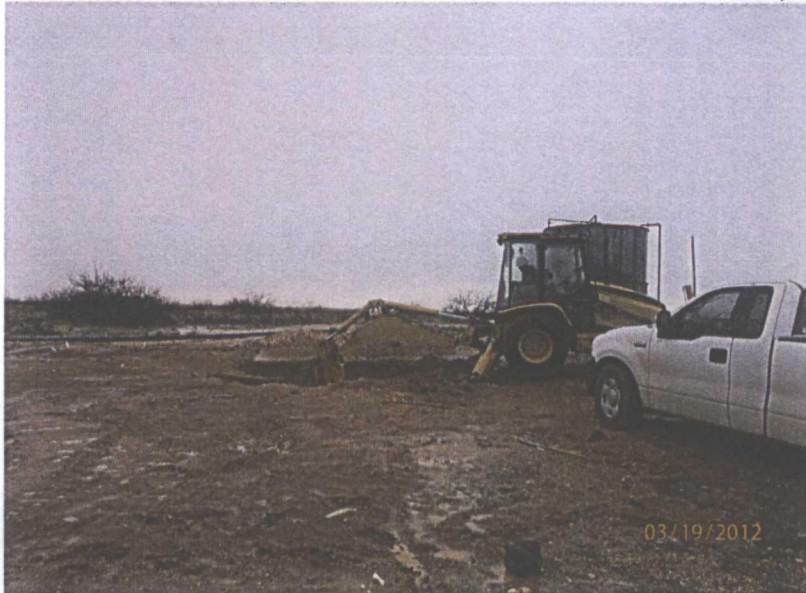
3/19/2012

Excavating site, facing west

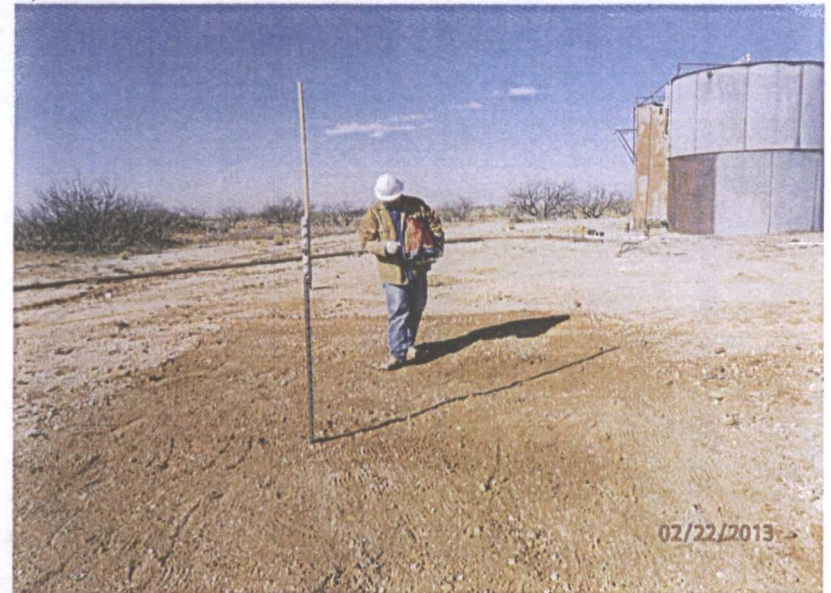
2/22/2013

Seeding site, facing west

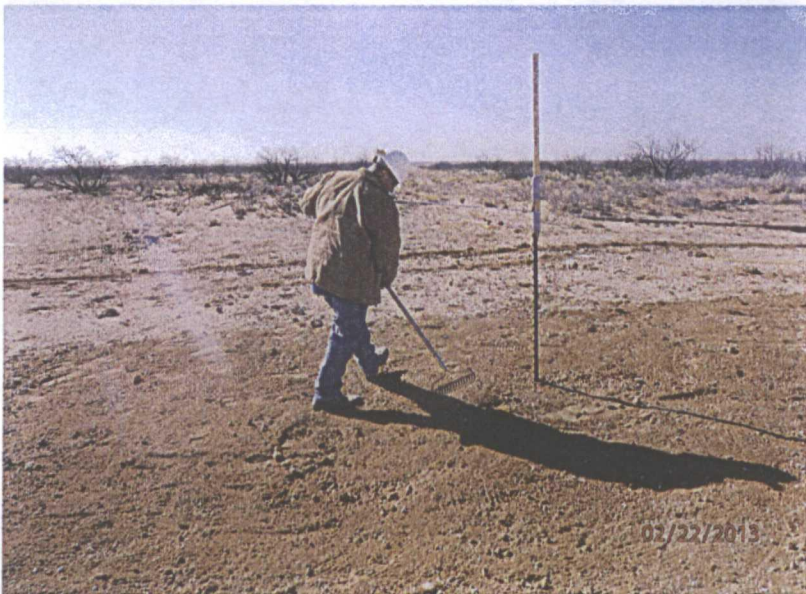
2/22/2013

Raking in seed, facing south

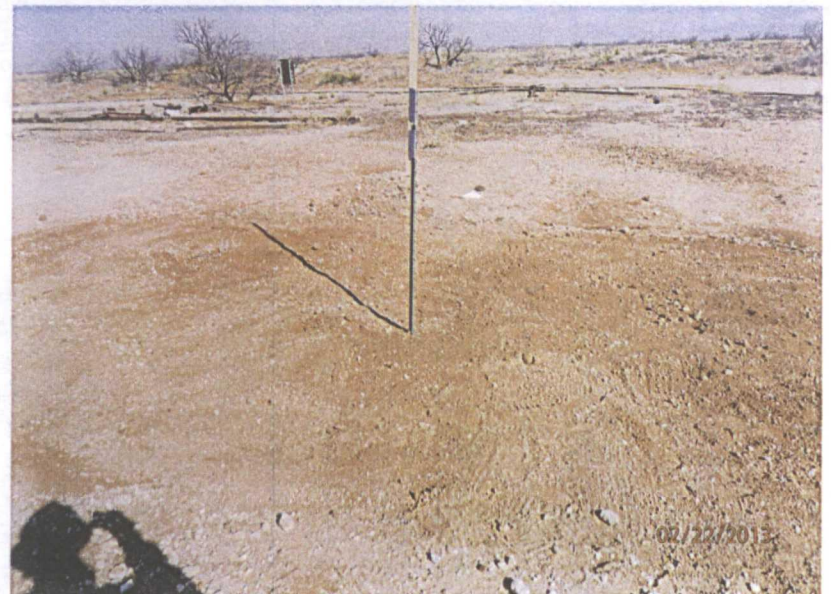
2/22/2013

Site completed

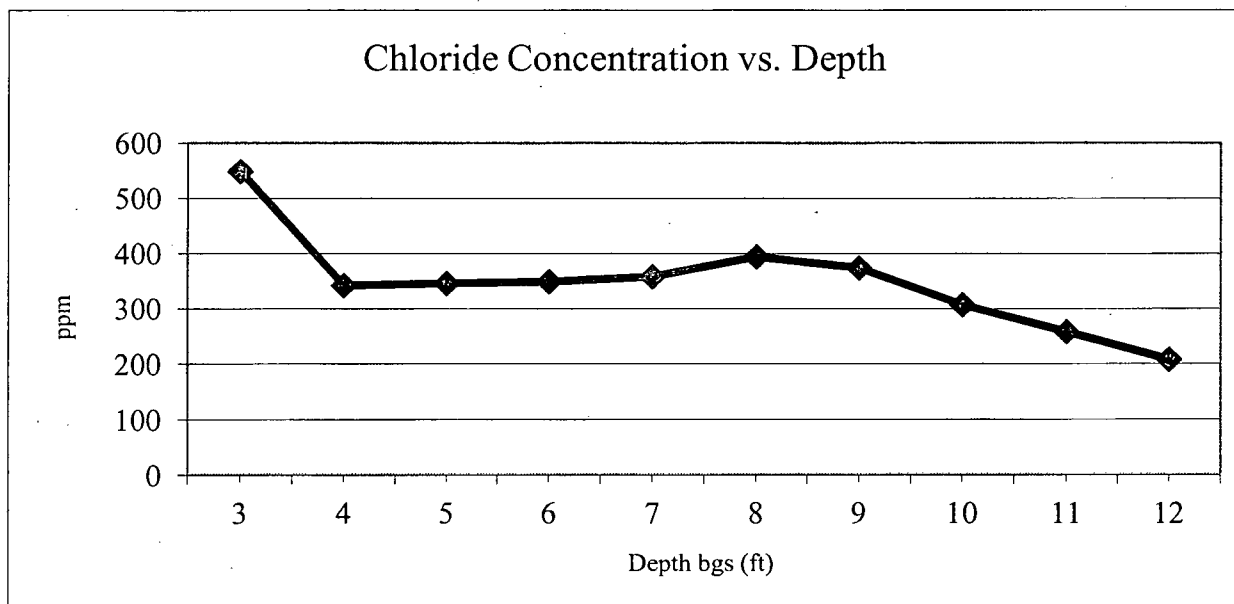
CHLORIDE CONCENTRATION CURVE

Backhoe samples at junction (source)

Depth bgs (ft)	[Cl ⁻] ppm
3	549
4	342
5	346
6	349
7	358
8	394
9	374
10	307
11	258
12	208

Groundwater = 225 ft
