**RE: Termination Request  
for the Rice Operating Company's  
EME L-19-2 Site  
Unit Letter L, Section 19, T20S, R37E, NMPM, Lea County, New Mexico  
Remediation Plan (1R427-83) Termination**

RE: Termination Request  
EME L-19-2 (1R427-83): UL/L, Sec. 19, T20S, R37E  
RICE Operating Company – Eunice Monument Eumont SWD System

# EME L-19-2 (1R427-83)

UL/L, Section 19, T20S, R37E

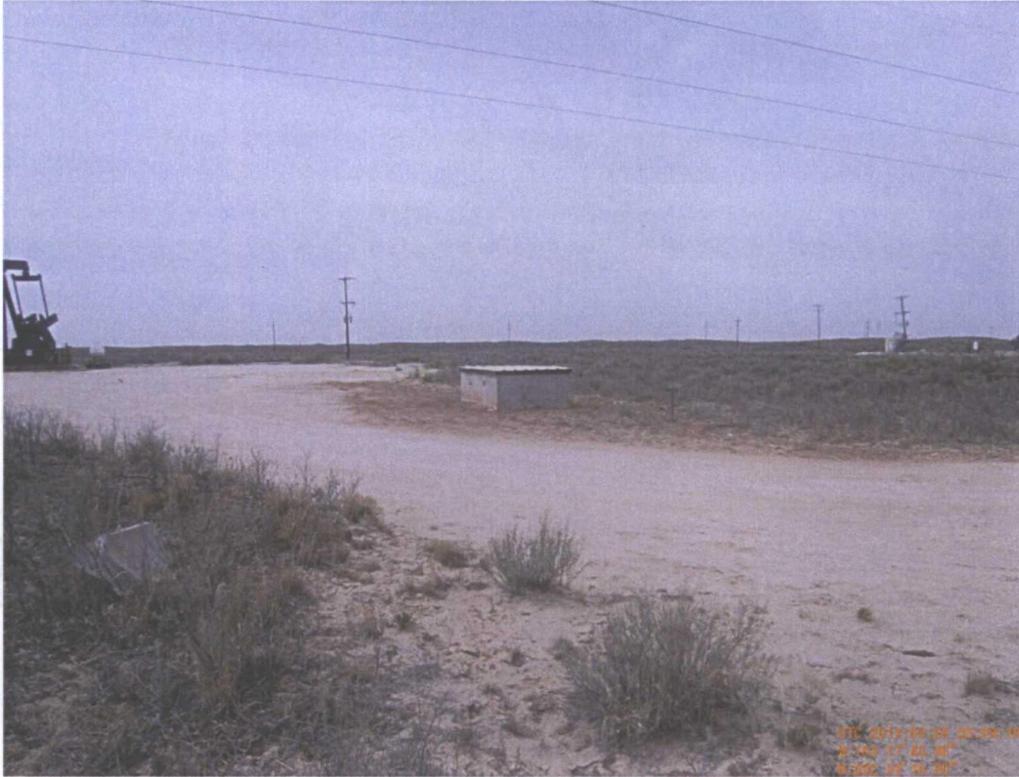
Facing west

3/20/2013

A total of 36 cubic yards of excavated soil was properly disposed of at a NMOCD facility. A compacted clay layer was installed and will provide a barrier that will inhibit the downward migration of chlorides to groundwater. The excavation was backfilled with blended soil and a new, watertight junction was installed over the site. The site is located next to a lease road; therefore, seeding is not required.

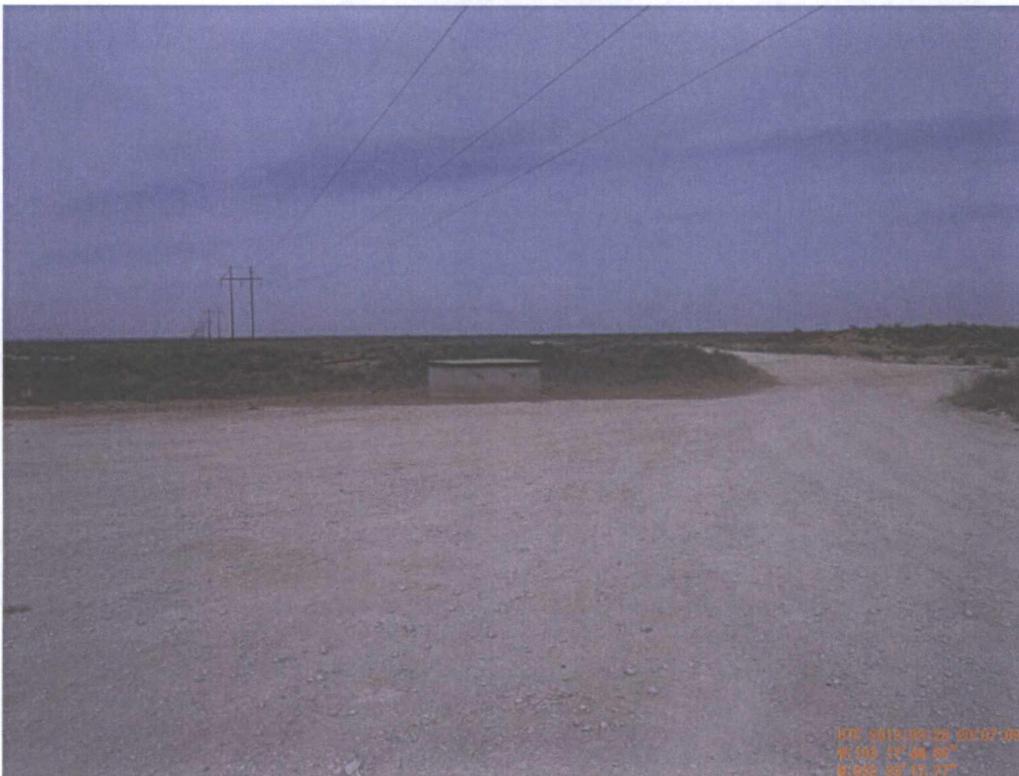
Facing north

3/20/2013
