**RE: Termination Request
for the Rice Operating Company's
EME H-27-1 Site
Unit Letter H, Section 27, T19S, R36E, NMPM, Lea County, New Mexico
Remediation Plan (1R427-159) Termination**

RE: Termination Request
EME H-27-1 (1R427-159): UL/H, Sec. 27, T19S, R36E
RICE Operating Company – Eunice Monument Eumont SWD System

**RICE OPERATING COMPANY
JUNCTION BOX FINAL REPORT**

EME jct. H-27

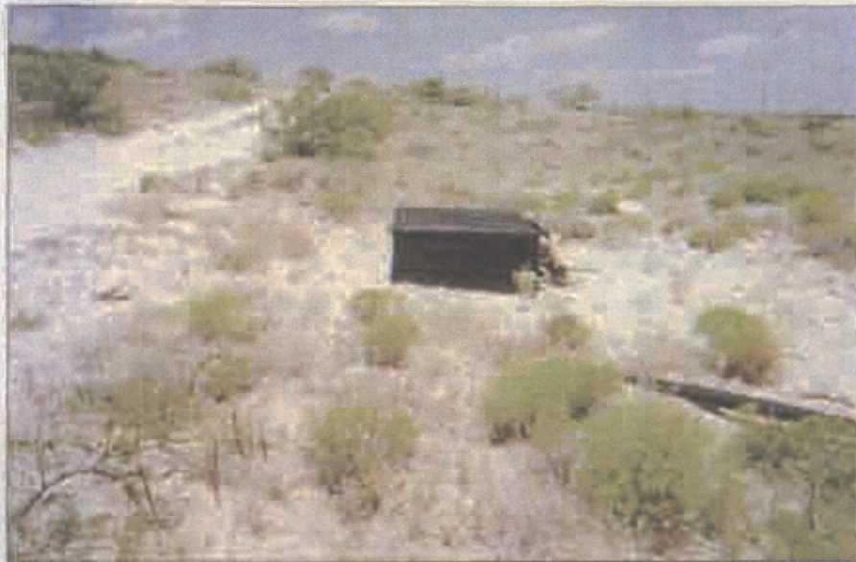
8/20/2004

undisturbed junction box before excavation

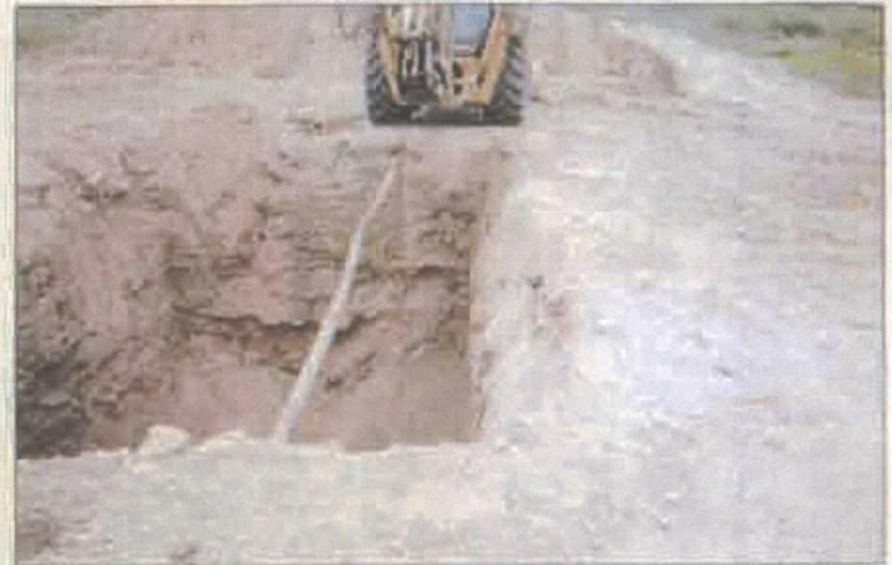
9/7/2004

excavation & delineation 10 x 10 x 7-ft

In 2004, ROC initiated work on the former H-27-1 junction box. The site is located in UL/H, Sec. 27, T19S, R36E. NM OSE records indicate that groundwater would likely be encountered at +/- 59 ft. The site was delineated using a backhoe to collect soil samples at regular intervals, creating a 20x10x13 ft deep excavation. Each sample was field titrated for chlorides and field screened using a PID for hydrocarbons, resulting in chloride concentrations that decreased with depth and low PID readings. Representative samples of the sidewalls and bottom were collected and sent to a commercial laboratory for analysis of chloride and TPH, resulting in a sidewall chloride concentration of 542 mg/kg and a gasoline range organics (GRO) and a diesel range organics (DRO) concentration below detectable limits. The bottom sample resulted in a chloride concentration of 1,000 mg/kg and concentrations of GRO and DRO below detectable limits. The excavation was backfilled to 6 ft bgs with remediated excavated soil. A sample of the remediated backfill was sent to a commercial laboratory for analysis of chloride and TPH, resulting in a chloride concentration of 287 mg/kg, a GRO concentration below detectable limits and a DRO concentration of 52.9 mg/kg. At 6 ft bgs, a 1 ft thick compacted clay layer was installed. The clay layer will provide a barrier that will inhibit the downward migration of chlorides to groundwater. The remaining

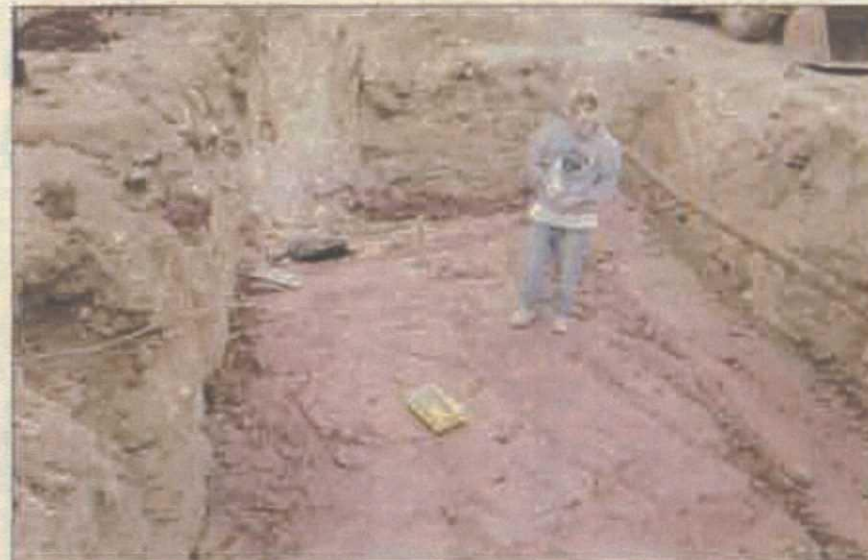
10/6/2004

testing clay barrier at 6 ft BGS

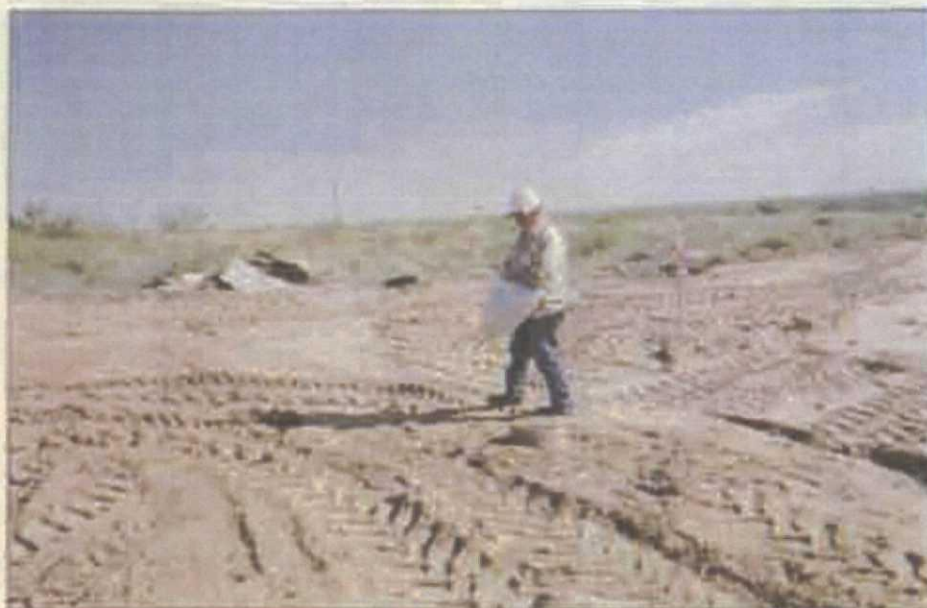
10/7/2004

seeding disturbed area at backfilled site; clay ID plate at feet

excavation was backfilled with the remediated backfill to ground surface and contoured to the surrounding area. On October 10/7/04, the site was seeded with a blend of native vegetation.

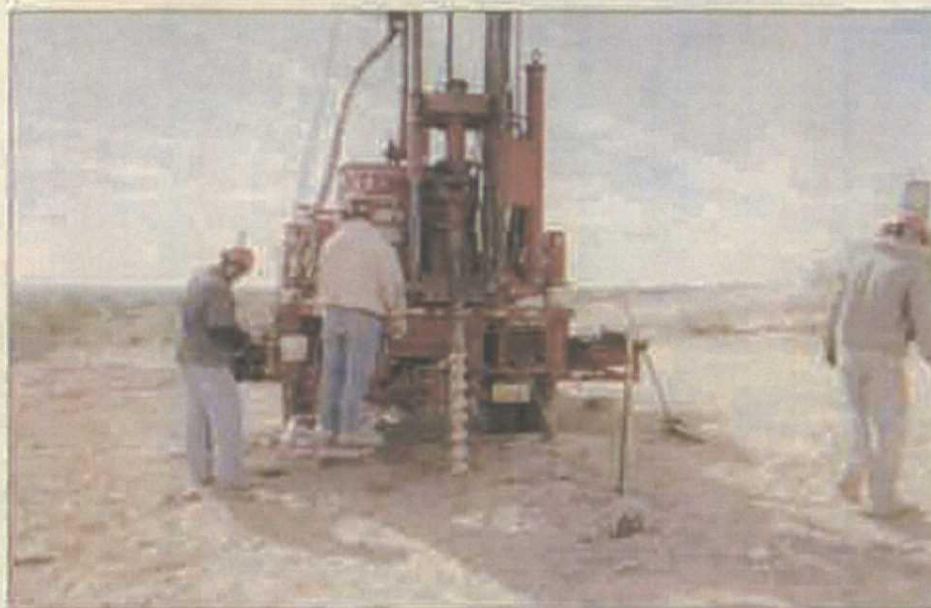
11/12/2004

delineation drilling

To further investigate the depth of chloride presence, a soil bore was initiated on November 12, 2004 at 5 ft east of the former junction box site. The boring was advanced to a depth of 45 ft BGS with soil samples collected every 5 ft between 20 and 45 ft. Each sample was field titrated for chlorides and field screened using a PID for hydrocarbons, resulting in concentrations that decreased with depth. The 45 ft sample was sent to a commercial laboratory for analysis, resulting in a chloride, GRO, and DRO concentration below detectable limits.

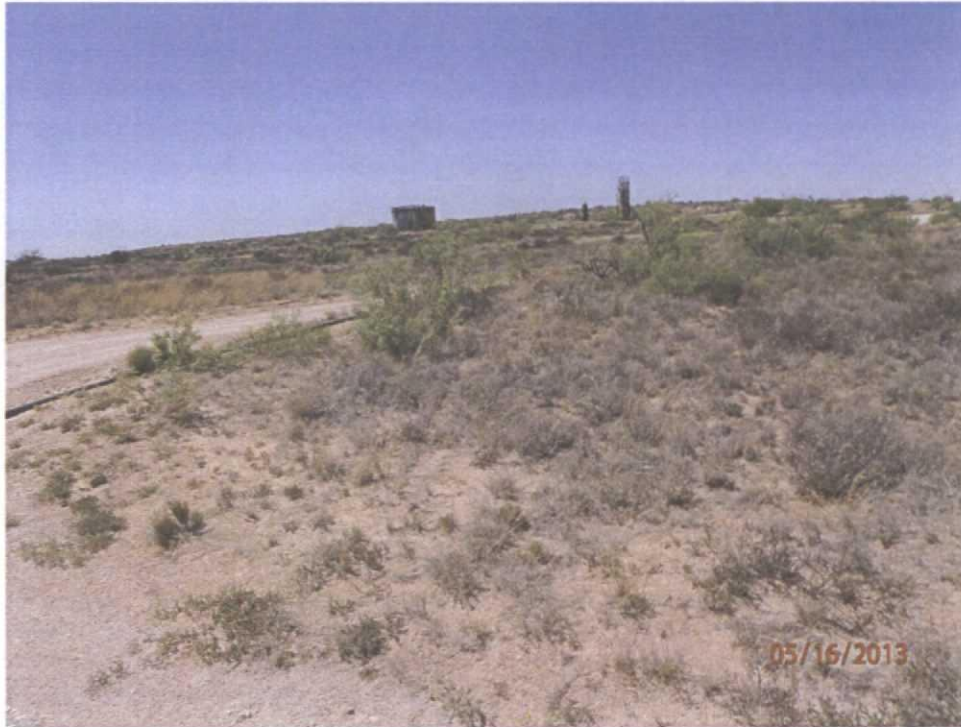
5/16/2013

Vegetation has rebounded at the site so no re-vegetation efforts are needed. A junction box is no longer required.

Facing NW

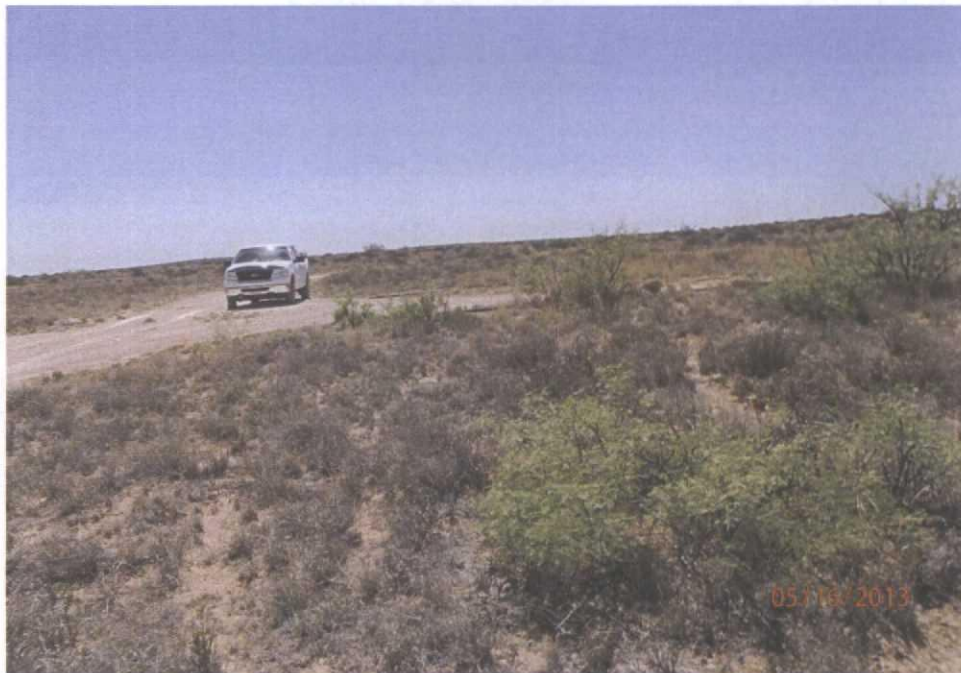
5/16/2013

Facing West
