**RE: Termination Request  
for the Rice Operating Company's  
EME H-2 Site  
Unit Letter H, Section 2, T20S, R37E, NMPM, Lea County, New Mexico  
Remediation Plan (1R427-58) Termination**

RE: Termination Request  
EME H-2 (1R427-58): UL/H, Sec. 2, T20S, R37E  
RICE Operating Company – Eunice Monument Eumont SWD System

**RICE OPERATING COMPANY  
JUNCTION BOX FINAL REPORT**

# EME H-2 (1R427-58)

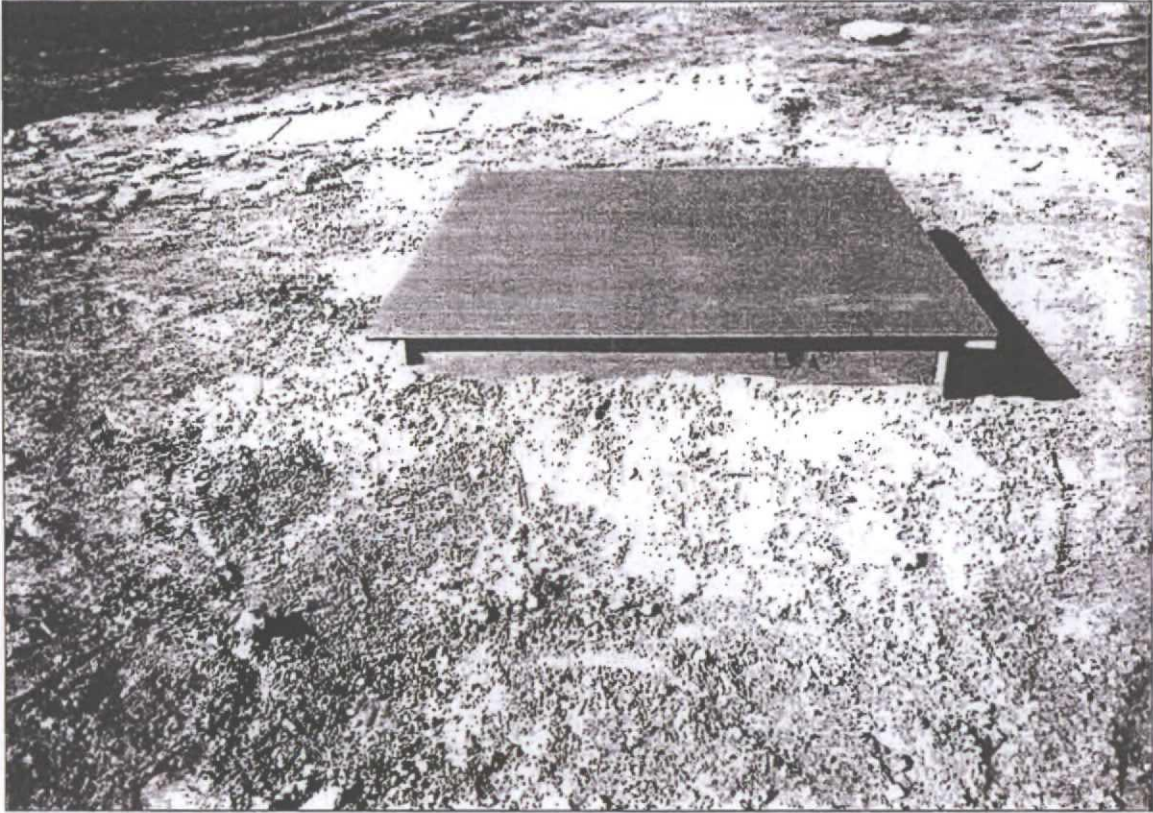
## **EME H-2 jct. box upgrade**

**new junction box**

threat to public health. A water-tight junction box has since been built at this location.
