## **REMEDIATION SUMMARY & RISK-BASED SITE CLOSURE REQUEST**

**BOPCO, LP  
NORTH INDIAN FLATS 26 FEDERAL #1  
Eddy County, New Mexico  
Unit Letter "G" (SW/NE), Section 26, Township 21 South, Range 28 East  
Latitude 32.452530° North, Longitude 104.054850 ° West  
NMOCD Reference #: 2RP-1624**

**December 2013**

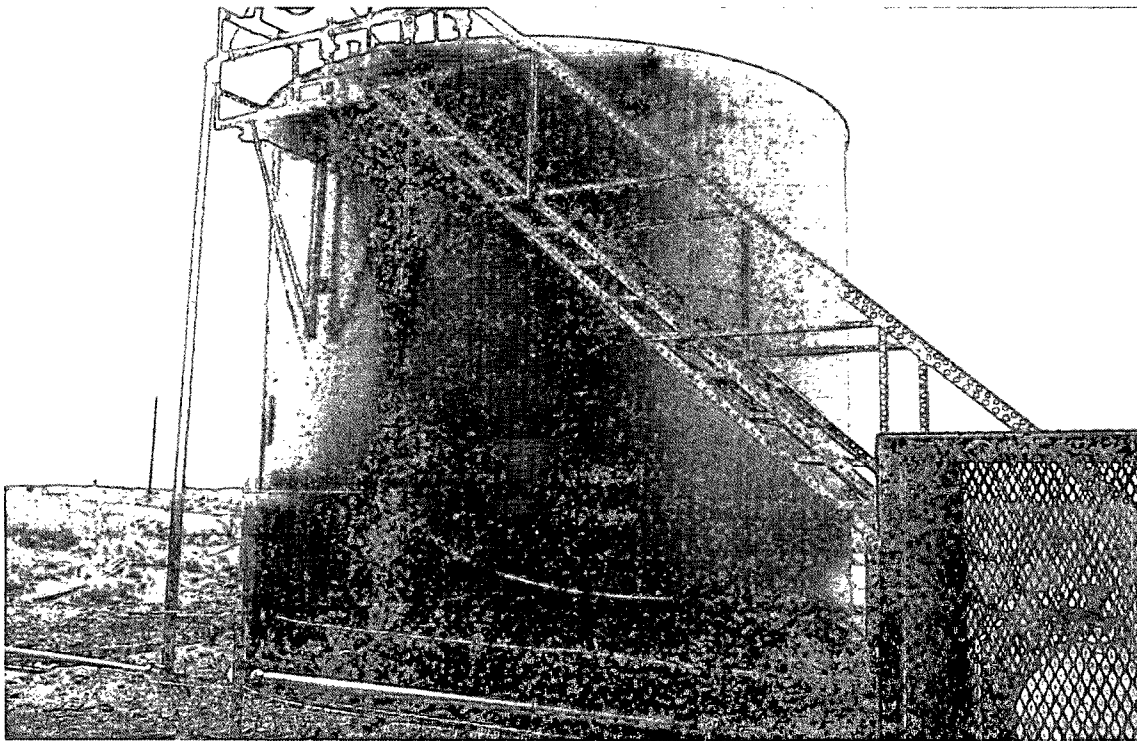
On April 4, 2013, BOPCO discovered a release had occurred at the North Indian Flats 26 Federal #1 tank battery. A three-inch (3") water dump line from the heater treater to the on-site produced water storage tank developed a leak, resulting in a release of produced water. The release was attributed to internal corrosion. During initial response activities, a repair clamp was installed to mitigate the release, and heavily impacted soil was scraped up and stockpiled on-site, pending final disposition.

North Indian Flats 26 Federal Battery #1 - Release Site

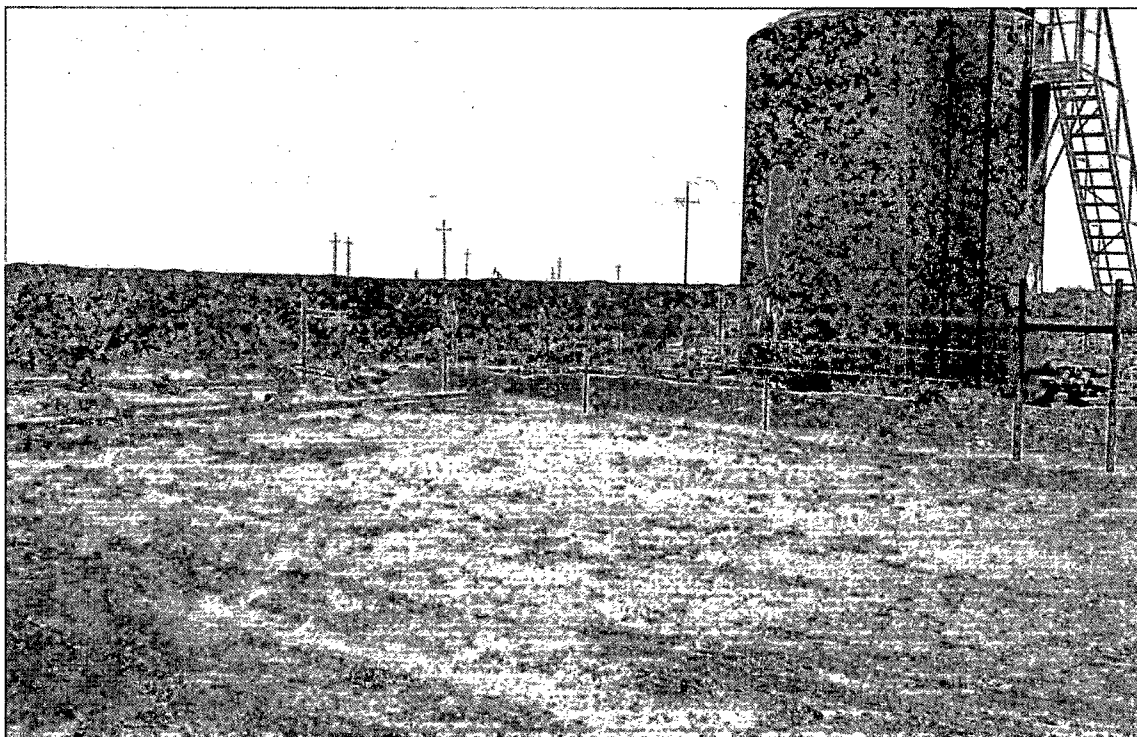
Laboratory analytical results indicated TPH and BTEX constituent concentrations were less than the appropriate laboratory method detection limit (MDL) in all submitted soil samples. Chloride concentrations ranged from 160 mg/kg in soil sample HA-6 @ 3' to 4,560 mg/kg in soil sample HA-1 @ 3'.

North Indian Flats 26 Federal Battery #1 - Release Site (Soil Boring HA-1 Flagged in Orange)

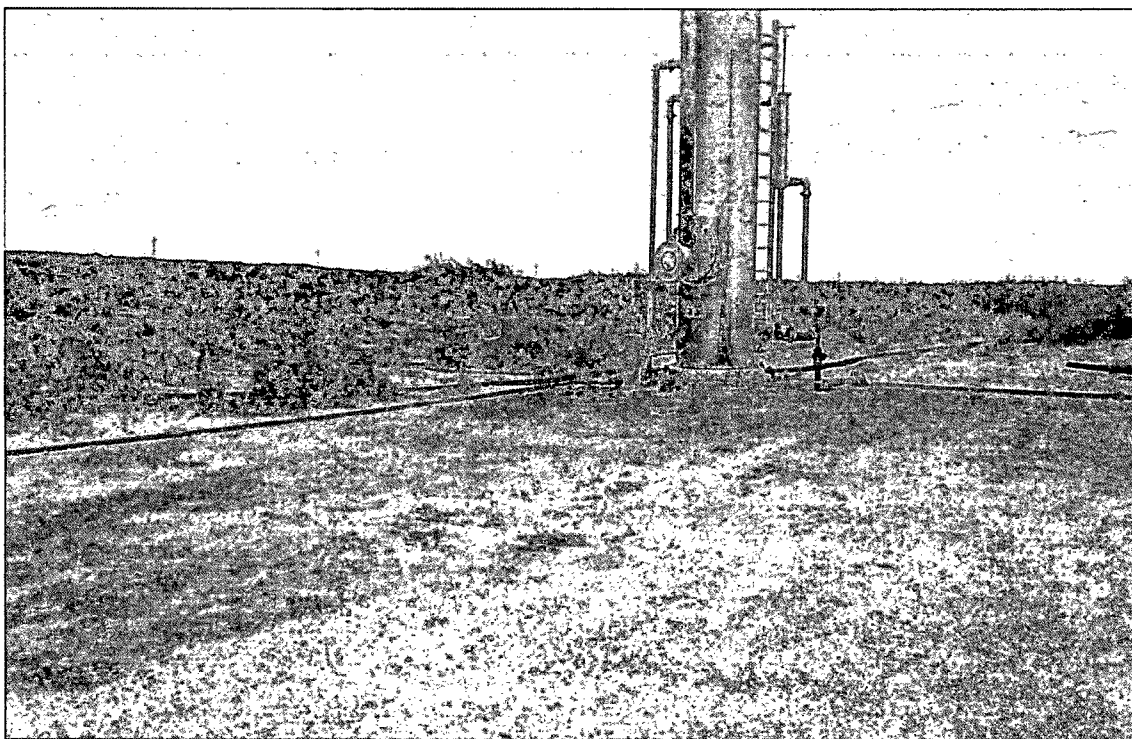
Review of laboratory analytical results and field-screens indicated that further vertical delineation would be required in the areas represented by soil borings HA- 1, HA-2, and HA-4.

North Indian Flats 26 Federal Battery #1 - Flow Path (Soil Boring HA-2 Flagged in Orange)

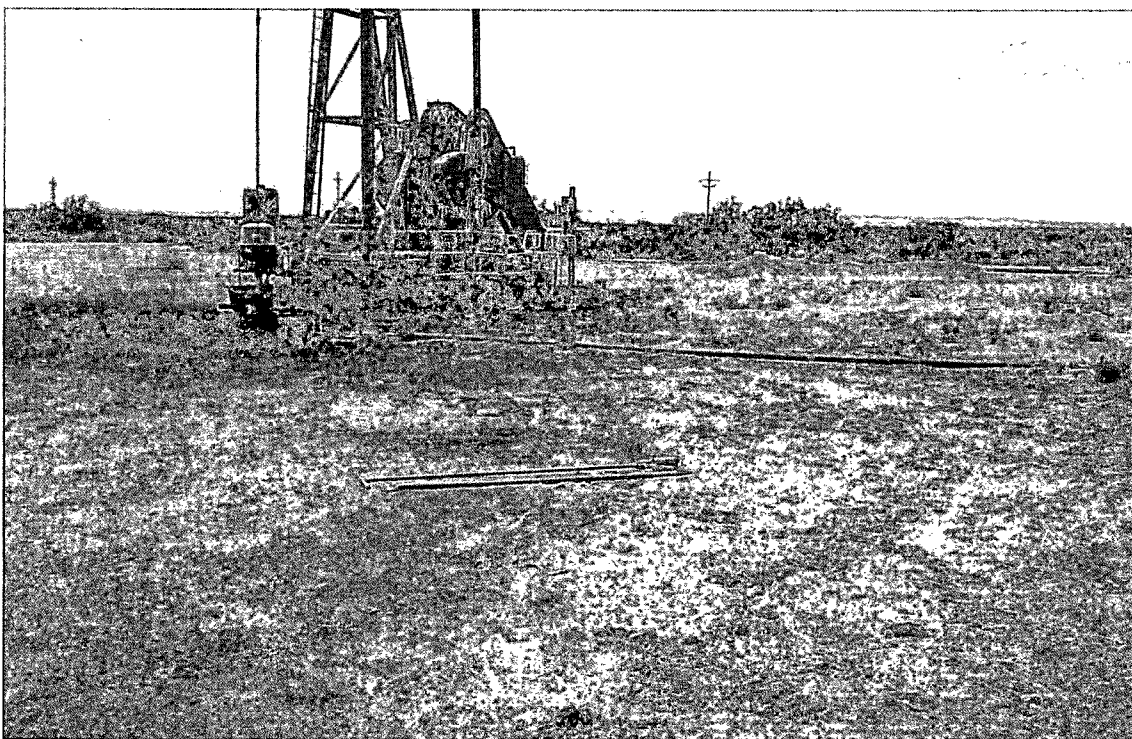
North Indian Flats 26 Federal Battery #1 - Flow Path (Soil Boring HA-3 Flagged in Orange)

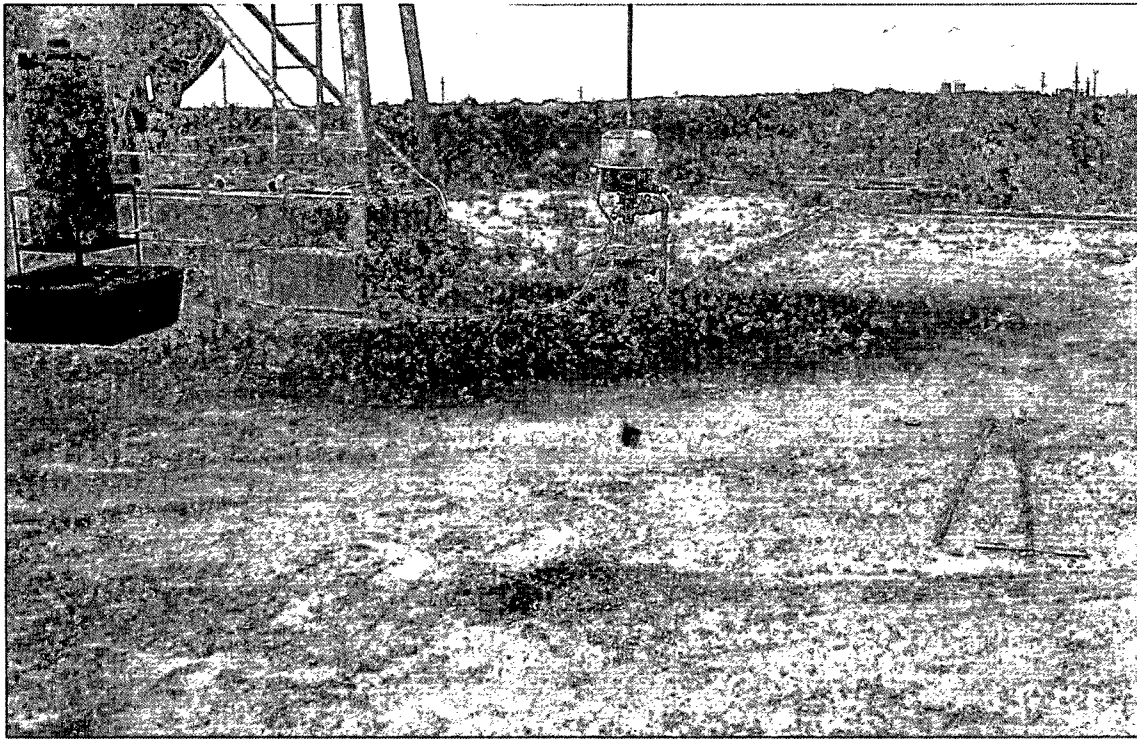
North Indian Flats 26 Federal Battery #1 - Soil Boring HA-4 (Flagged in Orange)

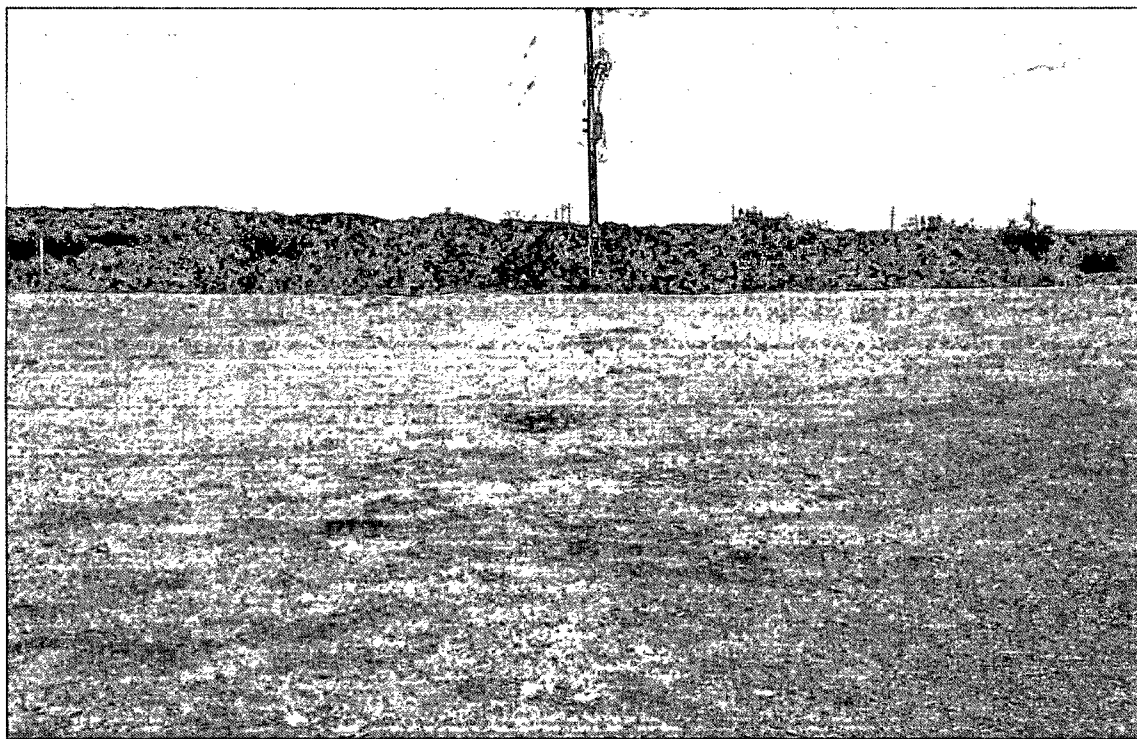
North Indian Flats 26 Federal Battery #1 - Flow Path  
(Looking South (Soil Boring HA-5 Flagged in Orange))

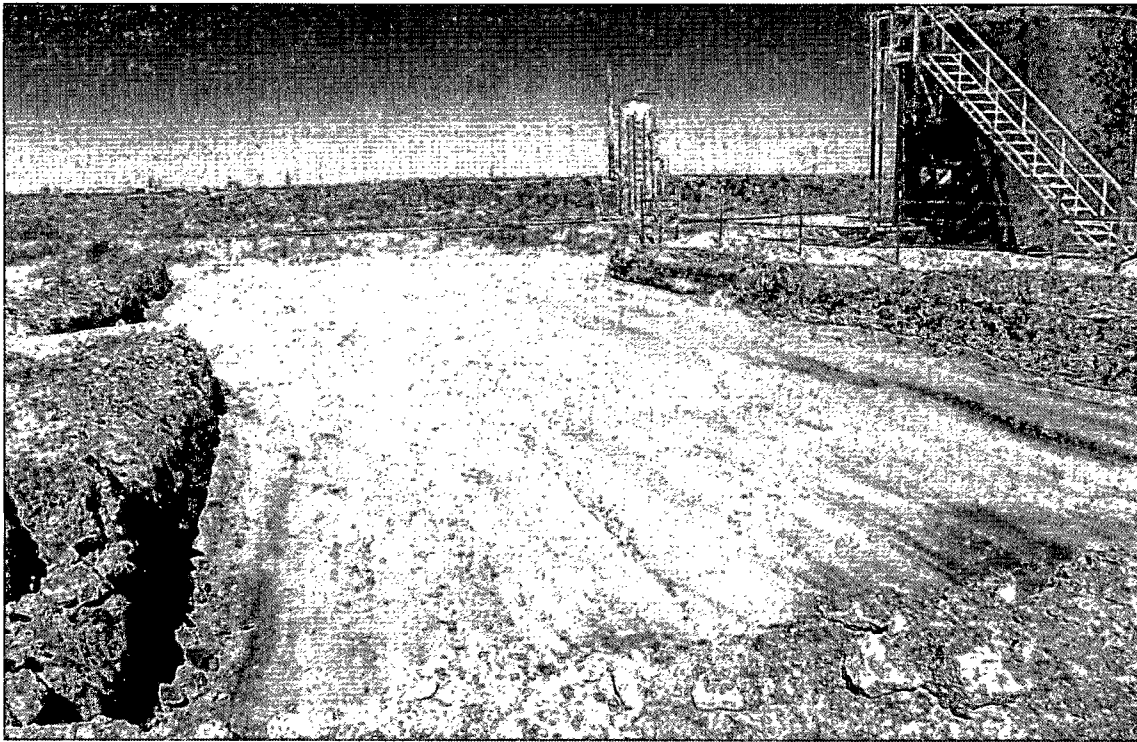
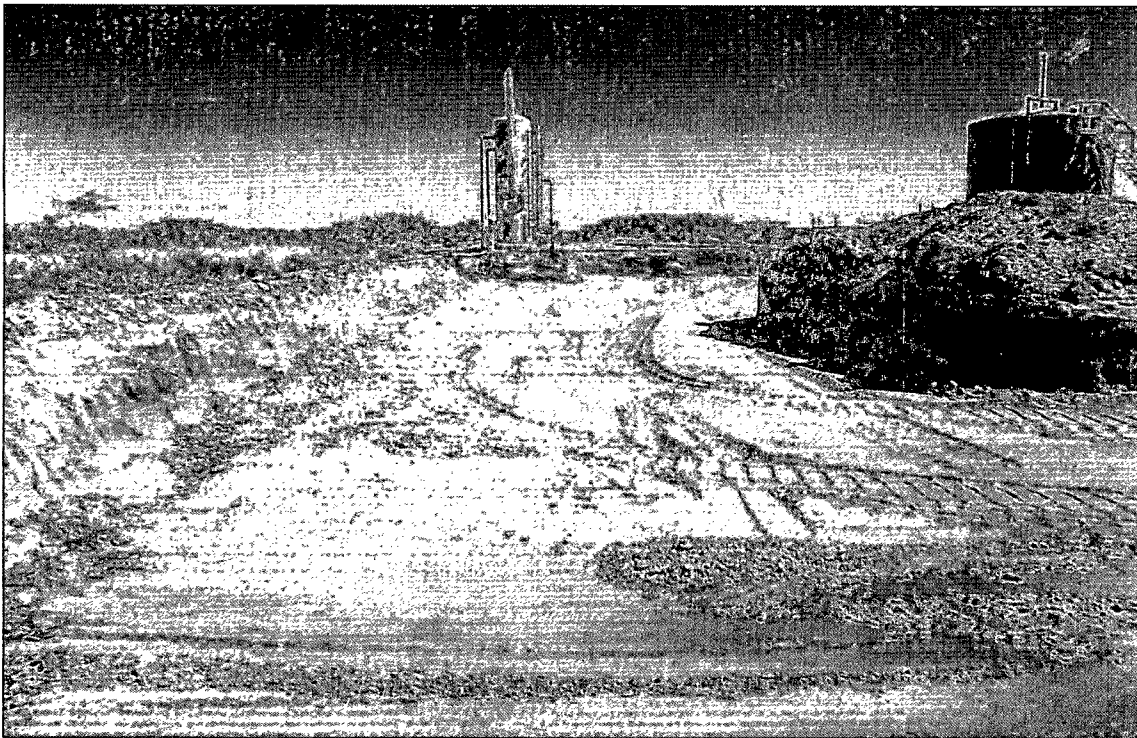
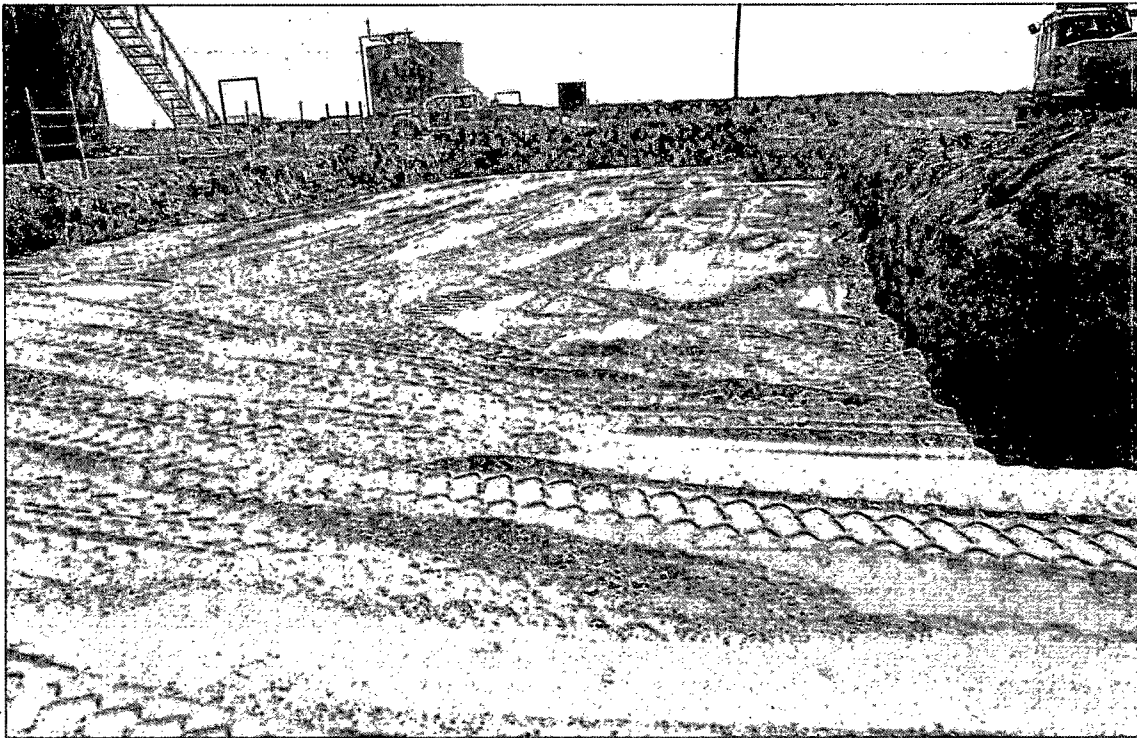
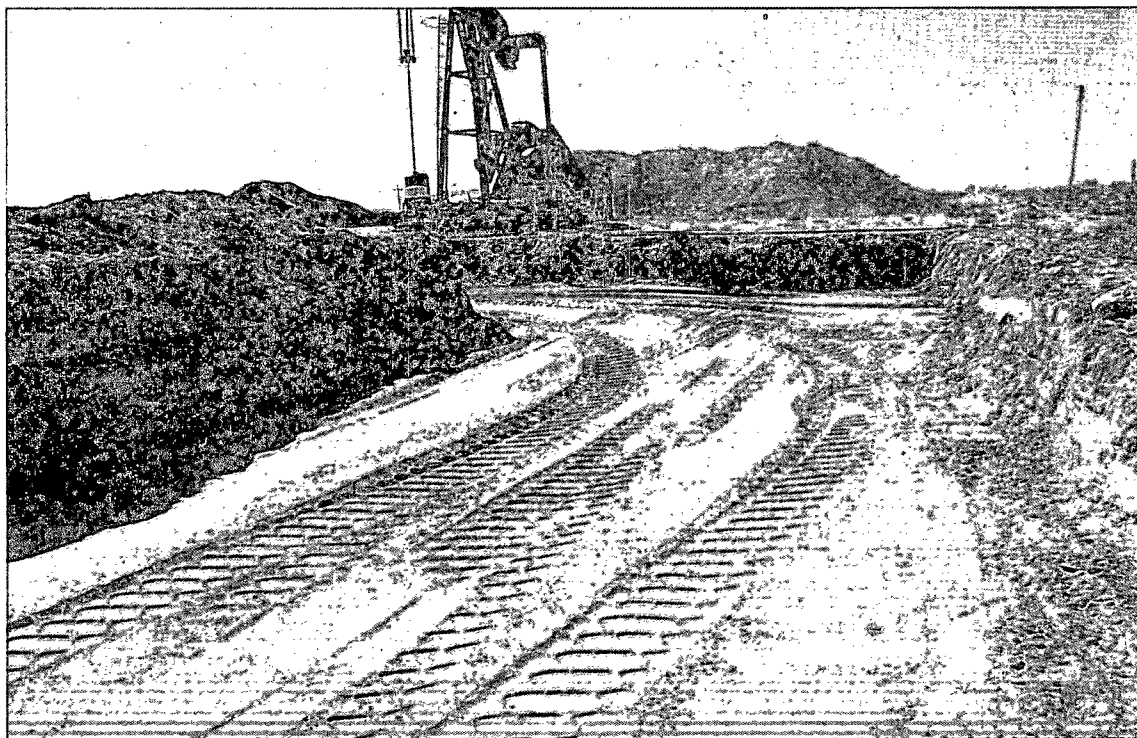
On October 2, 2013, excavation of impacted soil commenced at the site. A chloride test kit was utilized to field-screen the horizontal extent of impacted soil and to guide the excavation. From October 2 through October 11, 2013, excavated soil was stockpiled on-site, pending final disposition.

North Indian Flats 26 Federal Battery #1 - Excavation (Looking North)

North Indian Flats 26 Federal Battery #1 - Excavation (Looking East)

North Indian Flats 26 Federal Battery #1 - Excavation (Looking South)

North Indian Flats 26 Federal Battery #1 - Excavation (Looking West)

From October 4 through October 15, 2013, approximately one thousand, one hundred and forty cubic yards (1,140 yd<sup>3</sup>) of impacted soil was transported to Lea Land, Inc. (NMOCD Permit # WM-01-035), for disposal.

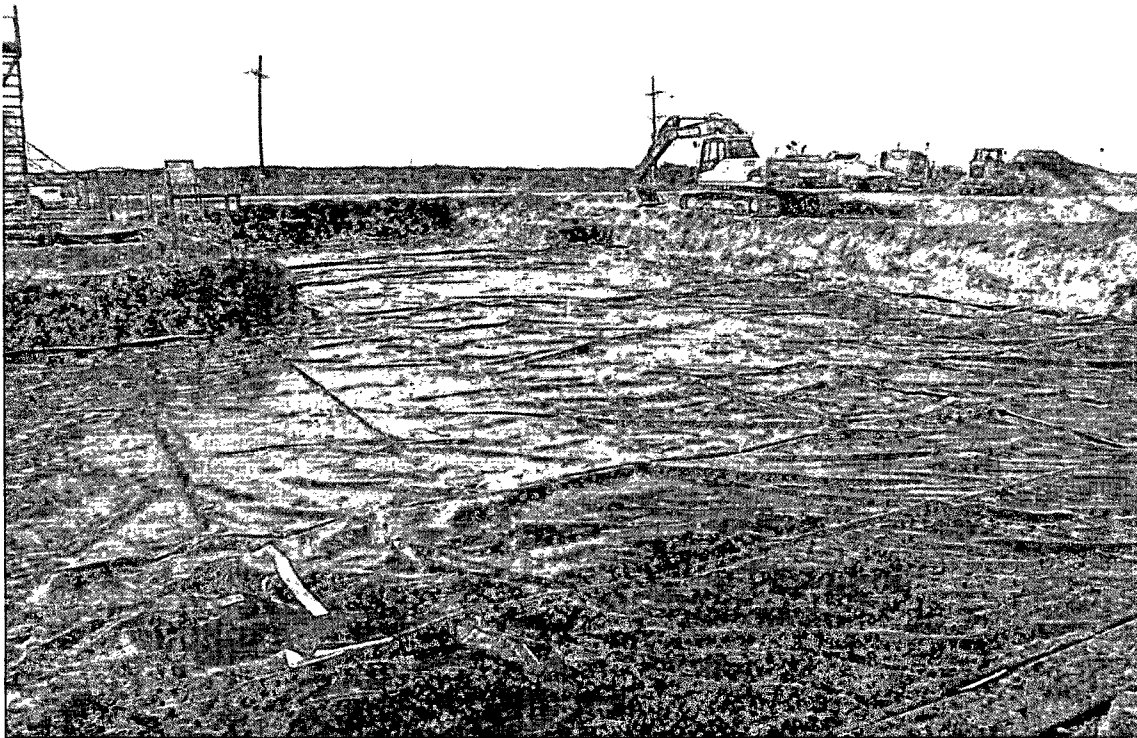
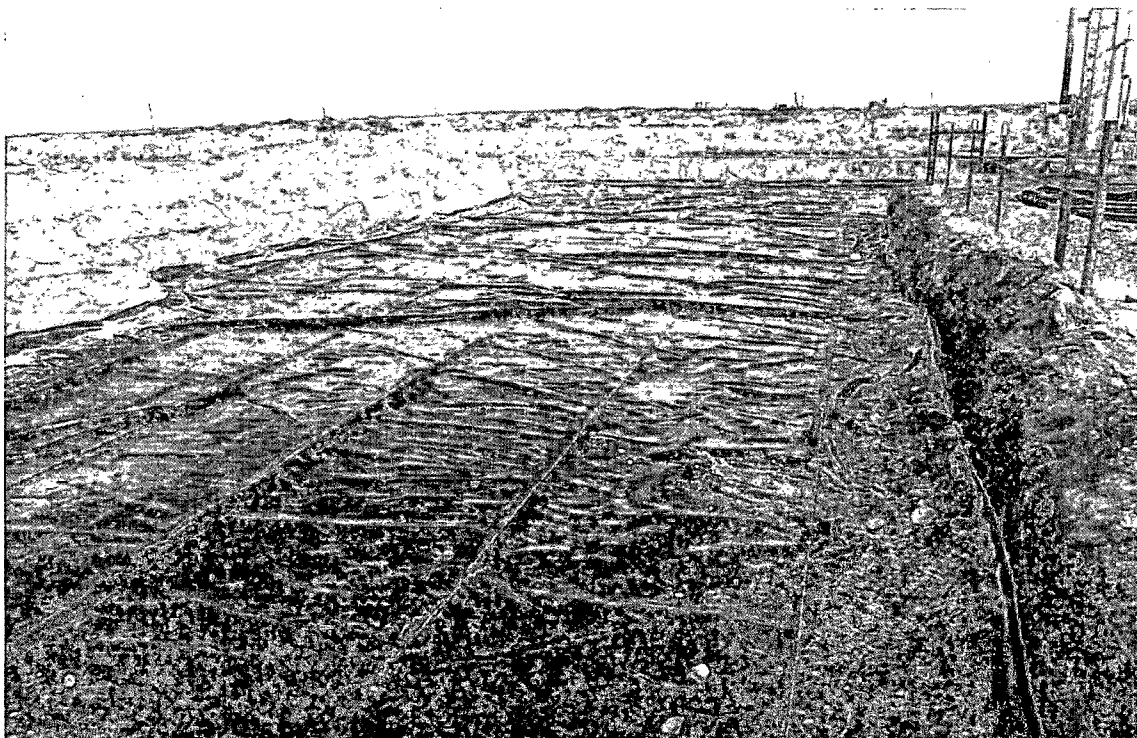
North Indian Flats 26 Federal Battery #1 - Liner Installation

From October 14 through October 18, 2013, the excavation was backfilled with locally purchased, non-impacted material, compacted, and contoured to fit the surrounding topography. Prior to backfilling, a twenty (20) mil polyurethane liner was installed on the floor of the excavation at approximately three feet (3') bgs. A cushion of sand was installed both above and below the liner to protect the liner from damage during installation and backfilling activities. The final dimensions of the excavation were approximately one hundred and twenty feet (120') in length, varying in width from approximately twenty-two feet (22') to one hundred and ten feet (110'), and varying in depth from approximately one foot (1') to approximately three feet (3') bgs.

The release site was excavated to the extent practicable. A twenty (20) mil polyurethane liner was installed on the floor of the excavation prior to backfilling. This engineered control will help mitigate future releases and effectively inhibit vertical migration of contaminants to groundwater. In-situ soil exhibiting chloride contamination above the regulatory remediation action levels established for the site will be remediated upon decommission and/or abandonment of the currently well, pipelines, and/or storage facilities.

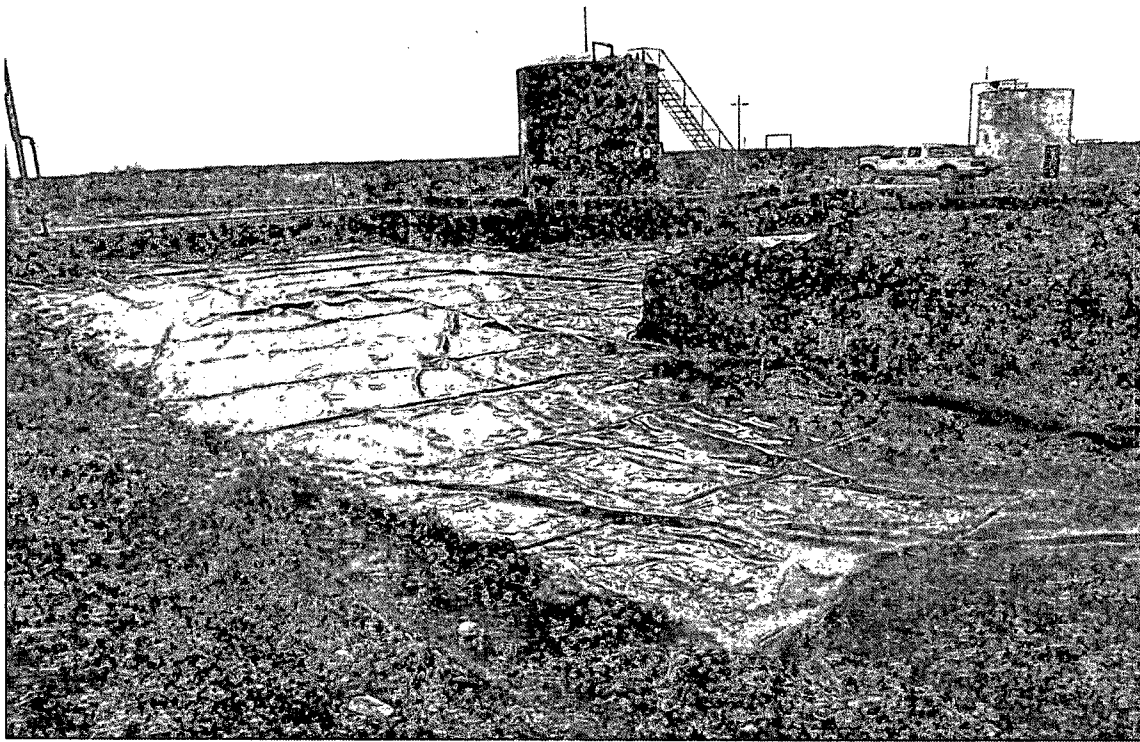
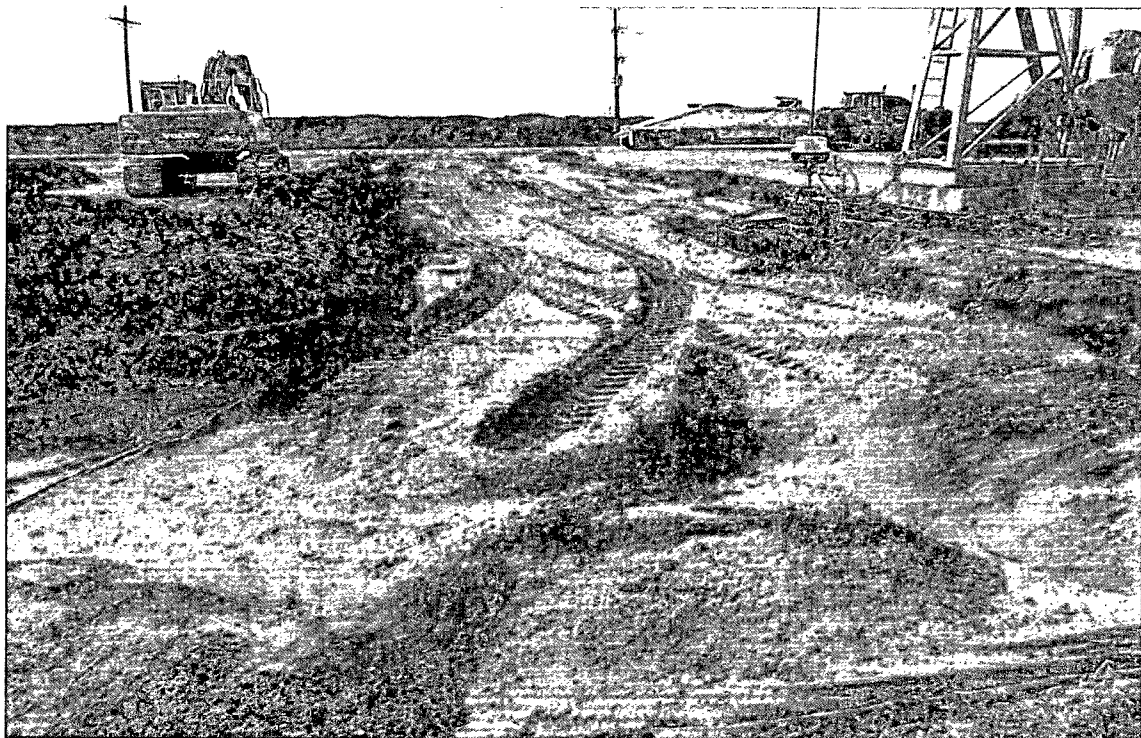
North Indian Flats 26 Federal Battery #1 - Installation of Pad Sand

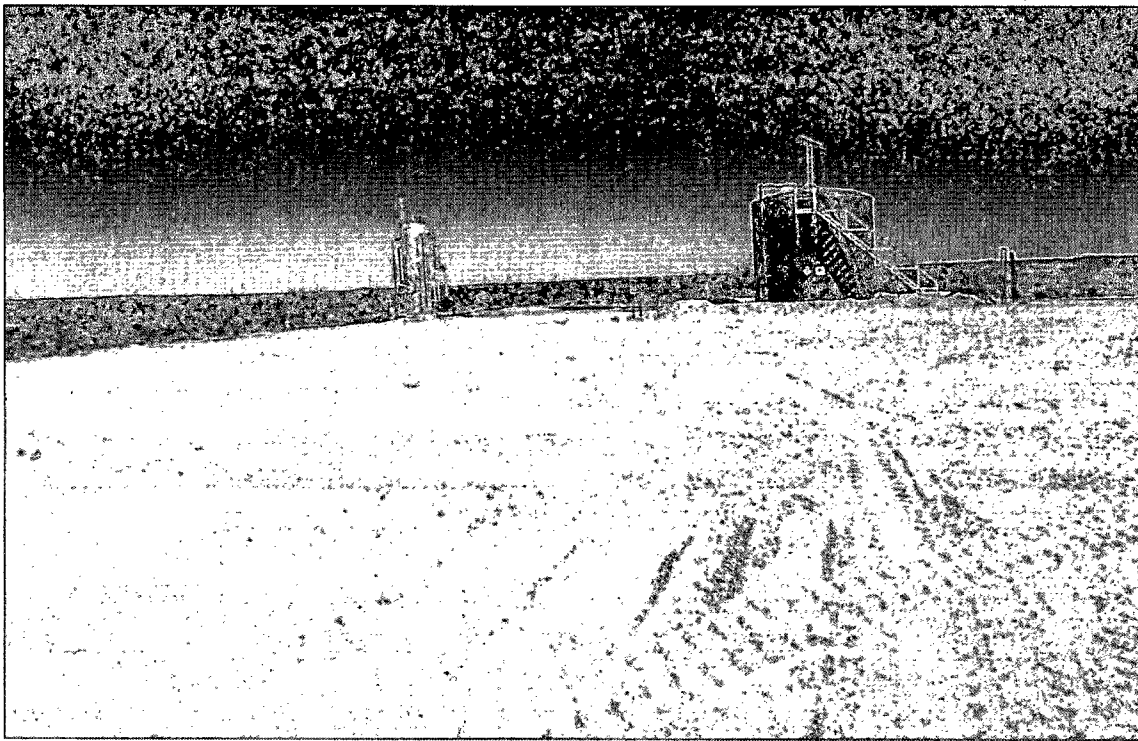
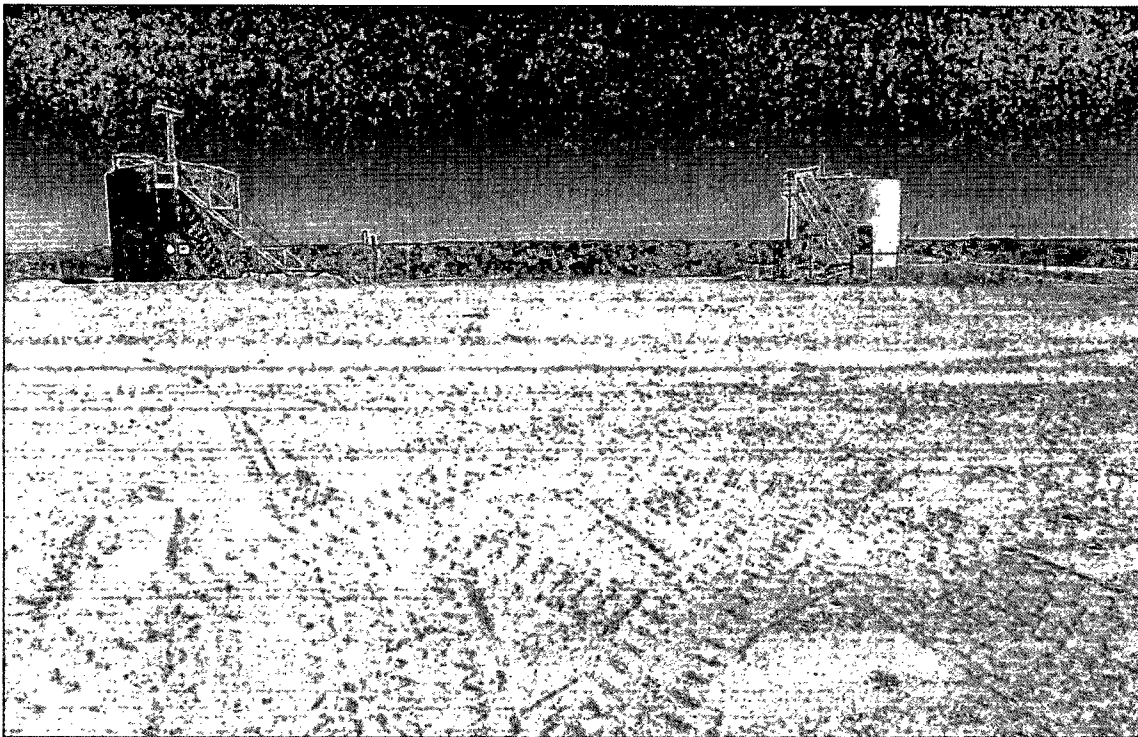
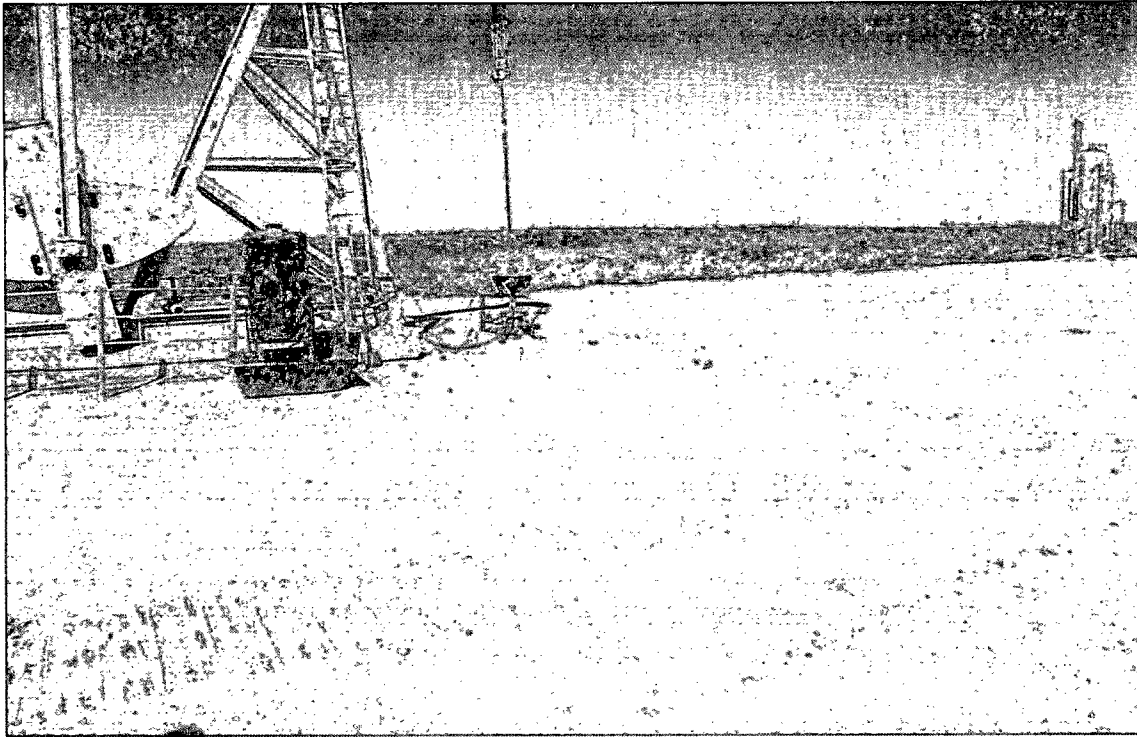
North Indian Flats 26 Federal Battery #1 - Following Backfill (Looking East-northeast)

North Indian Flats 26 Federal Battery #1 - Following Backfill (Looking East-southeast)

North Indian Flats 26 Federal Battery #1 - Following Backfill (Looking Northeast)
