REMEDIATION SUMMARY AND SITE CLOSURE REQUEST

**BOPCO, LP
POKER LAKE UNIT #49 ILLEGAL DUMP
Eddy County, New Mexico
Unit Letter "E" (SW/NW), Section 17, Township 24 South, Range 30 East
Latitude 32.219330° North, Longitude 103.908958° West
NMOCD Reference #2RP-2192**

April 2014

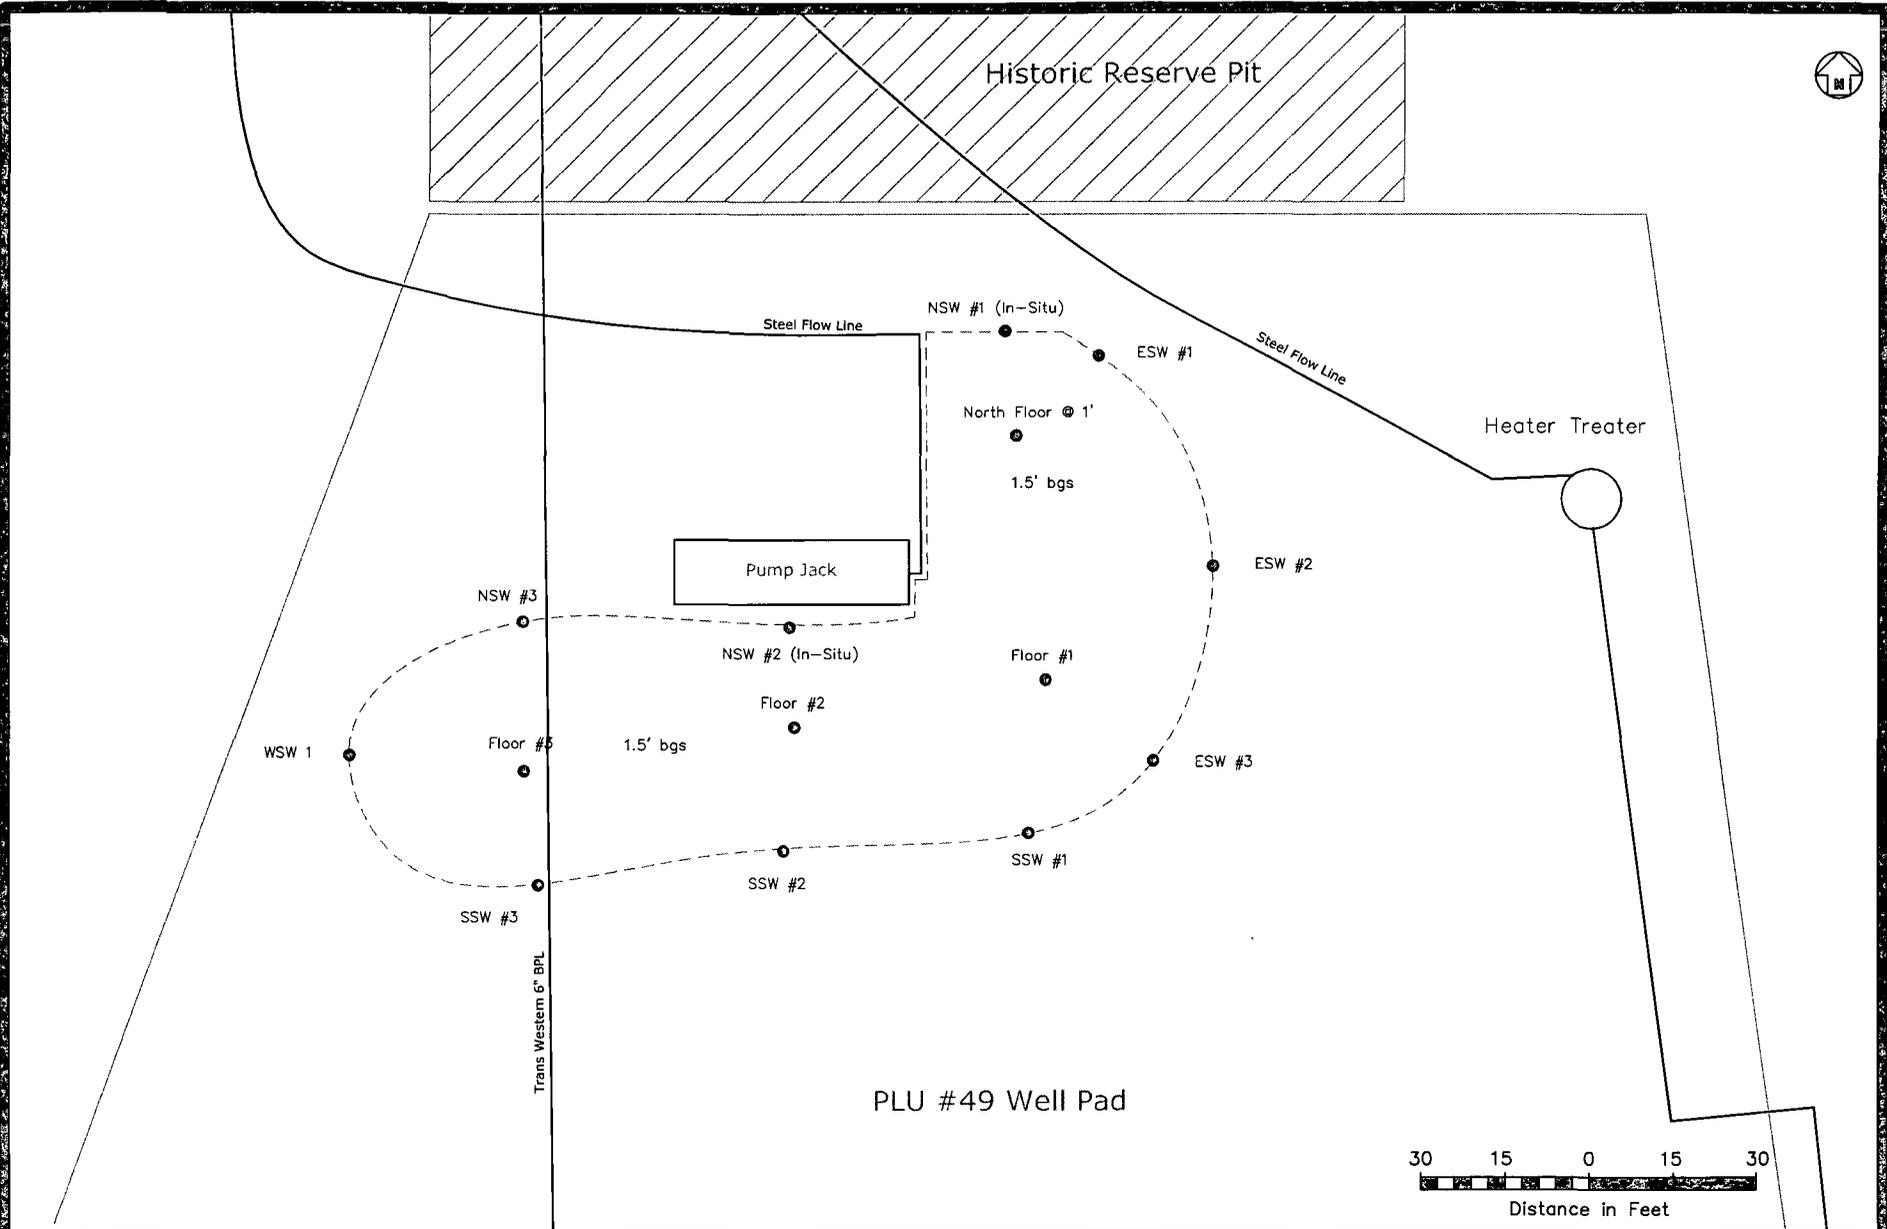
Figure 2
 Site & Sample Location Map
 BOPCO, L.P.
 Poker Lake Unit #49
 Eddy County, New Mexico

Historic Reserve Pit

- Excavation Extent
- Caliche Well Pad
- Pipeline
- Sample Location

On March 12, 2014, nine (9) soil samples (ESW #1, ESW #2, ESW #3, SSW #1, SSW #2, North Floor @ 1', Floor #1, Floor #2 and Floor #3) were collected from the excavation floor and sidewalls and submitted to the laboratory for analysis of chloride concentrations. Laboratory analytical results indicated chloride concentrations ranged from less than the laboratory method detection limit (MDL) for soil sample Floor #1 to 1,250 ppm for soil sample North Floor @ 1'. Soil samples North Floor @ 1' and Floor #2 were also analyzed for concentrations of BTEX and TPH, which were determined to be less than the appropriate laboratory MDL for each of the submitted soil samples. The north floor of the excavation was advanced and excavation activities continued toward the west. A summary of "Concentrations of Benzene, BTEX, TPH and Chloride in Soil" is provided in Table 1. A "Site and Sample Location Map" is provided as Figure 2. Laboratory analytical reports are provided as Appendix C.

On March 17, 2014, three (3) soil samples (WSW #1, SSW #3 and NSW #3) were collected from the excavation sidewalls and submitted to the laboratory for analysis of chloride concentrations. Laboratory analytical results indicated chloride concentrations ranged from 32.0 ppm for soil sample SSW #3 to 1,200 ppm for soil sample NSW #3.

On March 20, 2014, two (2) in-situ soil samples (NSW #1 (In-Situ) and NSW #2 (In-Situ)) were collected from the excavation sidewalls to help characterize the soil left in place beneath the pump jack and adjacent to a historic reserve pit on the north side of the well pad. The soil samples were submitted to the laboratory for analysis of chloride concentrations. Laboratory analytical results indicated chloride concentrations ranged from 3,440 ppm for soil NSW #2 (In-Situ) to 5,120 ppm for soil sample NSW #1 (In-Situ). Soil sample NSW #1 (In-Situ) was also analyzed for concentrations of TPH, which were determined to be less than the laboratory MDL. Further excavation to the north was limited since it was outside of the margins of the immediate illegal dump and led into a historic reserve pit.

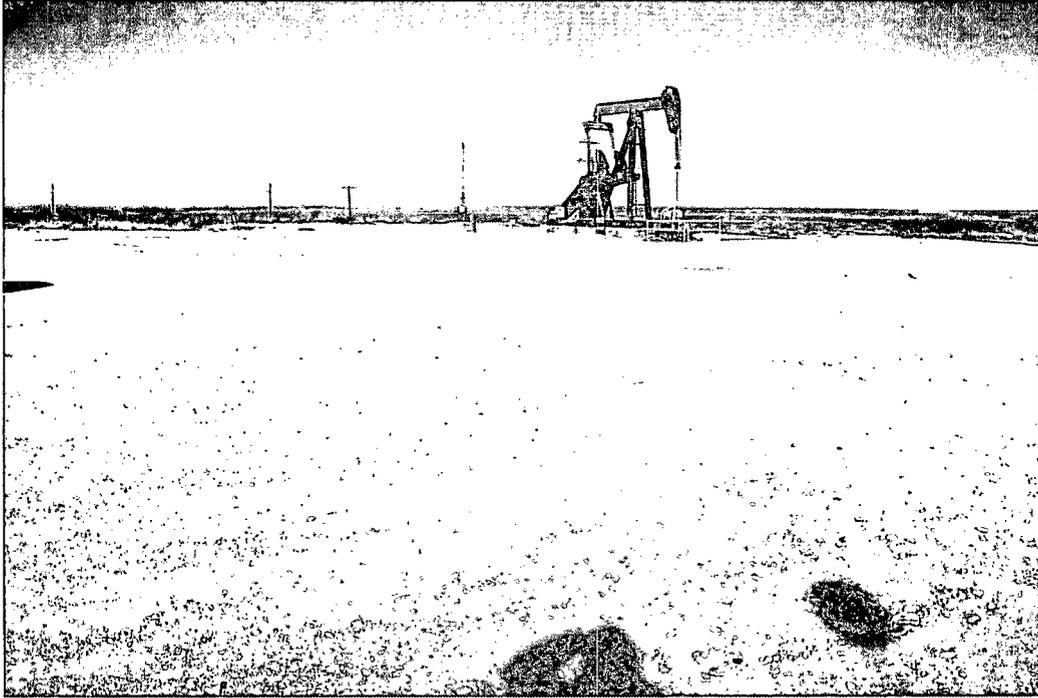
Photograph of surface staining from the illegal dump on the PLU #49 Well Pad.

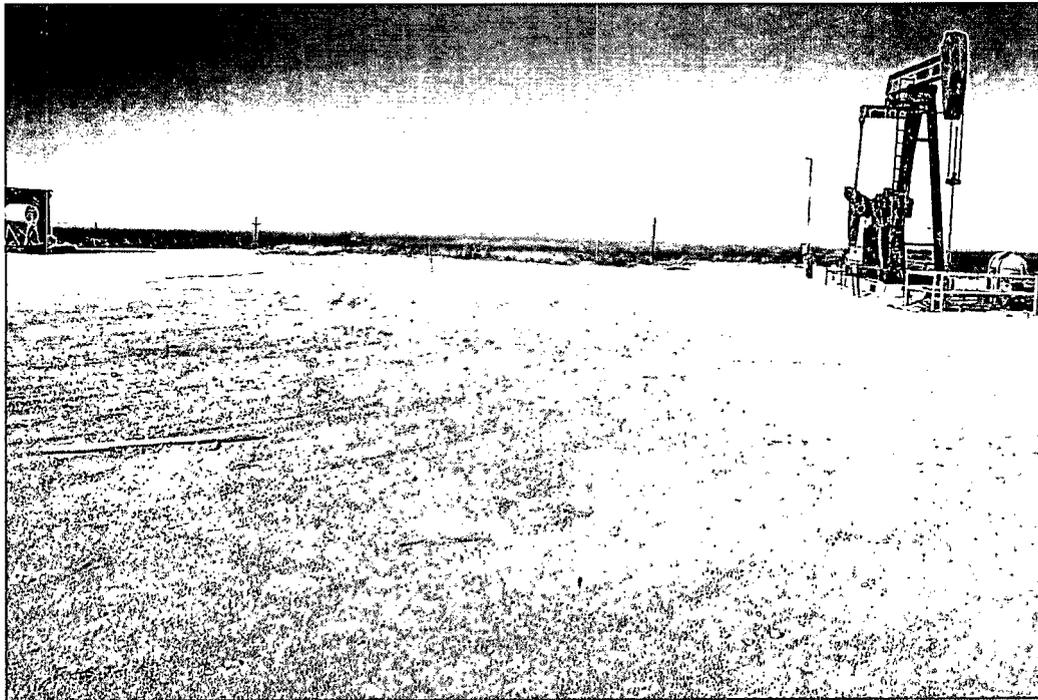
Photograph of surface staining from the illegal dump on the PLU #49 Well Pad.

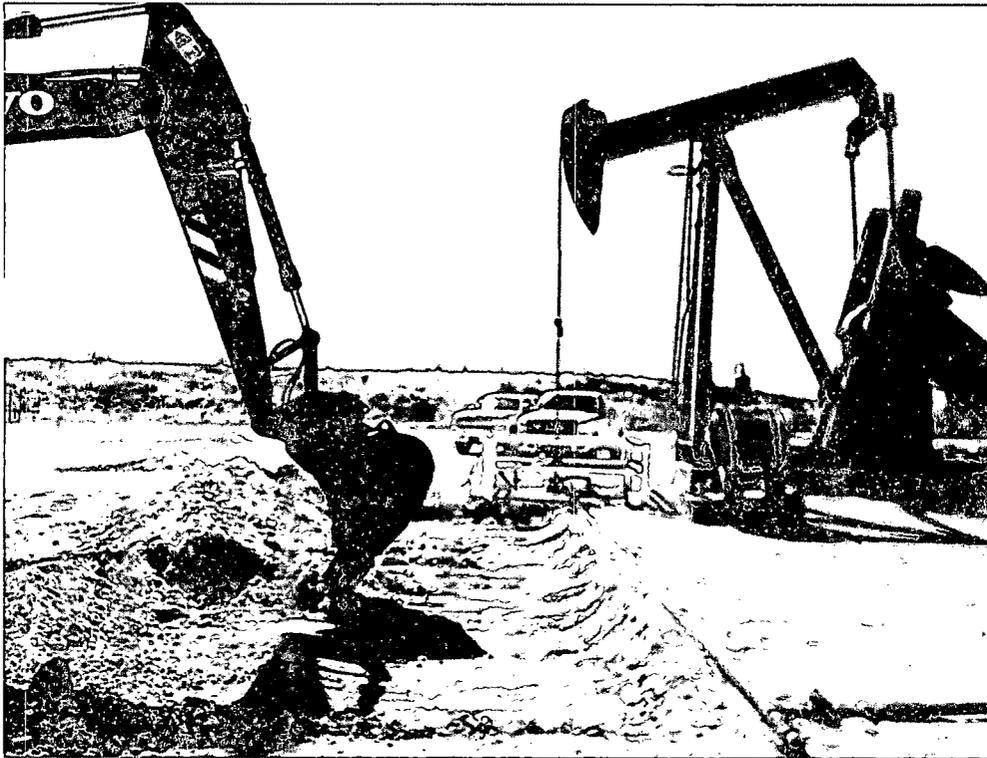
Photograph of excavation activities at the PLU #49 Illegal Dump Site.

On March 11, 2014, Basin began excavating impacted soil on the caliche well pad. The excavation was advanced until field tests suggested concentrations of BTEX, TPH and chloride were below NMOCD Regulatory Standards. Excavated soil was stockpiled on-site, pending final disposition.

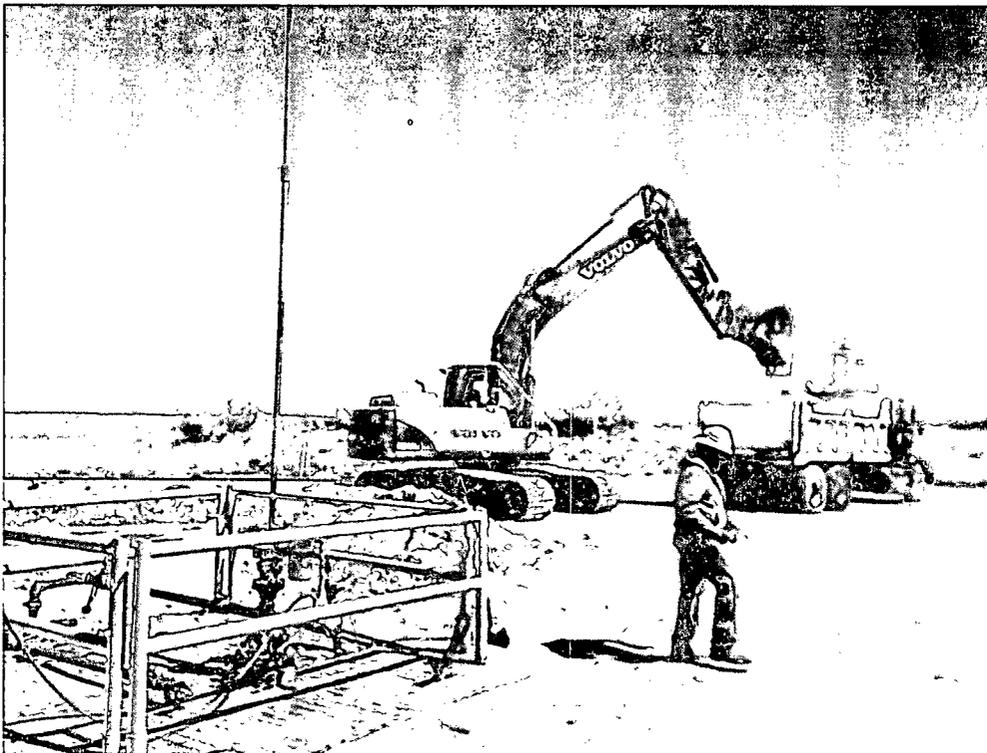
Photograph of excavation activities at the PLU #49 Illegal Dump Site.

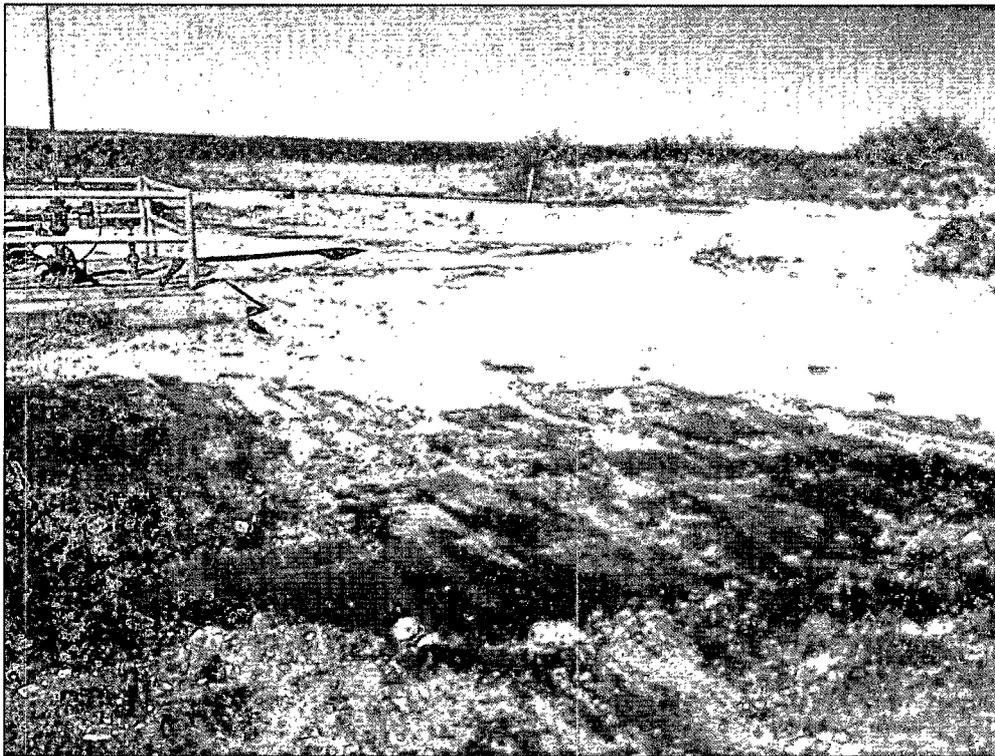
Photograph of excavation activities at the PLU #49 Illegal Dump Site.

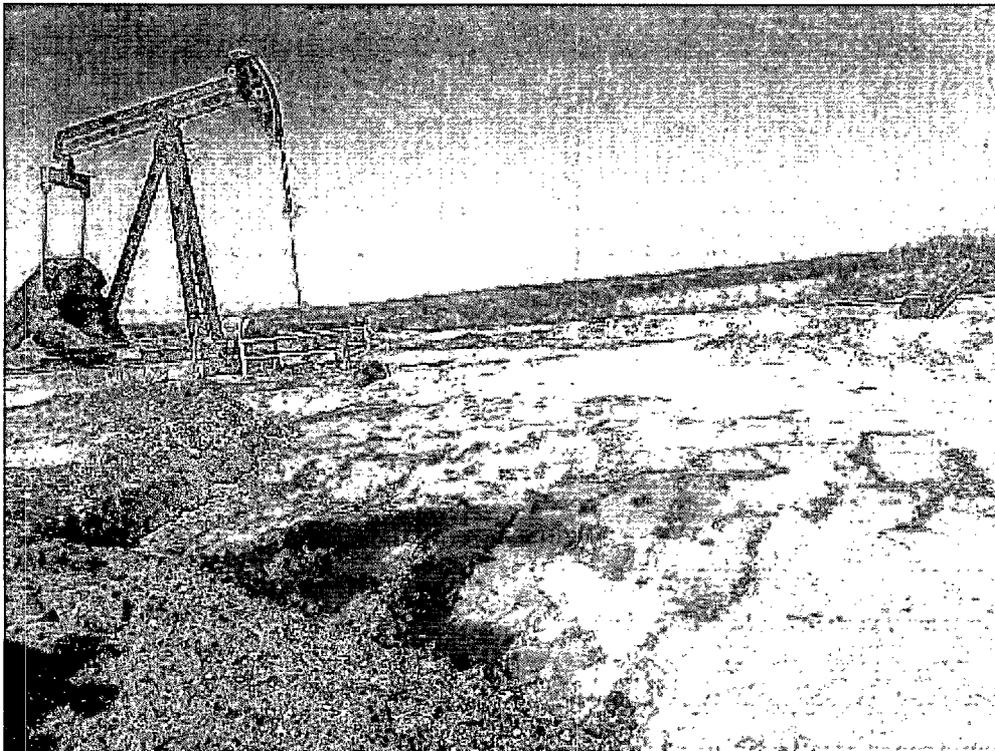
Photograph of excavation activities at the PLU #49 Illegal Dump Site.

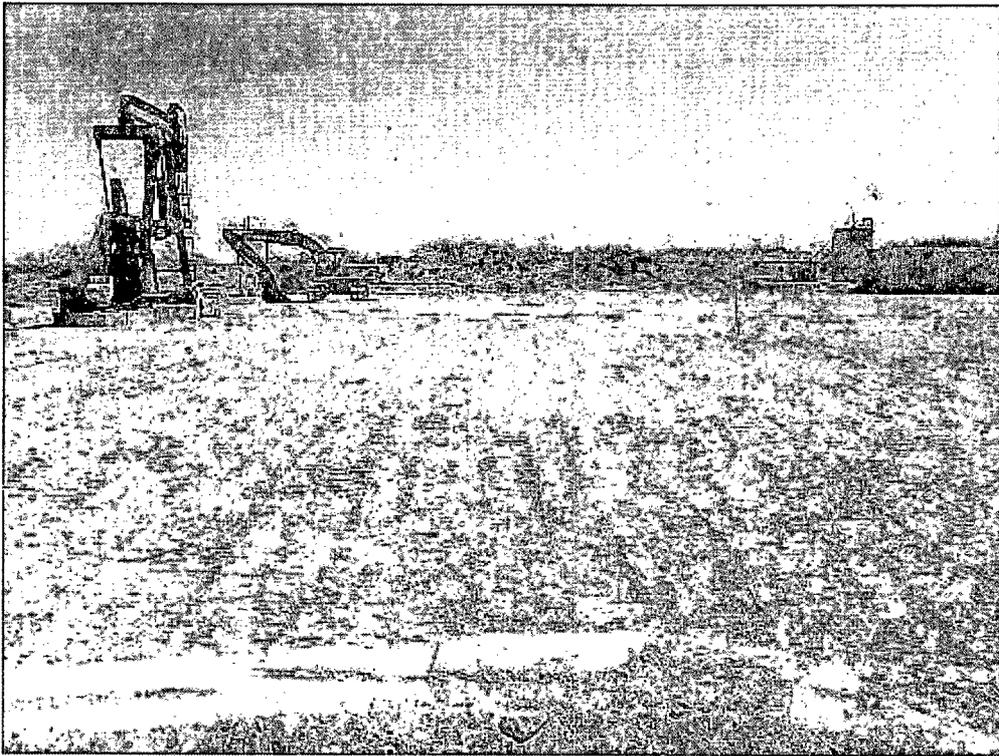
Photograph of backfilling activities at the PLU #49 Illegal Dump Site.

Between March 17 and 21, 2014, approximately eight hundred and eighty cubic yards (880 yd³) of impacted material was transported to Lea Land, Inc. (NMOCD Permit #WM-01-035), for disposal. The final dimensions of the excavation were approximately forty (40) to eighty feet (80') in width, one hundred and thirty-five feet (135') in length and eighteen inches (18") in depth. Upon receiving laboratory analytical data from confirmation soil samples, the excavated area was backfilled with locally purchased, non-impacted caliche. Following backfilling, areas affected by the remediation activities were compacted and contoured to meet the needs of the well pad.

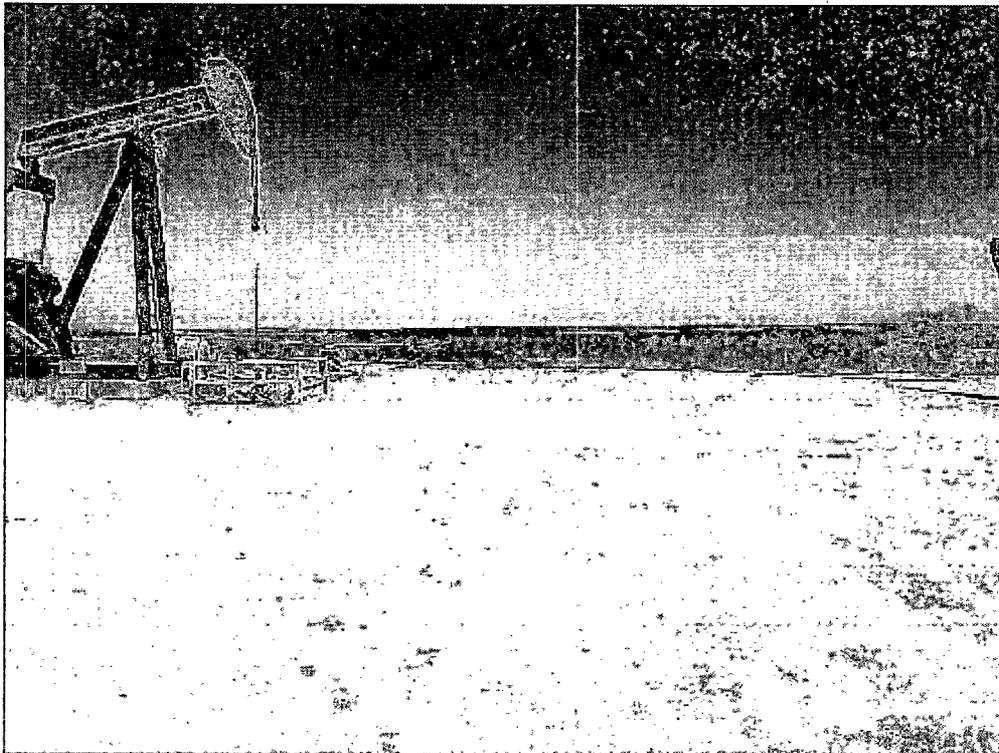
Photograph of the PLU #49 Illegal Dump Site after remediation activities.
