REMEDIATION SUMMARY AND SITE CLOSURE REQUEST

BOPCO, LP
PLU BIG SINKS 19-24-31 USA #1 BATTERY
Eddy County, New Mexico
Unit Letter "C" (NE/NW), Section 19, Township 24 South, Range 31 East
Latitude 32.209878° North, Longitude 103.81927° West
NMOCD Reference #2RP-2103

April 2014

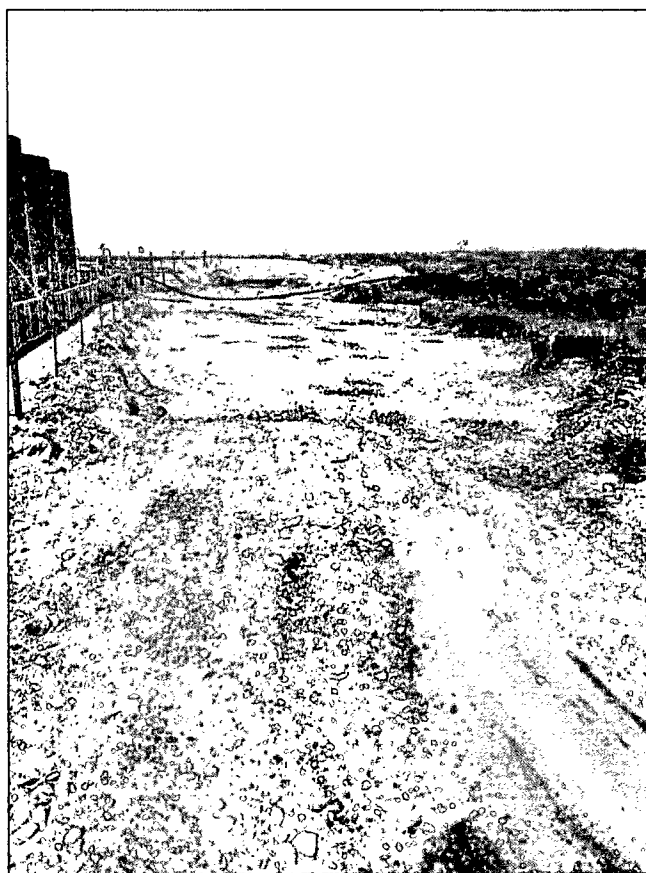
Photograph of excavation activities at the PLU Big Sinks 19-24-31 USA #1 Battery Release Site. (Looking West)

On March 25, 2014, Basin began excavating impacted soil at the release site. The excavation was advanced until field tests suggested concentrations of BTEX, TPH and chloride were below NMOCD regulatory standards. Excavated soil was stockpiled on-site, pending final disposition. The release site was divided into fifty foot (50') sections to facilitate remediation activities.

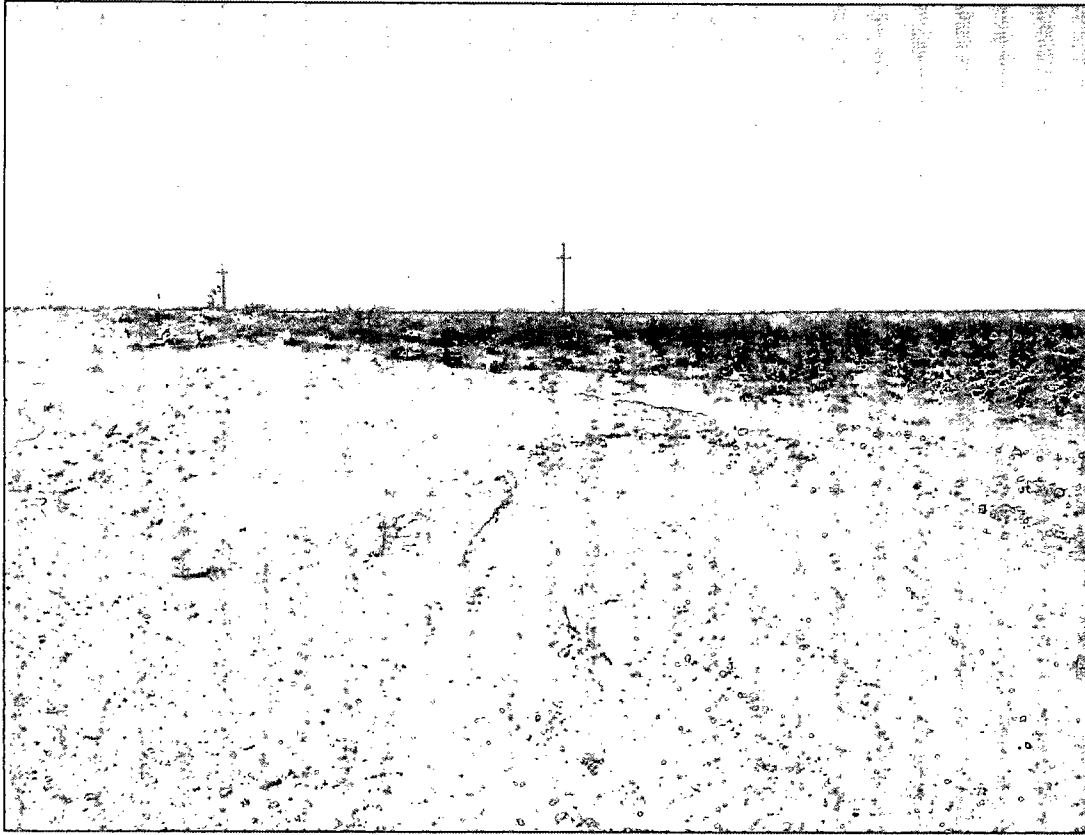
Photograph of backfilling activities at the PLU Big Sinks 19-24-31 USA #1 Battery Release Site. (Looking Northwest)

half feet (2.5') in depth. Upon receiving laboratory analytical data from confirmation soil samples, the excavated area was backfilled with locally purchased, non-impacted material. Following backfilling, areas affected by the remediation activities were compacted and contoured to match the surrounding topography.
