## **LINN ENERGY**

# HE West B Battery 2 and 4 – West B #19 (2RP-1960)

## Termination Request

**Linn Energy – HE West B Battery 2 and 4 – West B #19 (2RP-1960)**

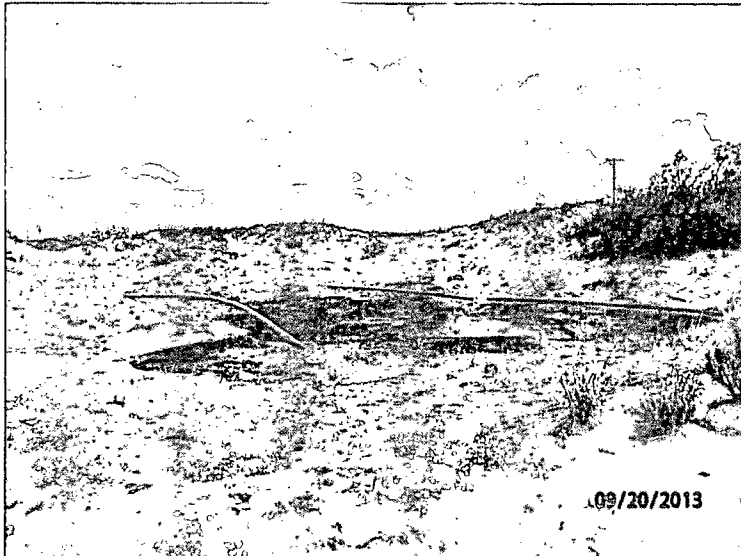
Initial site photo, facing north 9/20/13

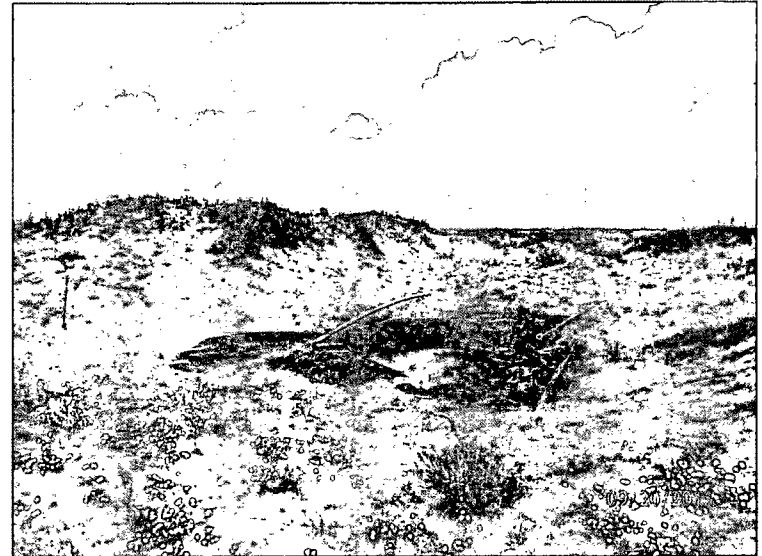
Initial site photo, facing northeast 9/20/13

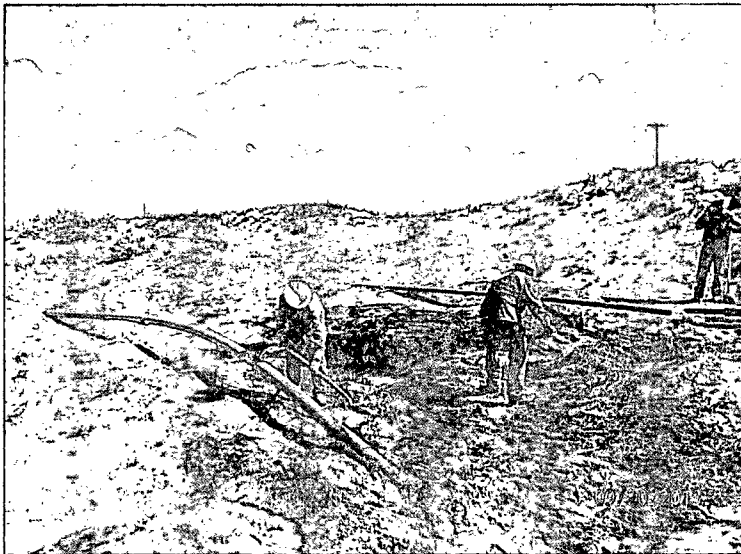
Hand shoveling release area, facing southeast 9/20/13

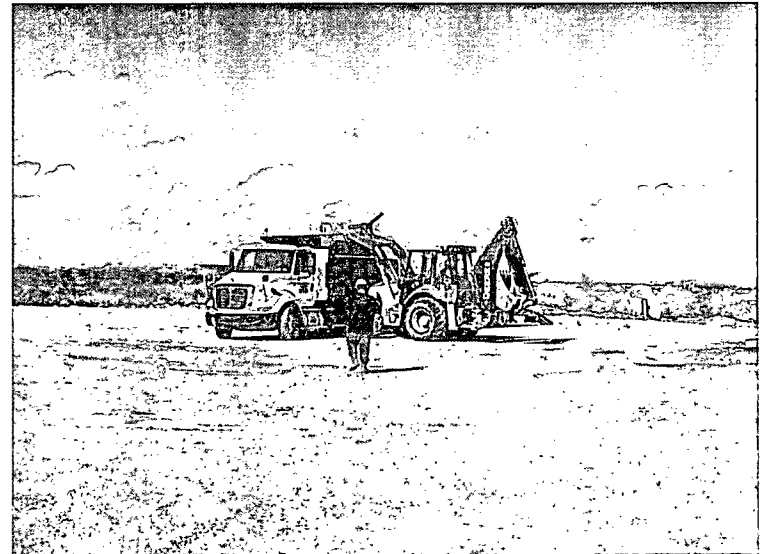
Exporting soil, facing northeast 9/20/13

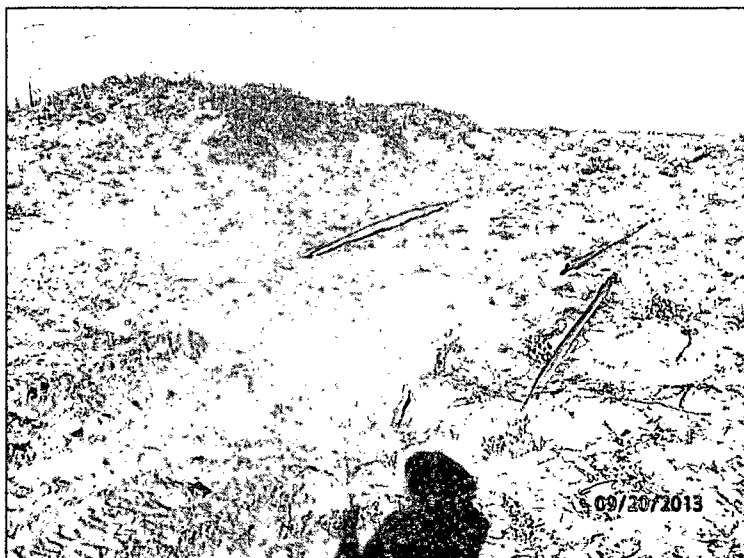
Hand shovel completed, facing northeast 9/20/13

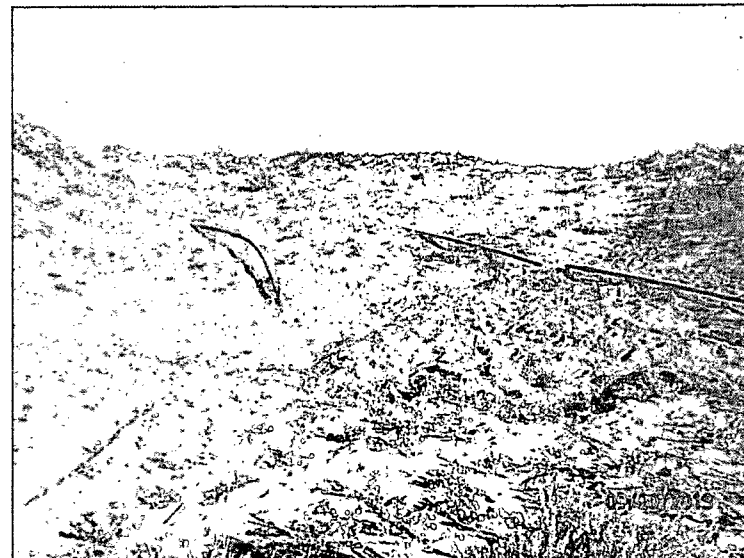
Hand shovel completed, facing southeast 9/20/13

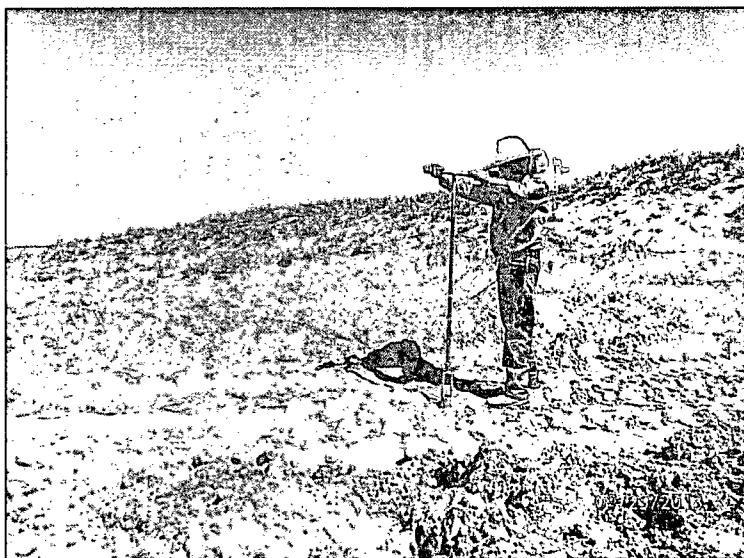
Hand auguring for depth, facing north 9/25/13

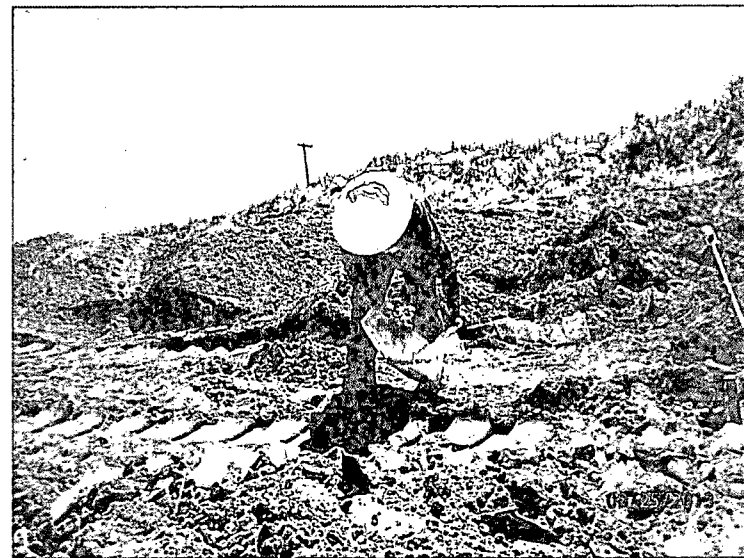
Plugging augur point in total with bentonite, facing south 9/25/13

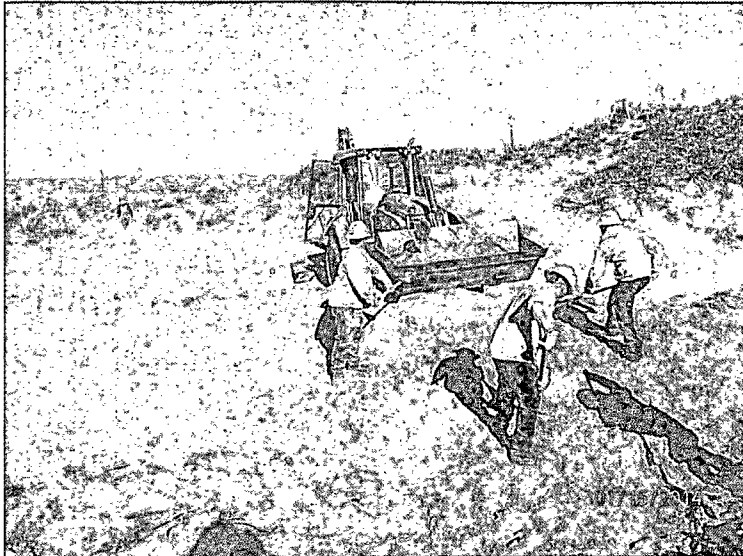
Hand digging release, facing north

CAP activities began on January 15<sup>th</sup>, 2014. The area around Vertical #2 was hand shoveled to a depth of 1 ft bgs and a total of 12 yards of contaminated soil was taken to a NMOCD approved facility for disposal (Figure 2). A total of 12 yards of top soil was imported to the site to serve as backfill. A 5 point composite of the backfill was taken to a commercial laboratory for analysis and returned a chloride value of non-detect (Appendix C). The scrape was backfilled with the clean, imported top soil and contoured to the surrounding location. On January 17<sup>th</sup>, 2014, soil amendments were added to the site and the site was seeded with LPC mix.

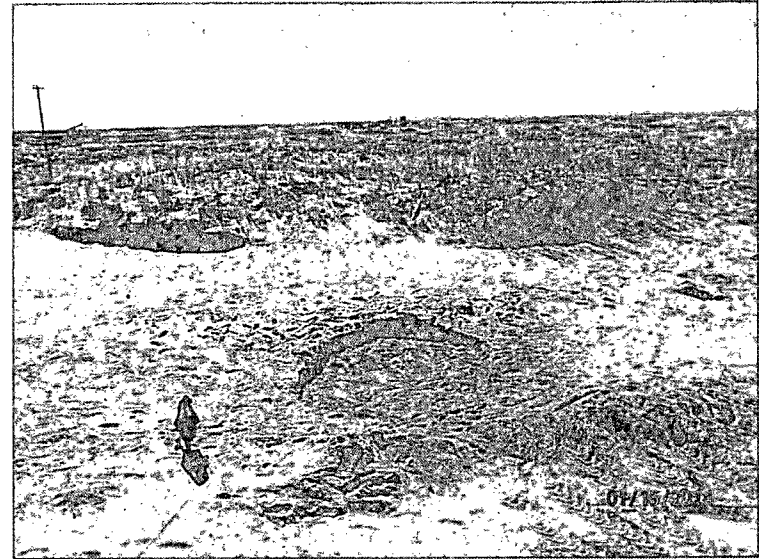
Scrape completed, facing south

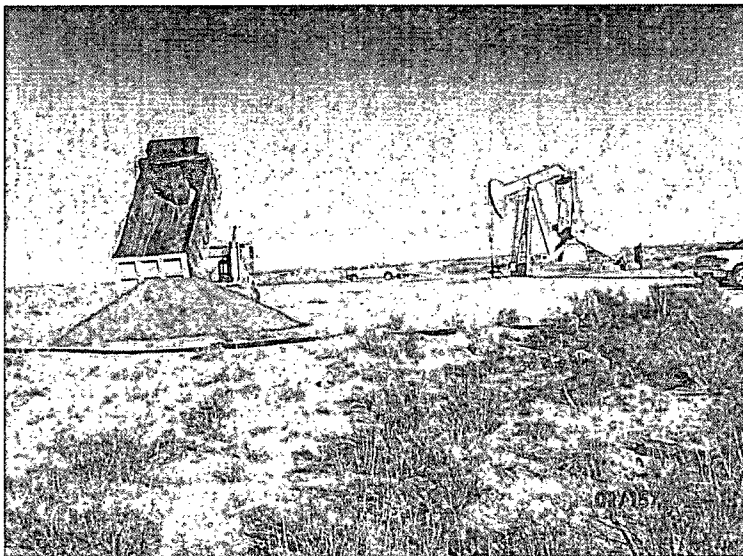
Importing soil, facing north

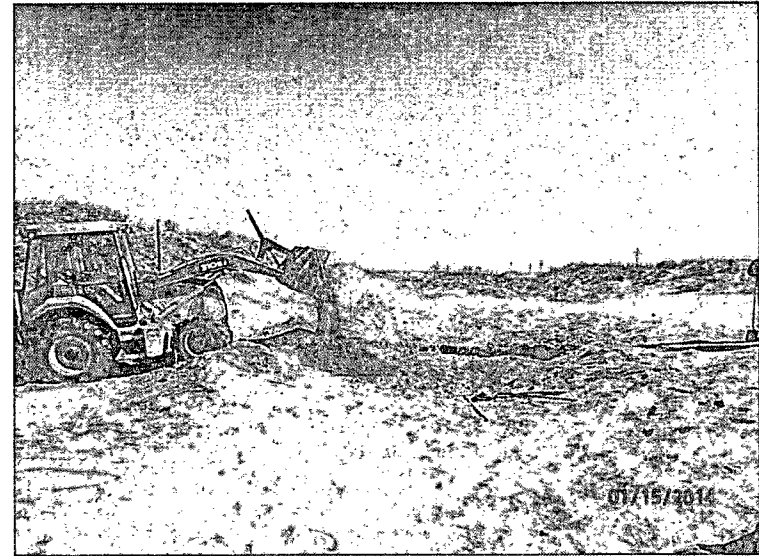
Backfilling site, facing east

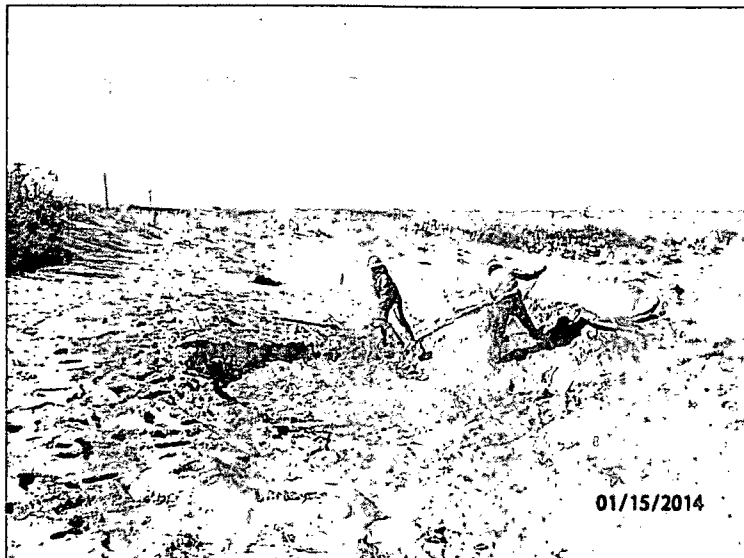
Backfilling site, facing west

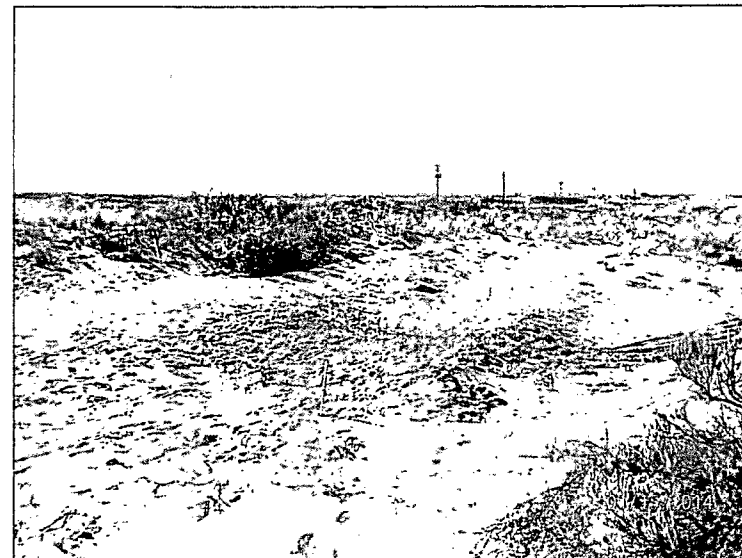
Backfilling completed, facing southwest

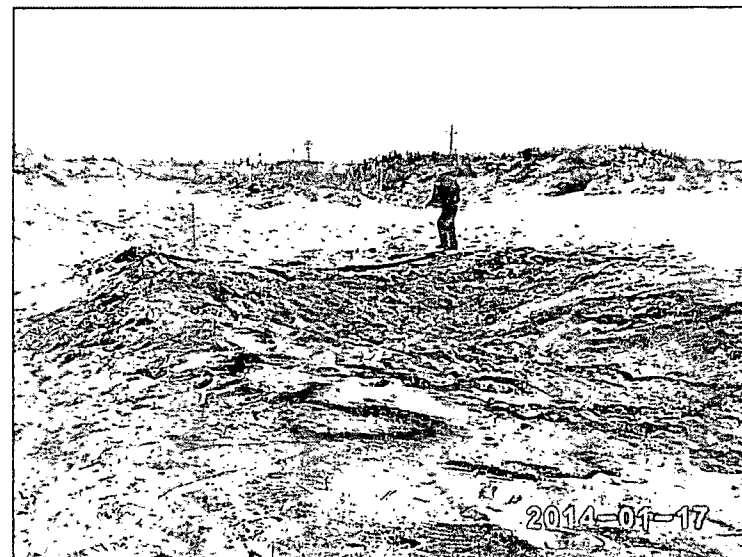
Seeding site, facing east
