## **REMEDIATION SUMMARY AND RISK-BASED SITE CLOSURE REQUEST**

**BOPCO, LP  
POKER LAKE UNIT #123 ILLEGAL DUMP  
Eddy County, New Mexico  
Unit Letter "K" (NE/SW), Section 22, Township 24 South, Range 31 East  
Latitude 32.200863° North, Longitude 103.767542° West  
NMOCD Reference #2RP-2134**

**May 2014**

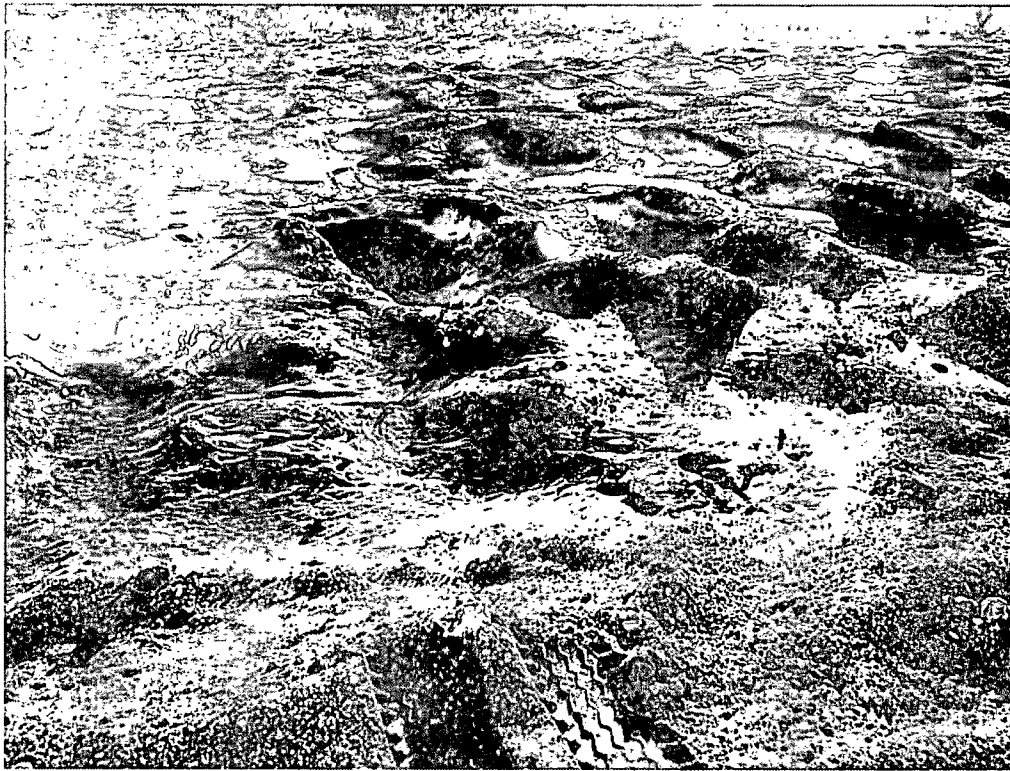
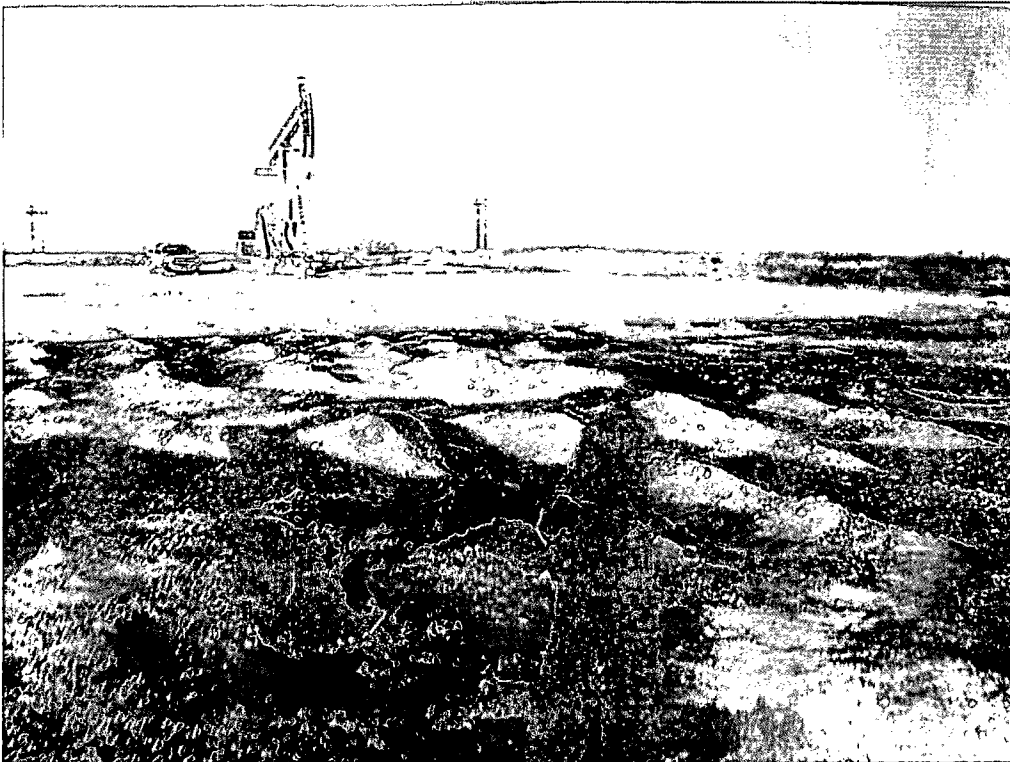
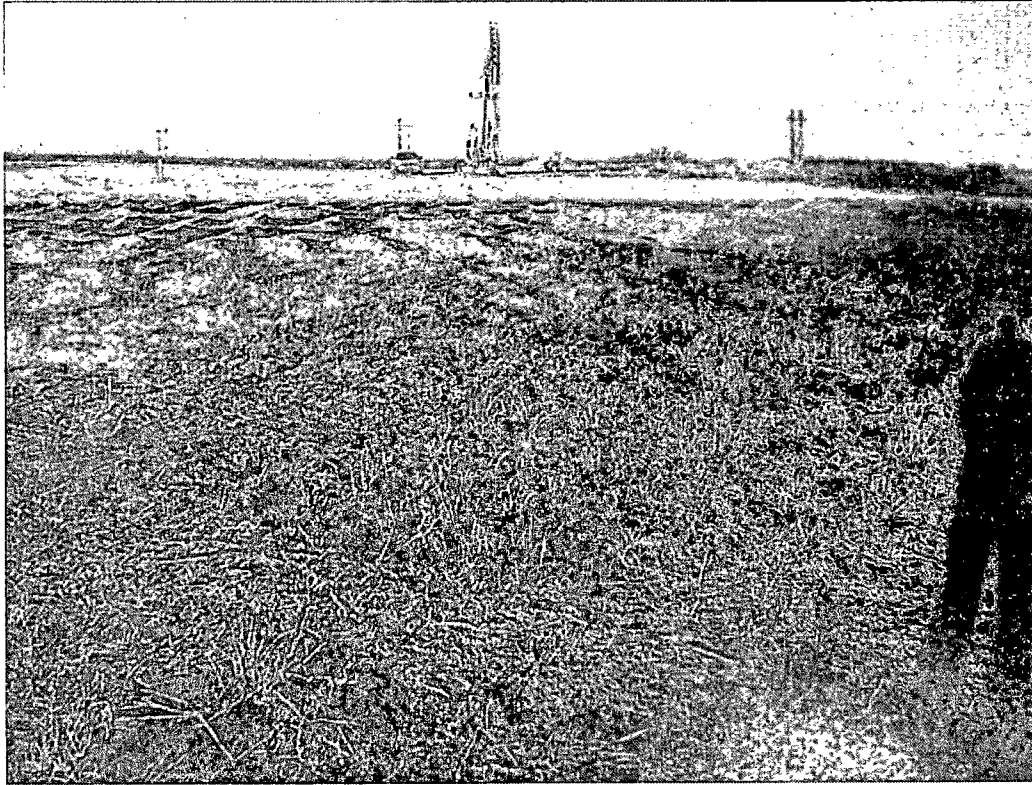
On December 22, 2013, during a routine inspection, BOPCO discovered a produced water transport truck illegally dumped approximately one hundred (100 bbls) of produced water at the PLU #123 well location. The New Mexico Oil Conservation Division (NMOCD)-Artesia District Office and BLM were notified immediately upon discovery. The "Release Notification and Corrective Action" (Form C-141) indicated approximately 6,858 ft<sup>2</sup> of an area just east of the well that had recently been remediated and reclaimed from a release that occurred on May 28, 2012. The Form C-141 is provided as Appendix A. General photographs of the release site are provided as Appendix B.

Photograph of the initial release at the PLU #123 Illegal Dump Release Site.

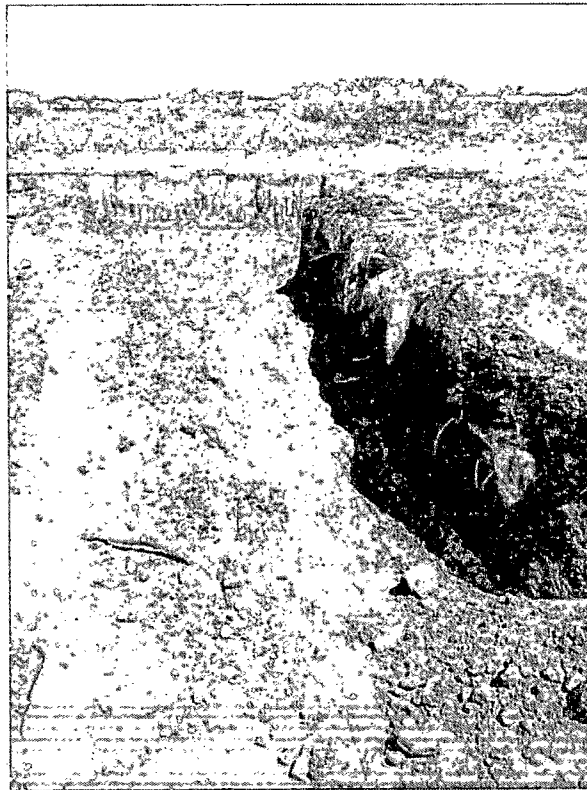
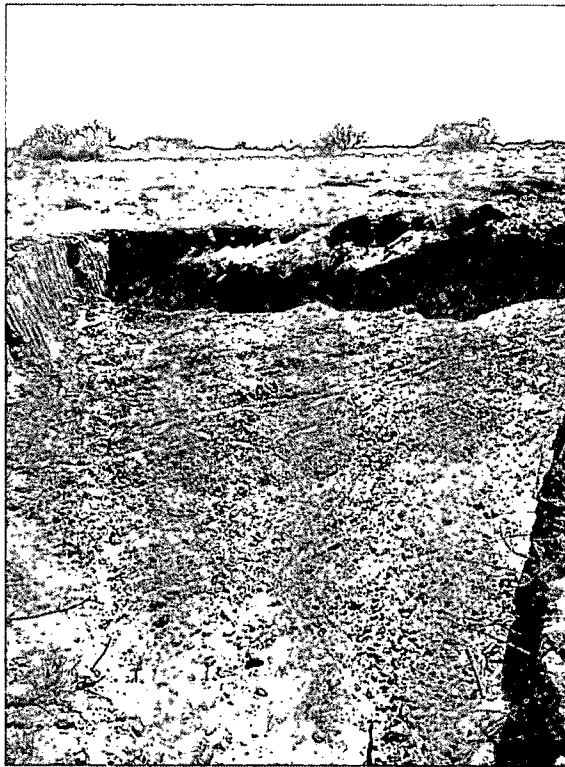
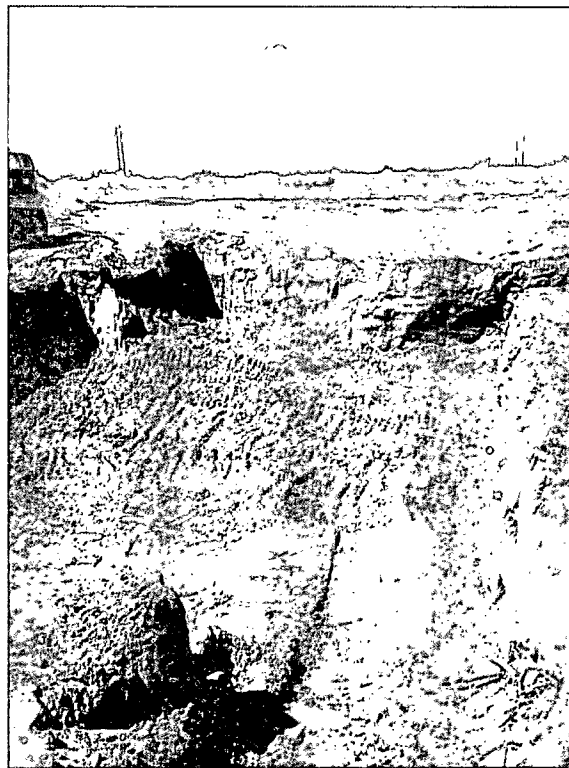
Photograph of excavation activities at the PLU #123 Illegal Dump Release Site.

On April 28, 2014, Basin began excavating impacted soil at the release site. The floor of the excavation was advanced to approximately five feet (5') bgs. Excavation sidewalls were advanced until field tests suggested concentrations of BTEX, TPH and chloride were below NMOCD regulatory standards. Excavated soil was stockpiled on-site, pending final disposition.

Between April 29 and May 2, 2014, approximately six hundred and eighty cubic yards (680 yd<sup>3</sup>) of impacted material was transported to Lea Land, Inc. (NMOCD Permit #WM-01-035), for disposal. The final dimensions of the excavation were approximately twelve (12) to fifty feet (50') in width, one hundred feet (100') in length and four (4) to five feet (5') in depth.

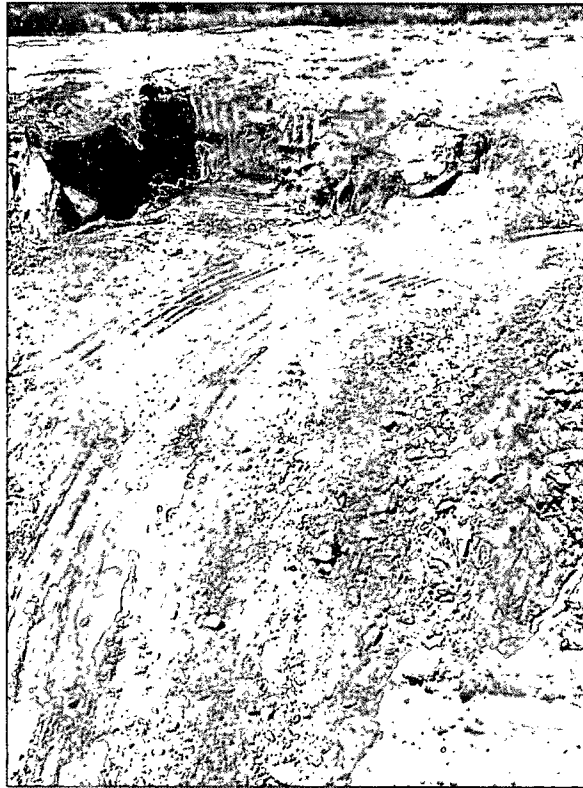
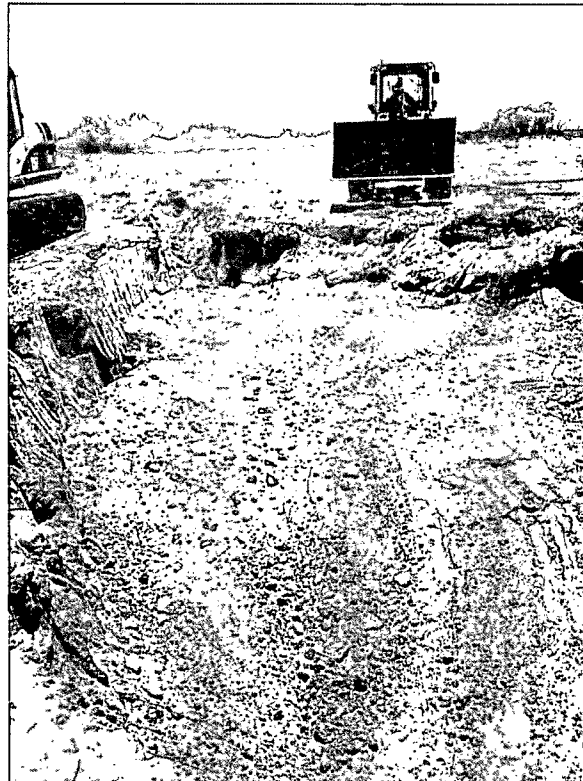
Photograph of the installation of caliche at the PLU #123 Illegal Dump Remediation Site.

On May 2, 2014, upon receiving NMOCD approval, a one-foot (1') layer of caliche was installed and compacted in the floor of the excavation in the areas represented by soil sample Floor #4 and TT-1. This engineering control was designed to inhibit the vertical migration of contaminants left in-situ. Upon installing the approved layer of caliche, the remaining portion of the excavation was backfilled with locally purchase, non-impacted material.

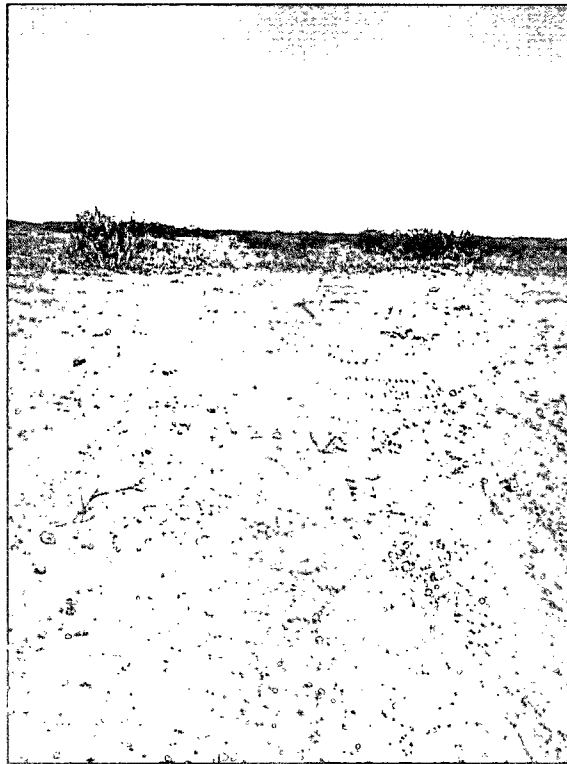
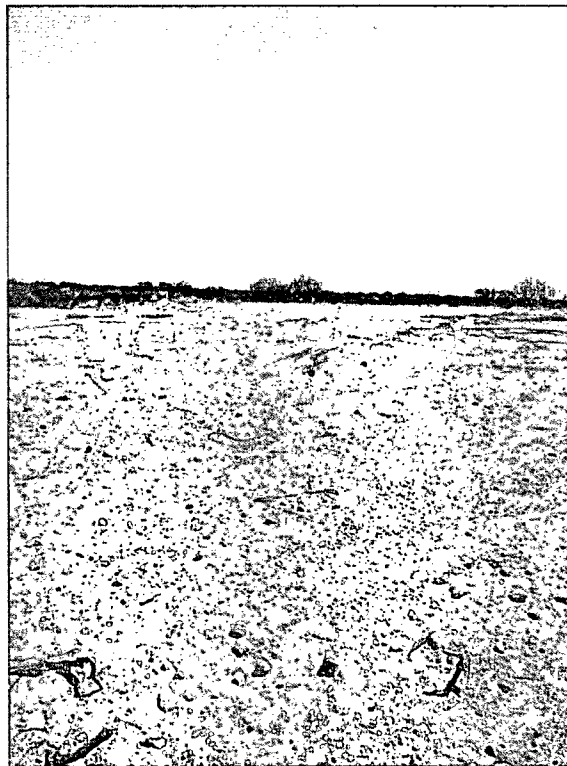
Photograph of the PLU #123 Illegal Dump Release Site after Remediation Activities.

Following backfilling, areas affected by the remediation activities were compacted and contoured to match the surrounding topography. The site will be reseeded with a BLM-approved seed mixture at a time more conducive to germination.
