REMEDIATION SUMMARY AND SITE CLOSURE REQUEST

**BOPCO, LP
POKER LAKE UNIT #129
Eddy County, New Mexico
Unit Letter "H" (SE/NE), Section 20, Township 24 South, Range 31 East
Latitude 32.204440° North, Longitude 103.793891° West
NMOCD Reference #2RP-2128**

May 2014

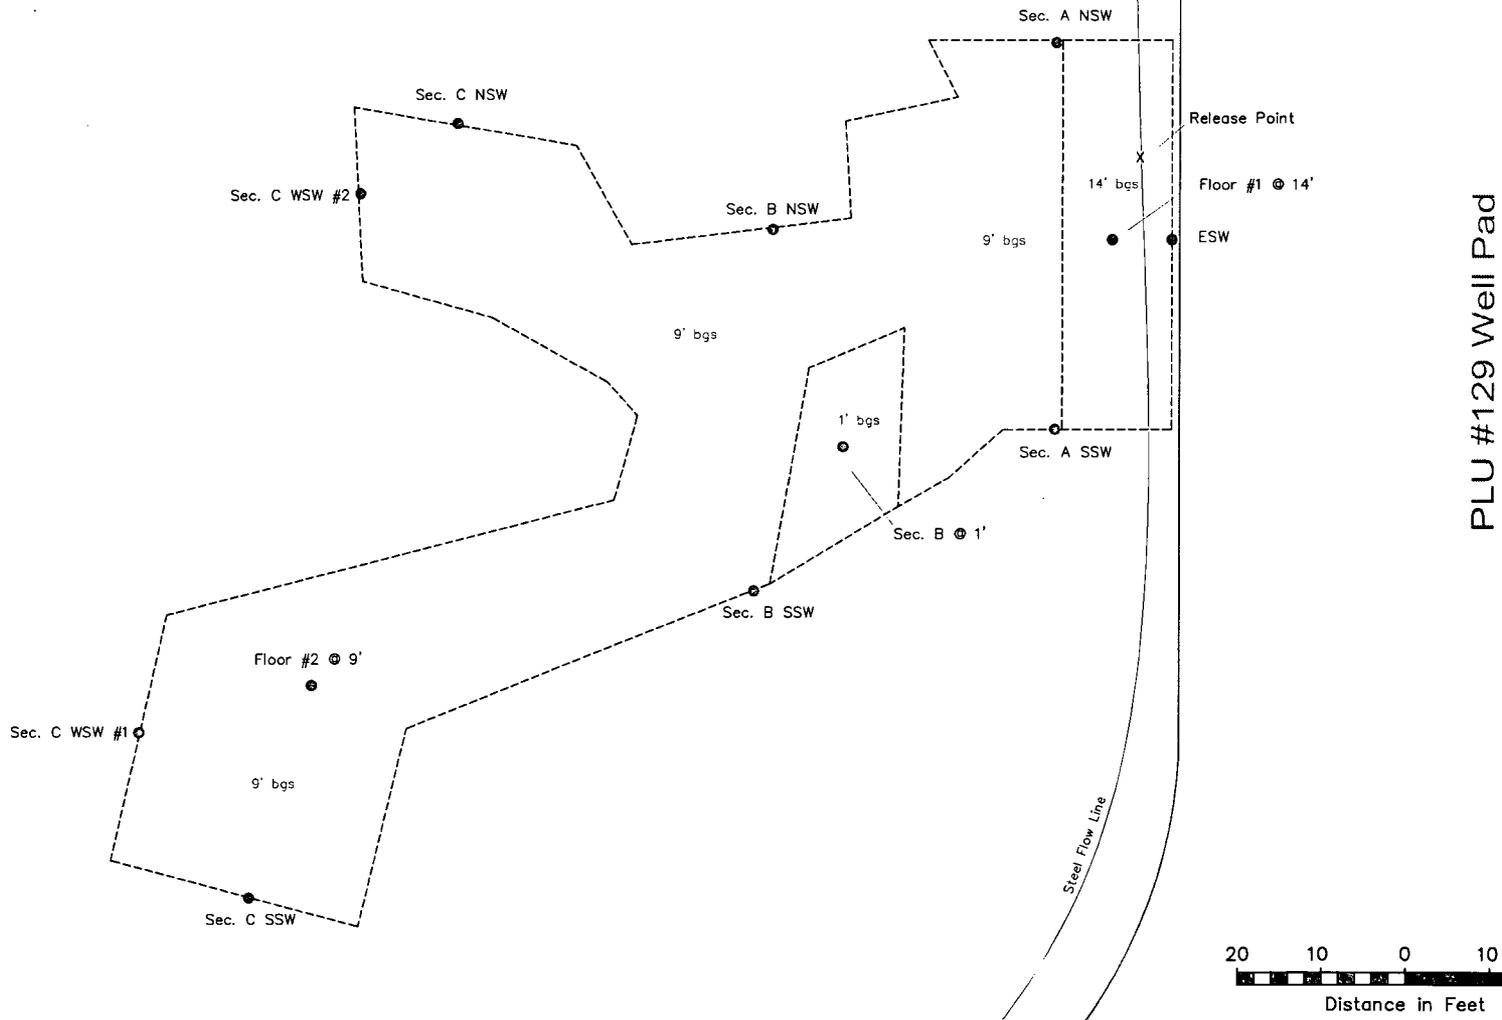
Figure 2
 Site & Sample Location Map
 BOPCO, L.P.
 Poker Lake Unit #129
 Eddy County, New Mexico

The final dimensions of the excavation were approximately fifteen (15) to forty feet (40') in width, one hundred and twenty feet (120') in length and one (1) to fourteen feet (14') in depth. Upon receiving laboratory analytical data from confirmation soil samples, the excavated area was backfilled with locally purchased, non-impacted soil. Following backfilling, areas affected by the remediation activities were compacted and contoured to match the surrounding topography.

On March 7, 2014, one (1) confirmation soil sample (Sec. B @ 1') was collected from the excavated area and submitted to the laboratory for analysis of chloride concentrations. Laboratory analytical results indicated the chloride concentration was 320 ppm. A summary of "Concentrations of Benzene, BTEX, TPH and Chloride in Soil" is provided in Table 1. A "Site and Sample Location Map" is provided as Figure 2. Laboratory analytical reports are provided as Appendix C.

On March 8, 2014, two (2) confirmation soil samples (Floor #1 @ 14' and Floor #2 @ 9') were collected from the floor of the excavation and submitted to the laboratory for analysis of TPH and chloride concentrations. Laboratory analytical results indicated TPH concentrations ranged from less than the laboratory method detection limit (MDL) for soil sample Floor #1 @ 14' to 57.6 ppm for soil sample Floor #2 @ 9'. Chloride concentrations ranged from 464 ppm for soil sample Floor #1 @ 14' to 624 ppm for soil sample Floor #2 @ 9'. The excavation was advanced toward the west.

On March 17, 2014, four (4) confirmation soil samples (Sec. A NSW, Sec. A SSW, Sec. B NSW and Sec. B SSW) were collected from the excavation sidewalls and submitted to the laboratory for analysis of chloride concentrations. Laboratory analytical results indicated chloride concentrations ranged from 32.0 ppm for soil sample Sec. B NSW to 320 ppm for soil sample Sec. A NSW. The excavation was advanced toward the west.

On March 22, 2014, five (5) confirmation soil samples (ESW, Sec. C NSW, Sec. C SSW, Sec. C WSW #1 and Sec. C WSW #2) were collected from the excavation sidewalls and submitted to the laboratory for analysis of chloride concentrations. Laboratory analytical results indicated chloride concentrations ranged from less than the laboratory MDL for soil samples Sec. C WSW #1 and Sec. C WSW #2 to 64.0 ppm for soil samples ESW and Sec. C NSW.

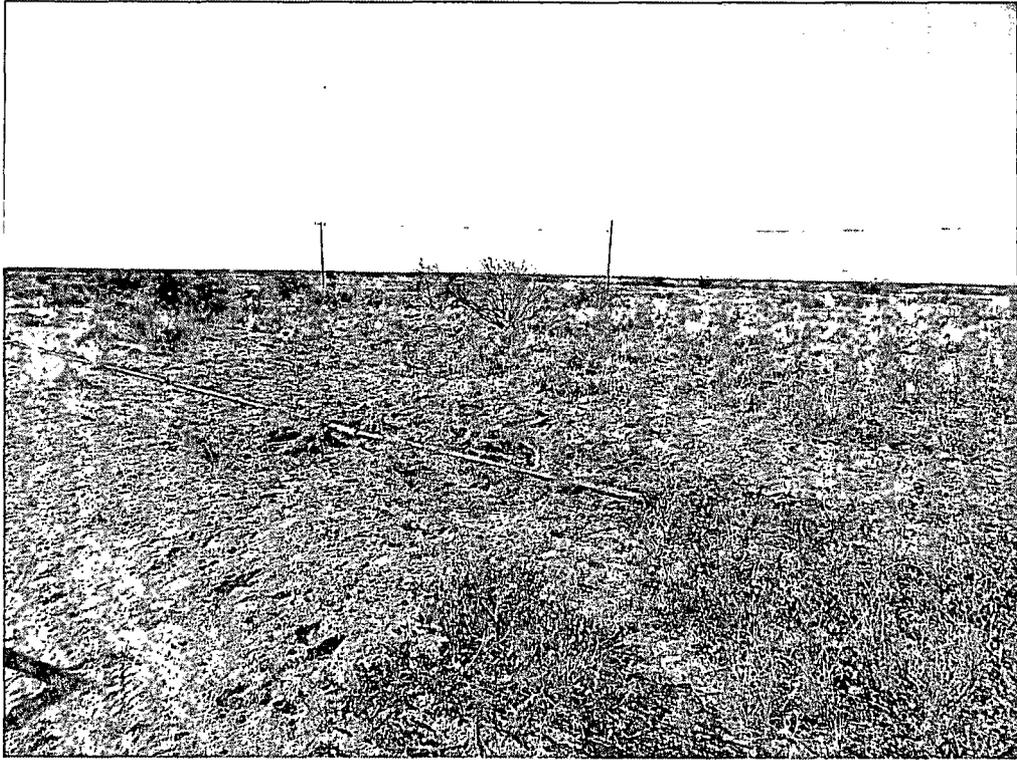
Photograph of the initial release at the PLU #129 Release Site.

On December 16, 2013, BOPCO discovered a release had occurred on the PLU #129 flow line. The release was attributed to the failure of a collar connection, resulting in the release of approximately two barrels (2 bbls) of crude oil and thirty-eight (38 bbls) of produced water. The New Mexico Oil Conservation Division (NMOCD)-Artesia District Office was notified of the release immediately upon discovery. The "Release Notification and Corrective Action" (Form C-141) indicated approximately 1,950 ft² of pasture was affected by the release. During initial response activities, the well was shut in and a vacuum truck was used to recover approximately one barrel (1 bbl) of crude oil and twenty-nine barrels (29 bbls) of produced water. The affected segment of pipe has since been replaced. The Form C-141 is provided as Appendix A. General photographs of the release site are provided as Appendix B.

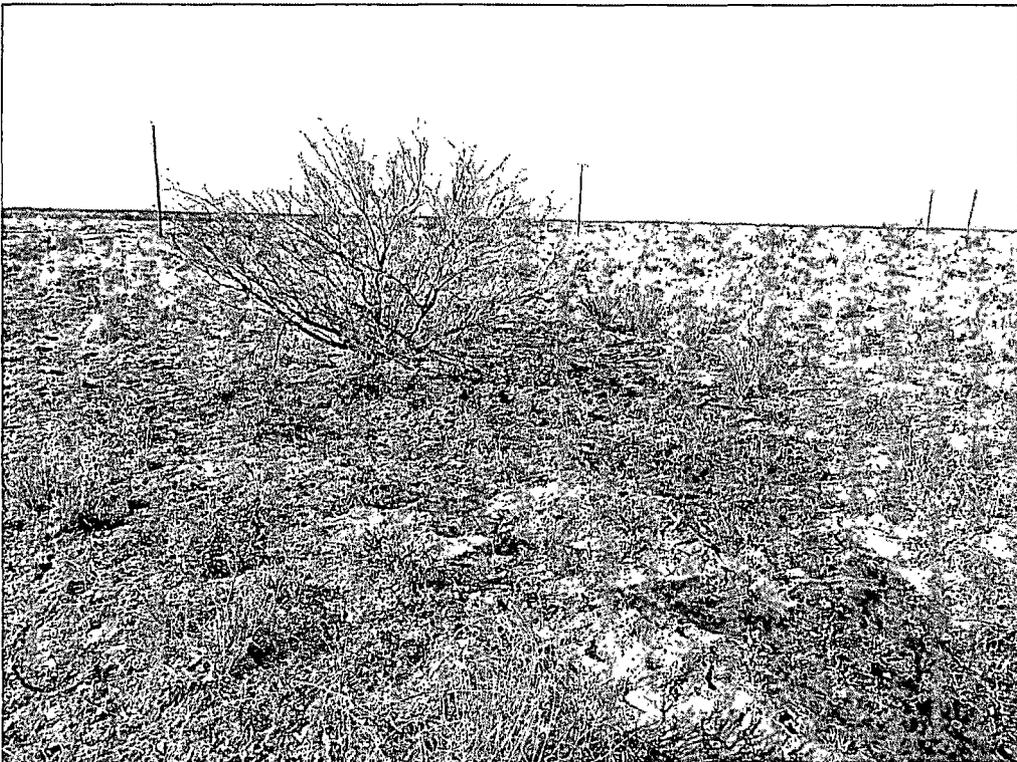
Photograph of the initial release at the PLU #129 Release Site.

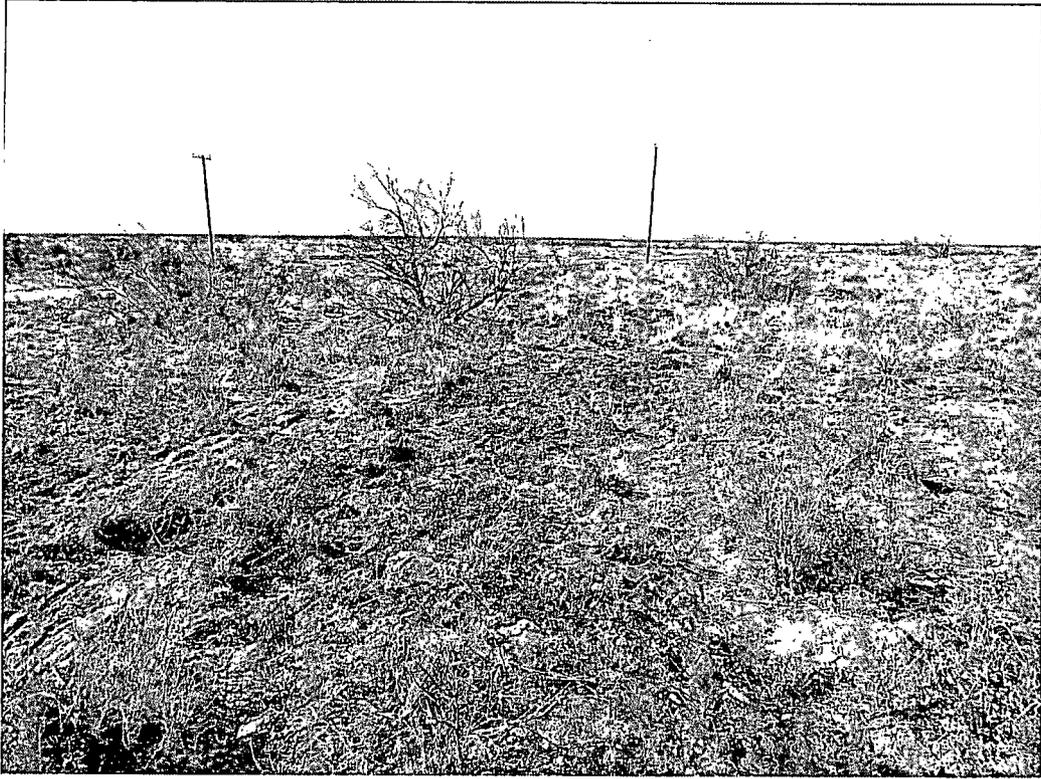
Photograph of the initial release at the PLU #129 Release Site.

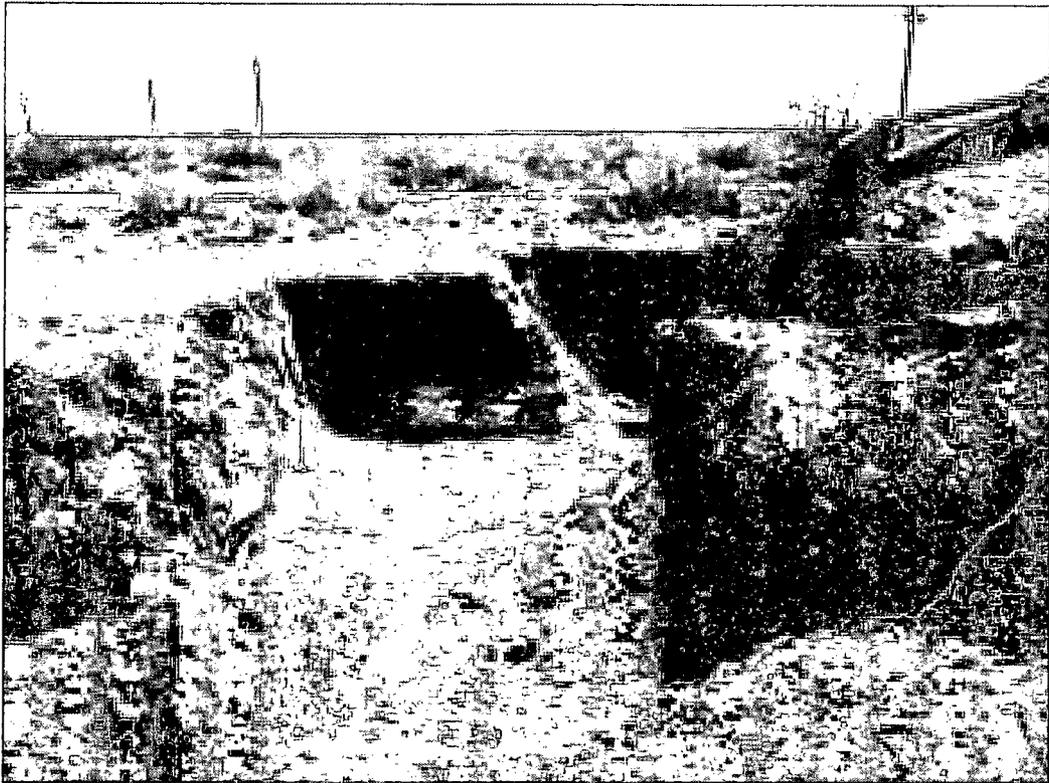
Photograph of excavation activities at the PLU #129 Release Site.

On March 4, 2014, Basin began excavating impacted soil at the release site. The floor and sidewalls of the excavation were advanced until field tests suggested concentrations of BTEX, TPH and chloride were below NMOCD regulatory standards. Excavated soil was stockpiled on-site, pending final disposition.
