BOPCO

Poker Lake Unit #241

CLOSURE REPORT

2RP-1173-0

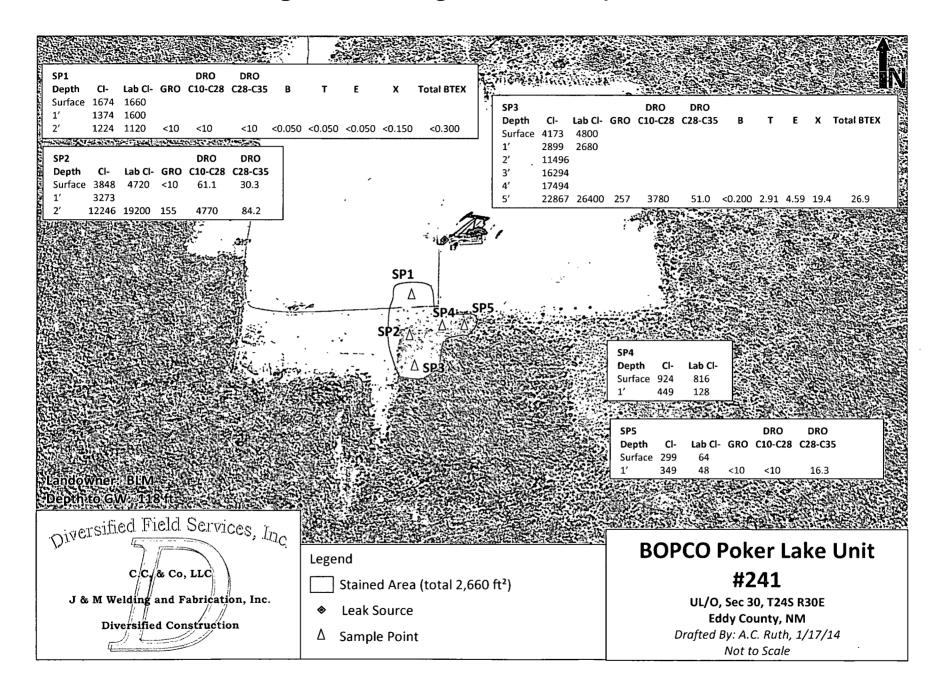
Figure - Site Diagram with Sample Data

On November 1, 2013, DFSI personnel collected and field tested soil samples from the leak area (Figure). Visually impacted soils were excavated and removed to a NMOCD approved disposal facility concurrent with sampling activities. The samples were submitted to a commercial laboratory for confirmation of chloride, BTEX, and TPH (Appendix IV).

Chloride at SP1 decreased to 1,120 mg/kg at 2 ft. below ground surface (bgs) and showed nondetect levels of TPH and BTEX. SP2 and SP3 were located within a previously reclaimed pit location. Chloride at these sample points remained at 19,200 mg/kg at 2 ft. and 26,400 mg/kg at 5 ft. bgs respectively, and TPH/BTEX levels remained elevated. SP4 and SP5 were located to the east. Chloride levels were 449 mg/kg or less and TPH totaled 16.3 mg/kg or less at 1 ft. bgs in these areas. Photographs of site activities can be viewed in Appendix II.

The area of SP1 was excavated to 1 ft. bgs. The remaining area south of the flow line was excavated to 2 ft. bgs and a reinforced plastic liner was installed in the excavation bottom. The excavation area on the well pad was backfilled with imported caliche and leveled. The pasture excavation area was backfilled with imported topsoil and the site was contoured to the surrounding landscape.

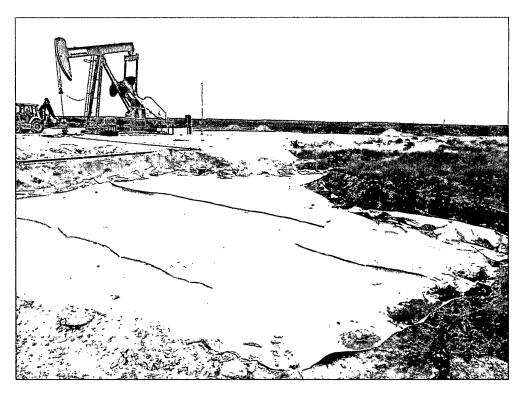
Lined excavation south of caliche pad 11/12/13

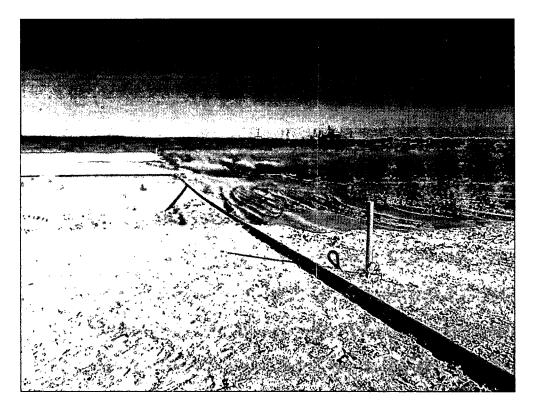
Excavation north of line, south of line backfilling 11/13/13

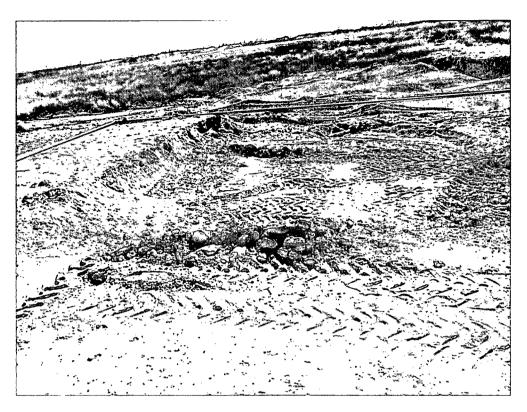
Excavation of flow line and impacted pasture area 11/13/13

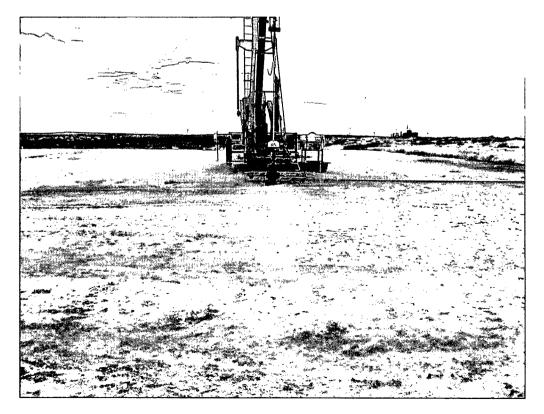
Site after completion 11/18/13
