Release Notification and Corrective Action

Mark Owens Battery

Termination Report

Apache Corporation - Mark Owens Battery

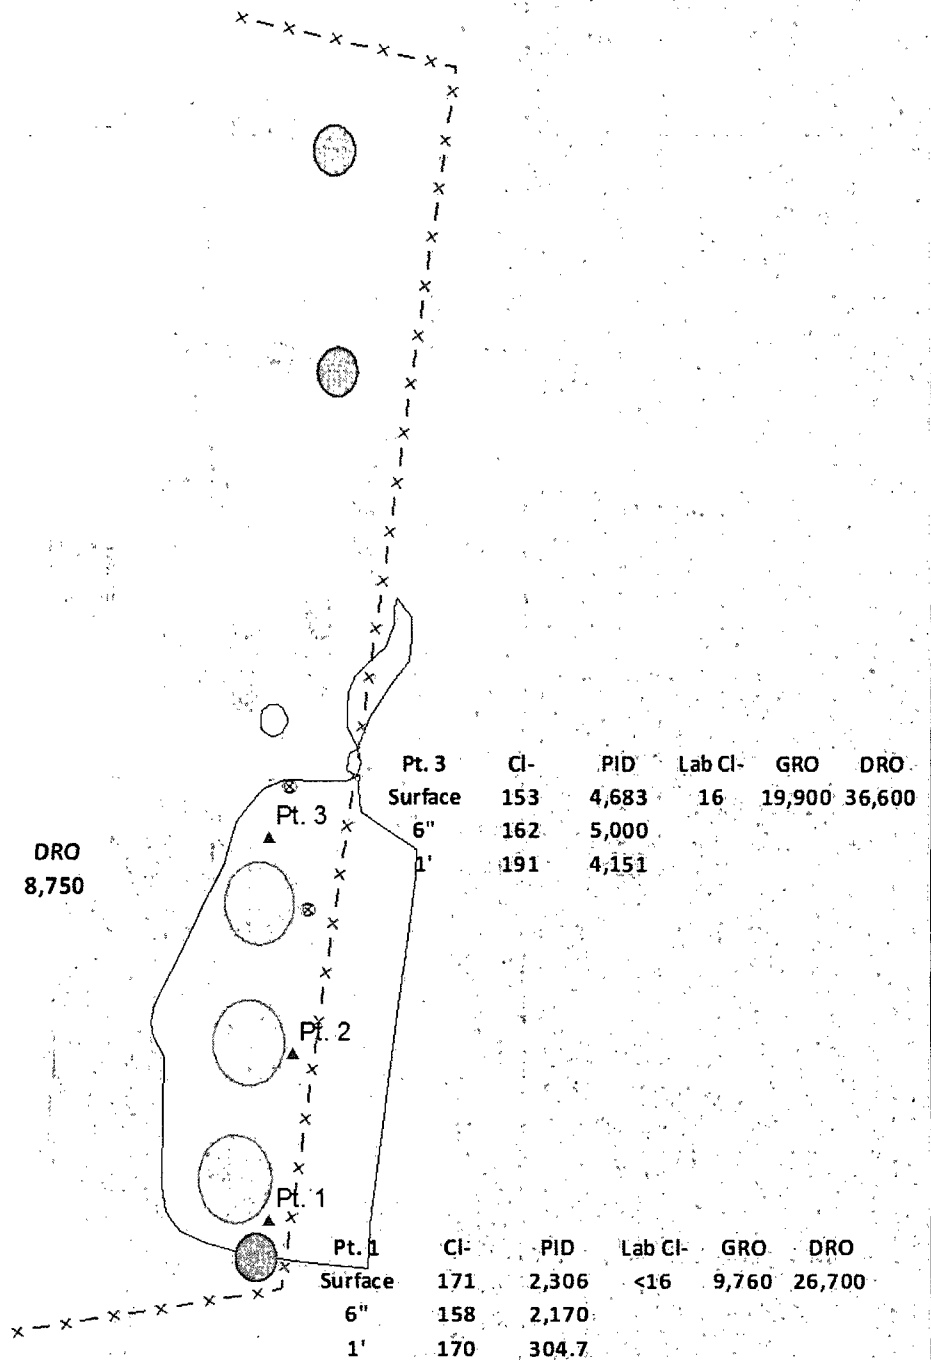
Figure 1

Initial Sampling Data

Pt. 2	Cl-	PID	Lab Cl-	GRO	DRO
Surface	793	3,744	976	4,430	8,750
6"	437	140.9			
1'	197	683.7			
1'6"	267	256.7			
2'	470	534

STAIN (2,169 sq ft)

On September 27th, 2012, RECS personnel were on site to begin work on the Mark Owens Battery. Samples were taken from the release area from the surface and with depth (Figure 1). The surface samples were taken to a commercial laboratory for analysis of chlorides, GRO and DRO (Appendix B). Due to safety concerns, the release area was scraped down six inches and the soil was exported to a NMOCD approved facility. A 5 point bottom composite was taken from the scraped area and sent to a commercial laboratory for analysis of chlorides, GRO, DRO and BTEX (Figure 2). The site was backfilled with clean, imported soil. Photo documentation of this can be found in Appendix C.

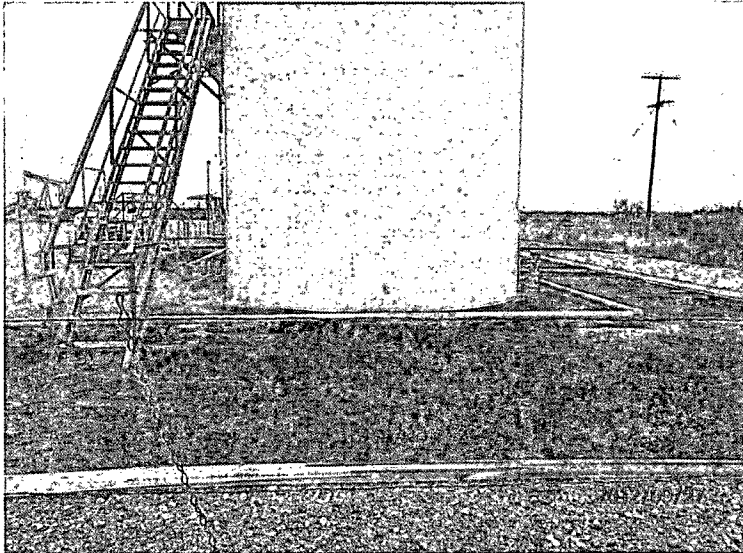
Initial release area, facing north

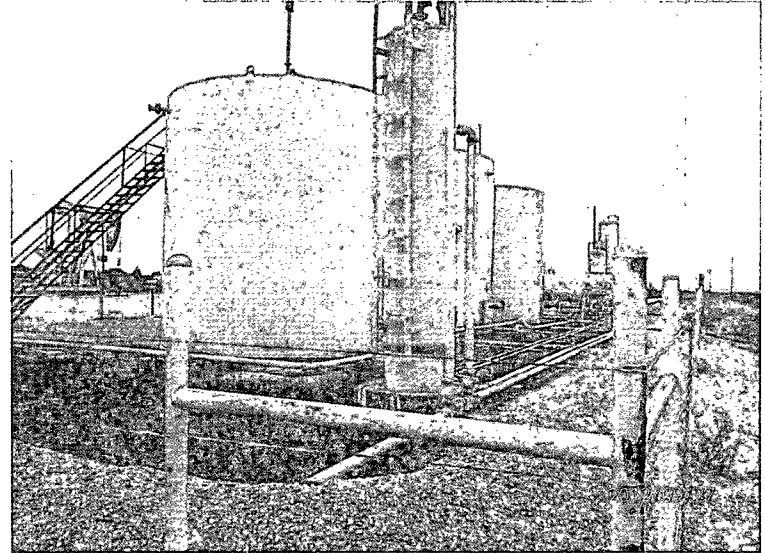
Initial release area, facing northwest

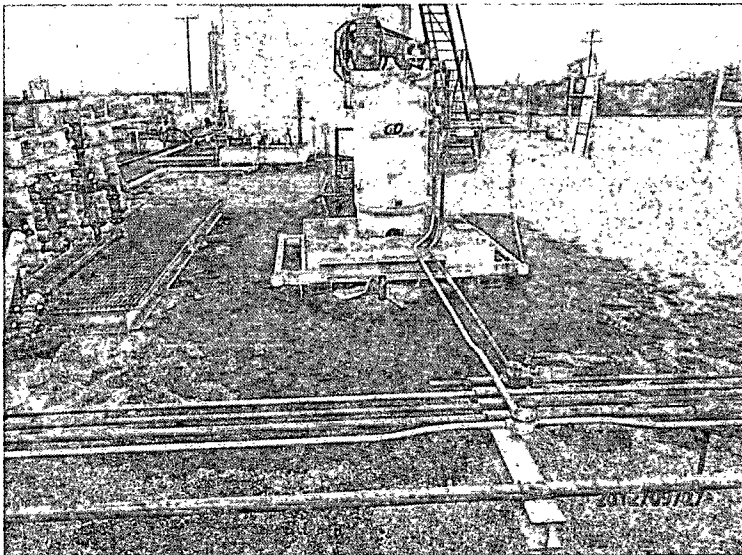
Initial release area, facing south

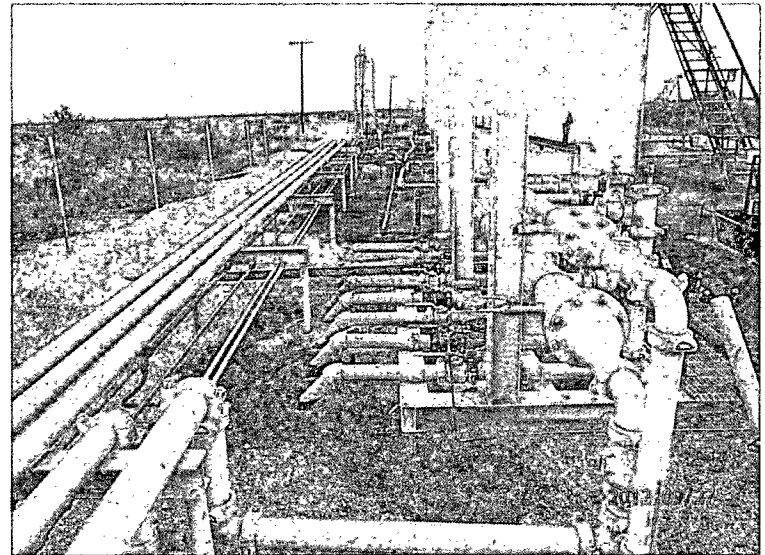
Initial release area, facing south

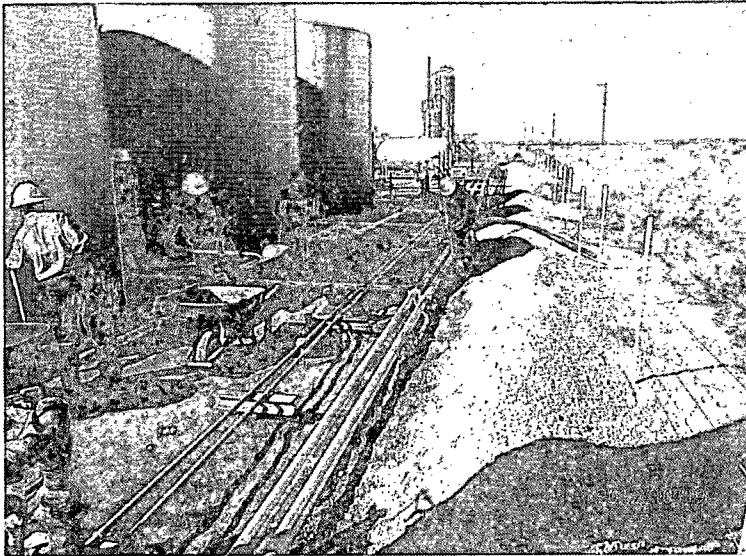
Removing contaminated soil, facing north 10/19/12

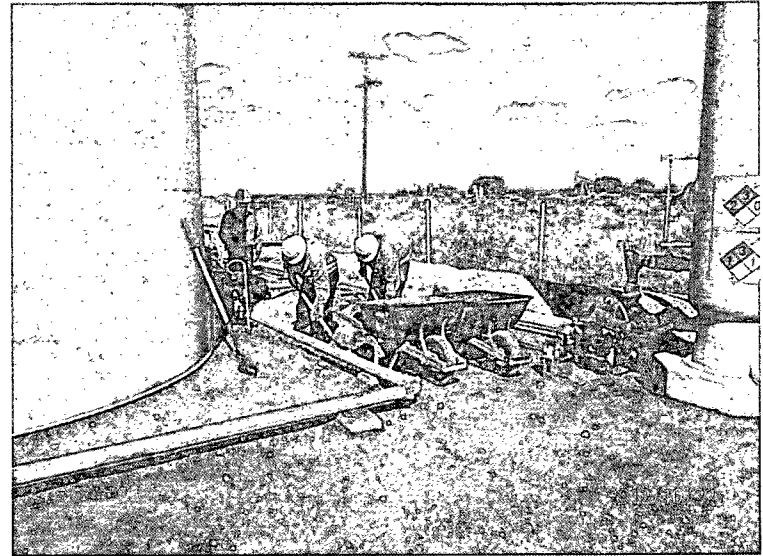
Removing contaminated soil, facing northeast
10/22/12

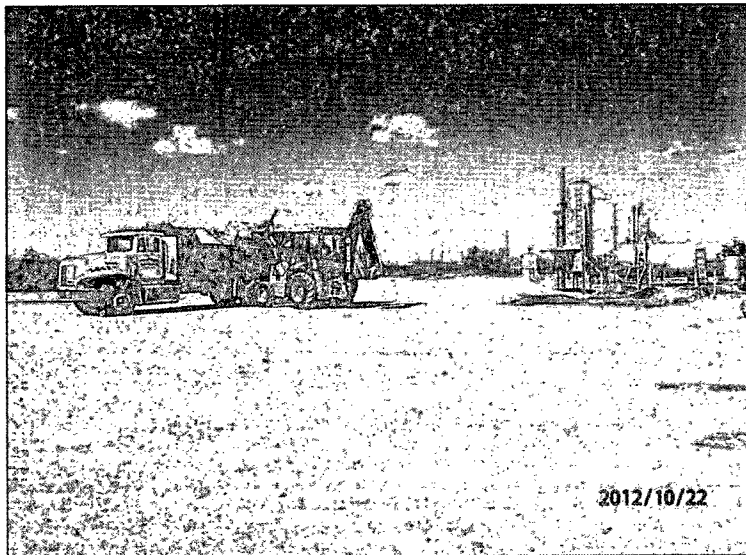
Exporting soil, facing north 10/22/12

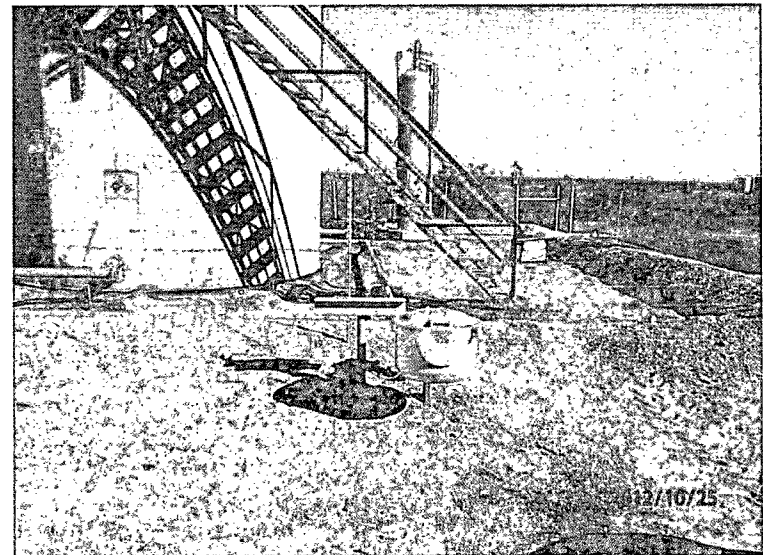
Scrape completed, facing east 10/25/12

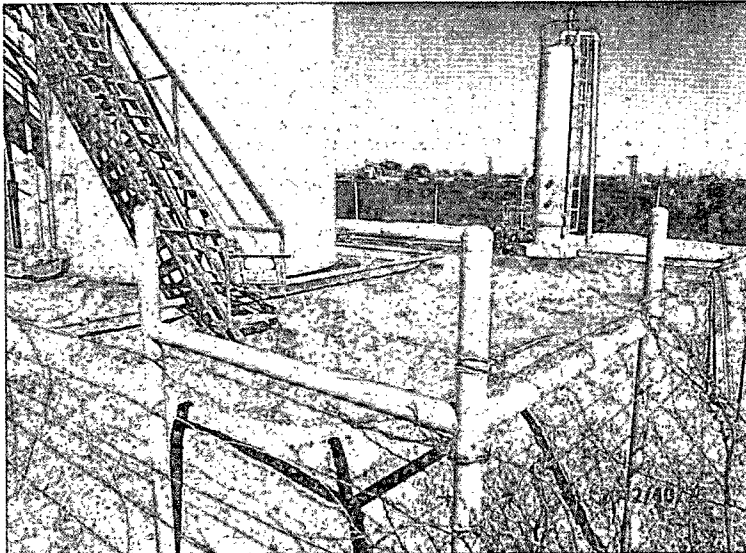
Scrape completed, facing northeast 10/25/12

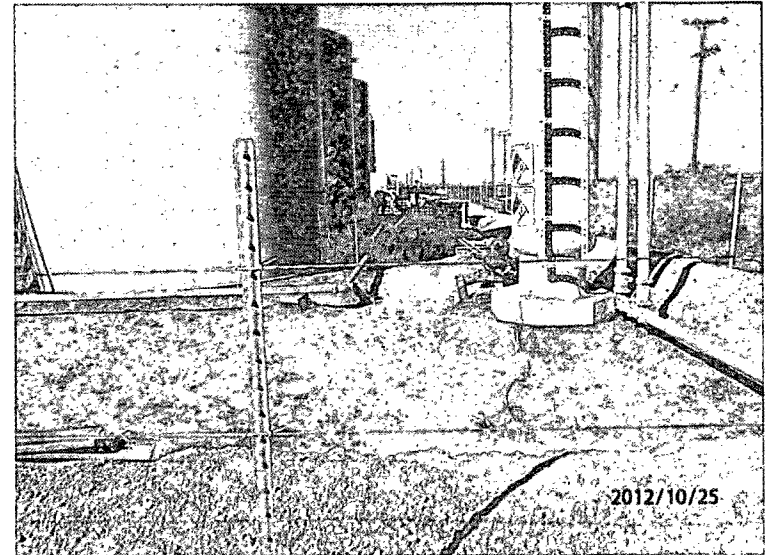
Scrape completed, facing north 10/25/12

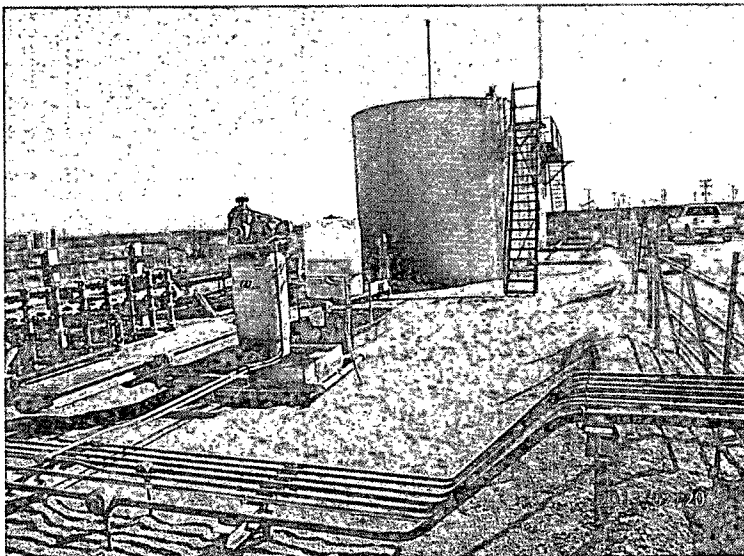
Site backfilled, facing southeast 2/20/13

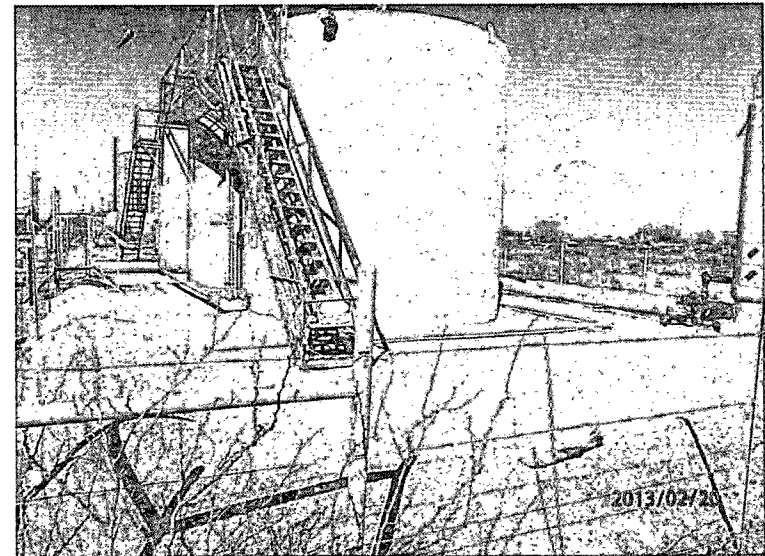
Site backfilled, facing northeast 2/20/13
