BOPCO

Poker Lake Unit #123

CLOSURE REPORT

2RP-1203

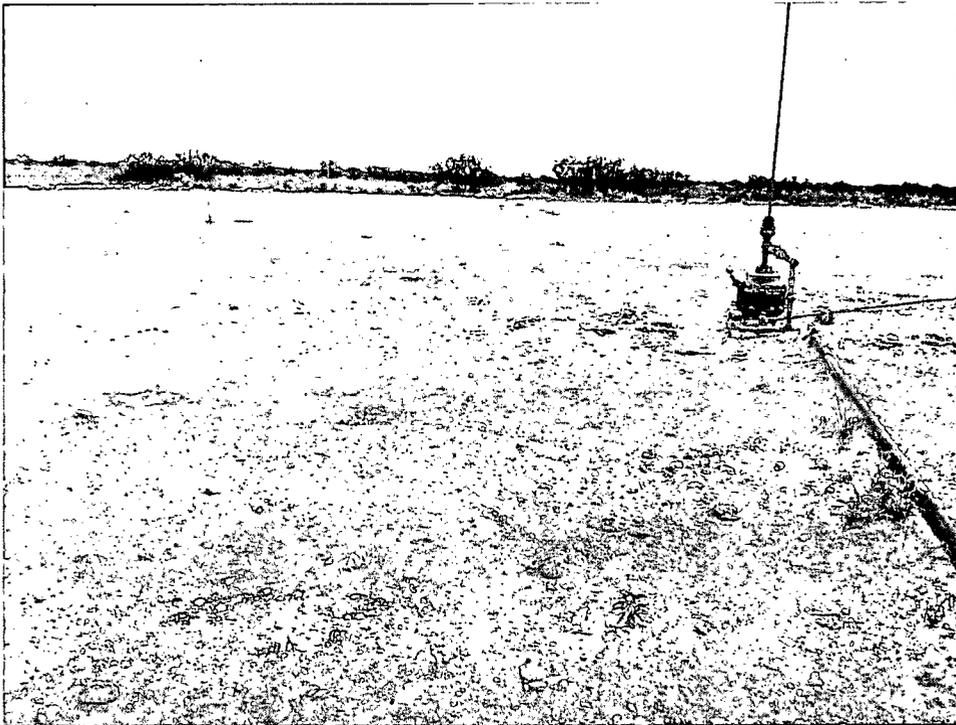
Impacted area southeast of well head 8/7/13

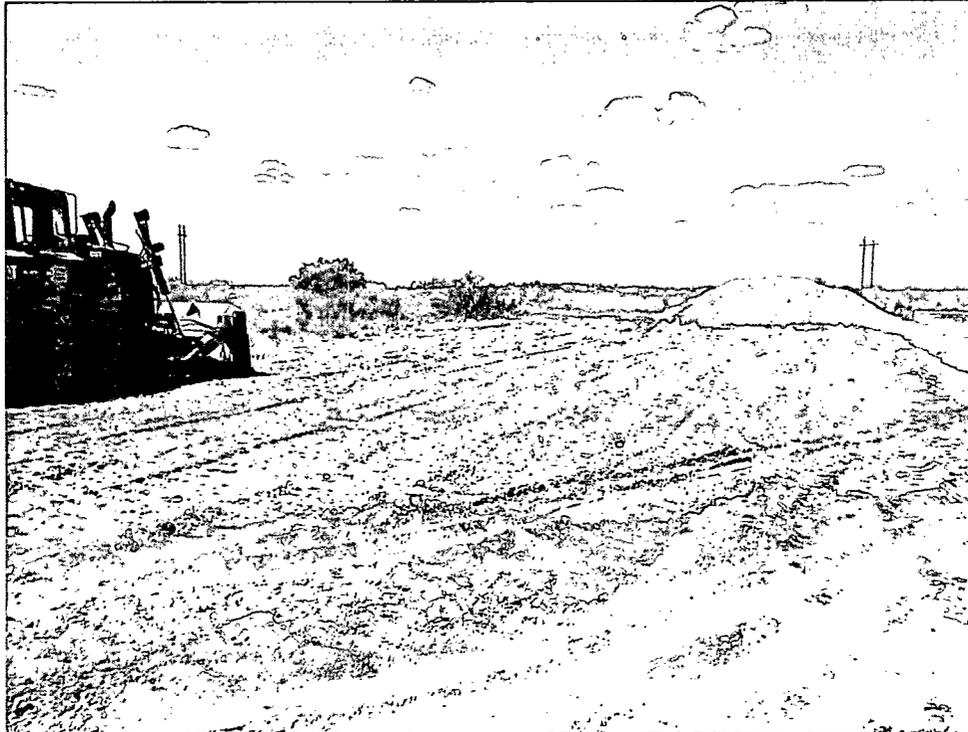
Reclaim of west side of caliche pad 8/30/13
