LINN ENERGY

McClay Federal #7
2RP-1914
2RP-1959

Termination Request

RE: CAP Report and Termination Request

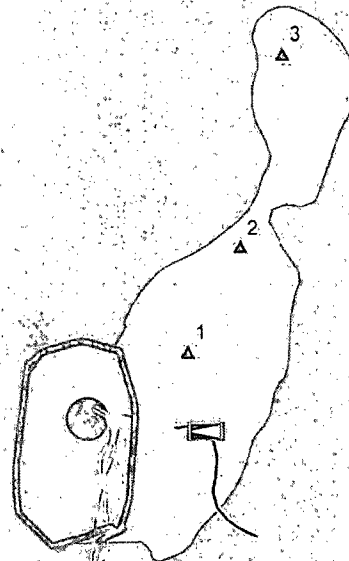
Legend

- ▲ AUGUR POINTS
- LINED BERM
- ☐ GAS REGULATOR
- 3 in SURFACE POLY
- 3 in SURFACE STEEL
- ☐ HEATER
- ☐ STAIN (2,486 sq ft)

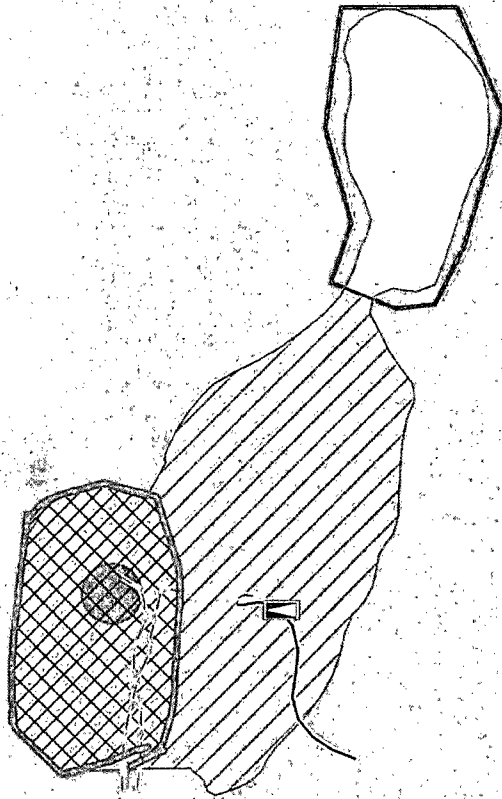
Proposed CAP Activities

- LINED BERM
- GAS REGULATOR
- 3 in SURFACE POLY
- 3 in SURFACE STEEL
- REMOVE AND REPLACE CALICHE OVER LINER
- SCRAPE AREA TO 6 INCHES
- PROPOSED 20-MIL REINFORCED POLY LINER AT 4 FT BGS
- HEATER
- STAIN (2,486 sq ft)

The area around Point 3 will be excavated to depth of 4 ft bgs. The walls of the excavation would be advanced horizontally until laboratory analyses showed the walls to have a chloride reading below 1,000 mg/kg and combined GRO/DRO below 1,000 mg/kg. At the base of the 4 ft bgs excavation, a 20 mil reinforced poly liner would be installed at properly seated (Figure 2).

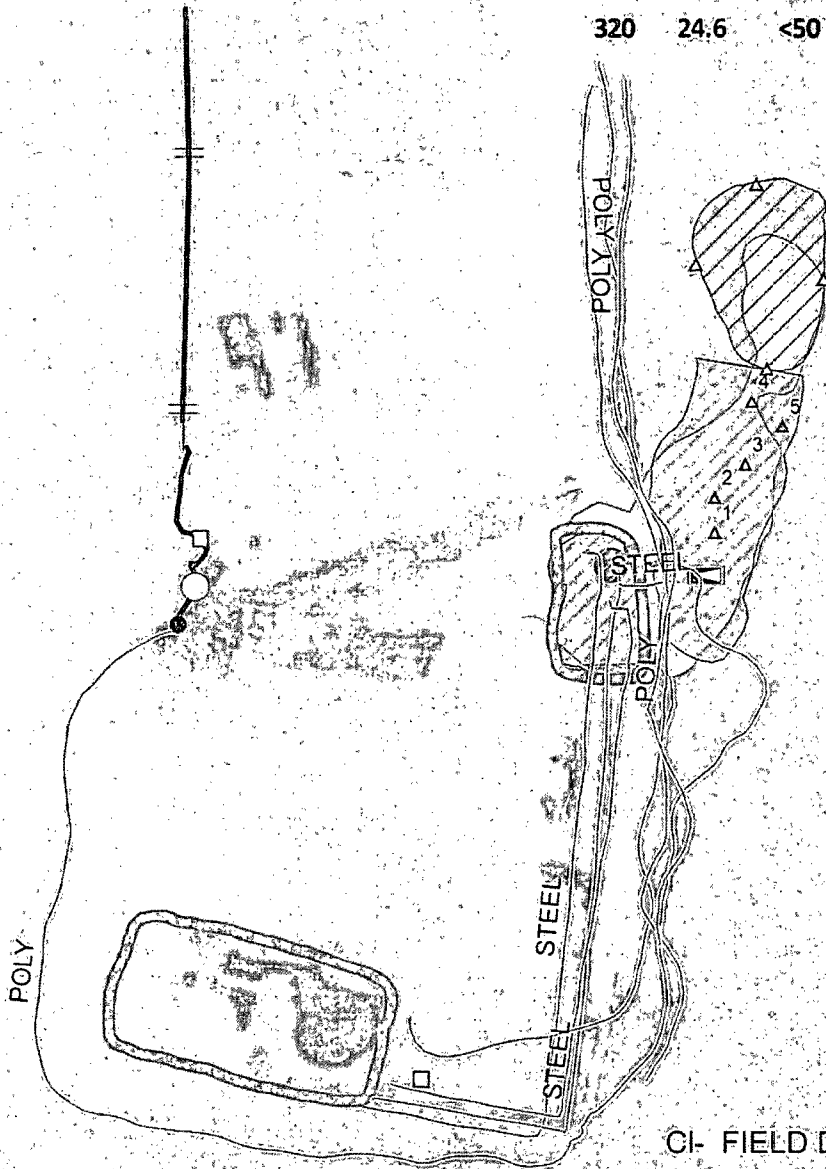
- ▲ FINAL WALL SAMPLE POINTS
- ▲ SAMPLE POINT
- CHEMICAL TANK
- ⊥ ELECTRIC POLE
- ELECTRICAL BOX
- WELLHEAD
- ▬ BERM
- OVERHEAD ELECTRICAL
- ▬ PAD
- SURFACE ELECTRICAL
- SURFACE PIPELINE
- ⊡ GAS REGULATOR
- ▨ 6 IN SCRAPE
- ▨ HEATER
- ▨ STAIN (2,486 sq ft)
- ▨ 4 FT EXCAVATION

Once the 4 foot excavation was completed, wall samples were taken to a commercial laboratory for analysis to confirm all constituents were below regulatory standards (Appendix C). At the base of the 6 inch scrape, a 5 point bottom composite was taken

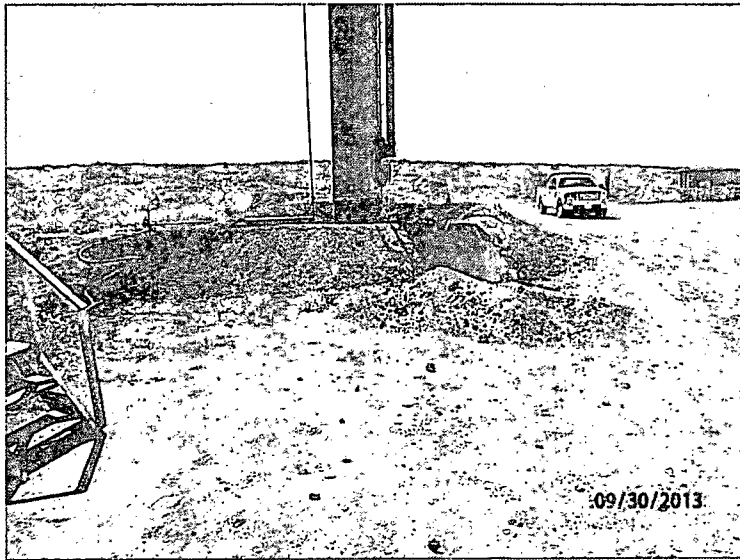
Initial release area, facing west

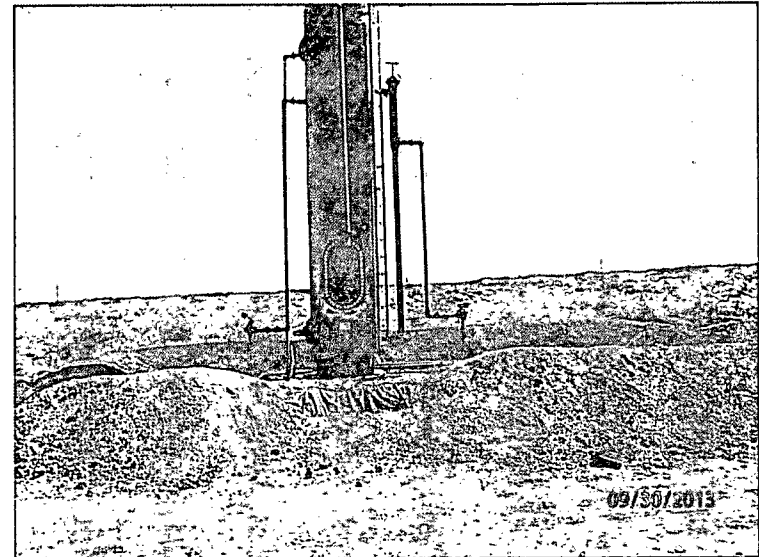
Showing liner beneath release, facing south

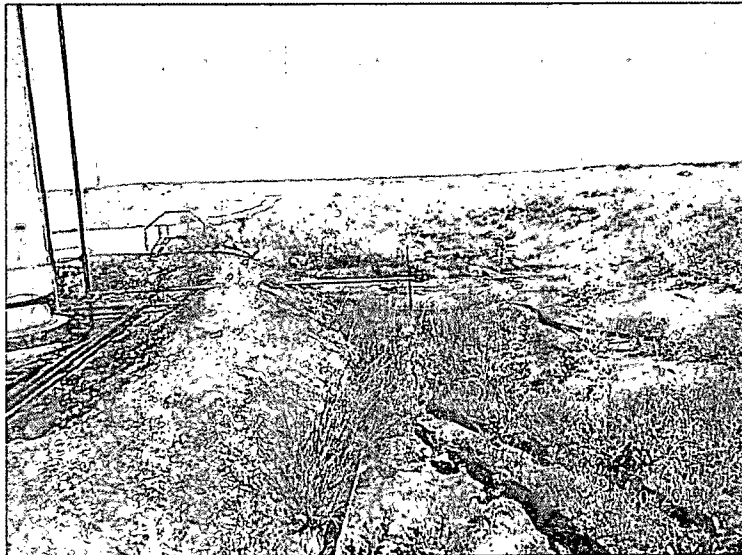
Initial release area, facing east

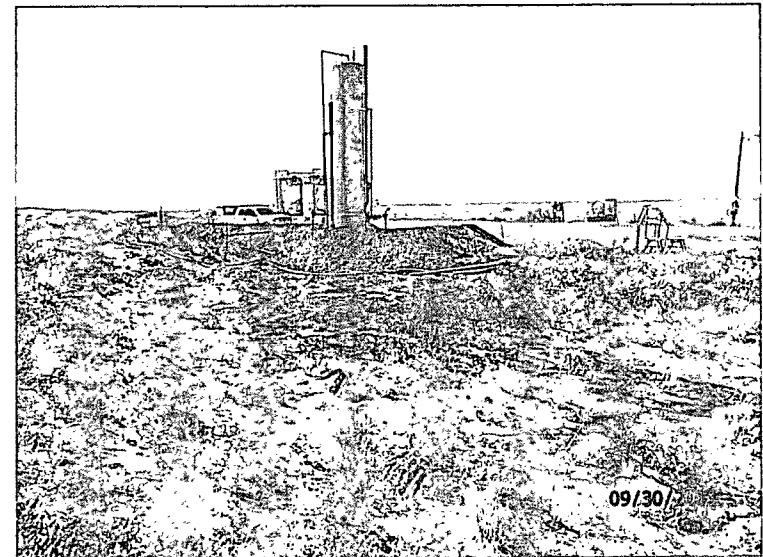
Initial release area, facing northwest

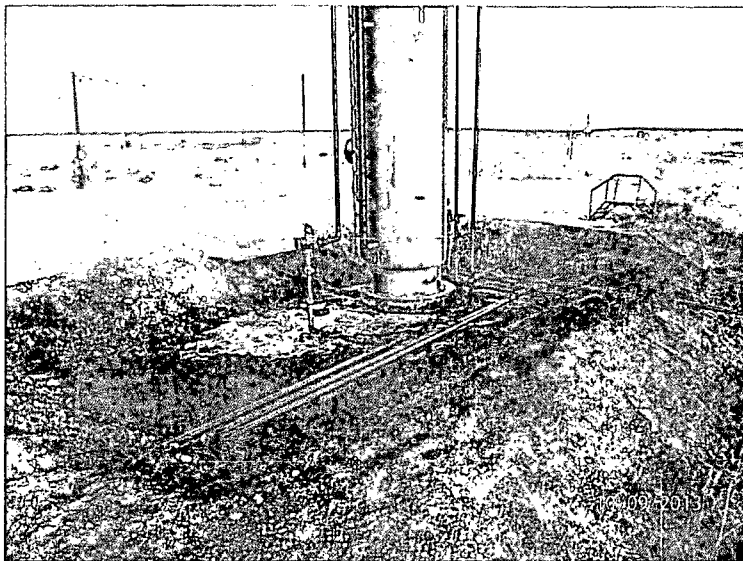
Initial release area, facing northeast

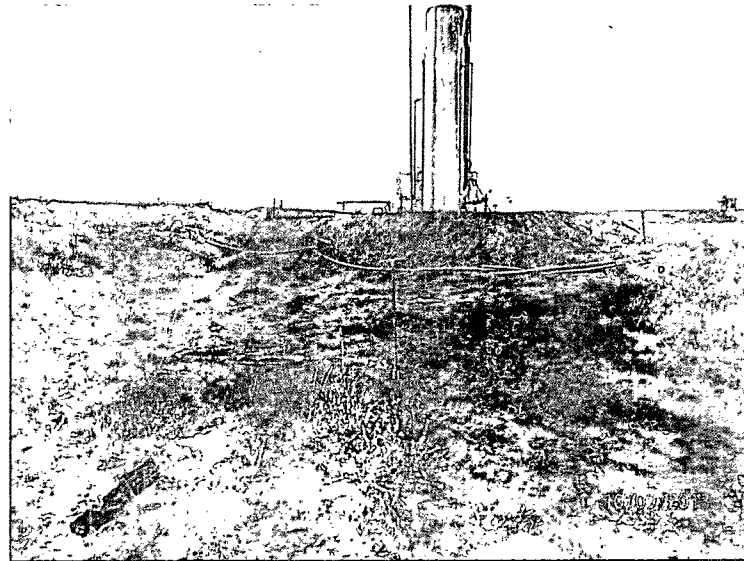
Hand augur site for depth, facing northwest
