# Linn Energy Skelly Unit #158

## CLOSURE REPORT

API No. 30-015-25040

Unit Letter P, Section 22, Township 17 South, Range 31 East

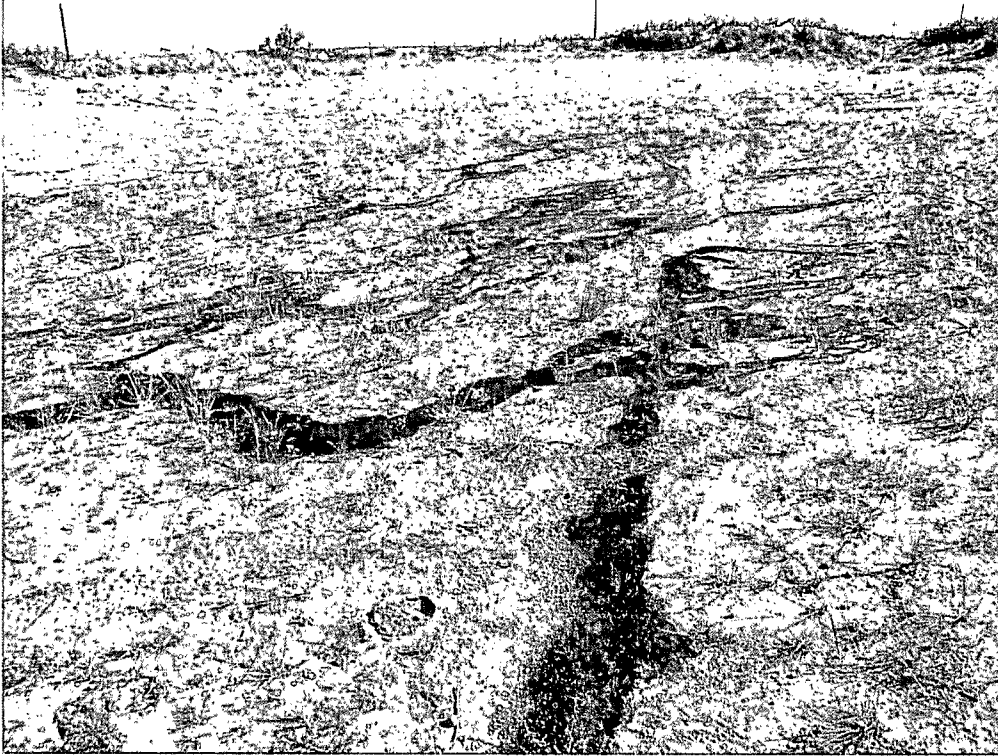
Area of SP1-SP3 from top right to bottom left, facing northeast 9/5/13

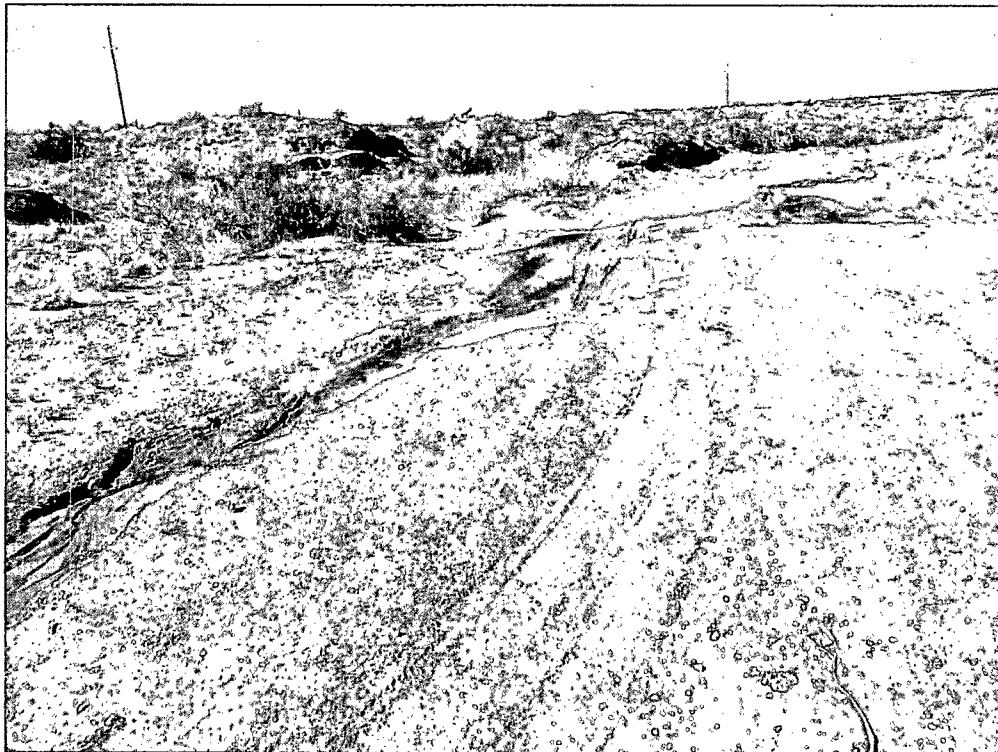
Area of SP4-SP5 from bottom left to top right, facing southwest 9/4/12

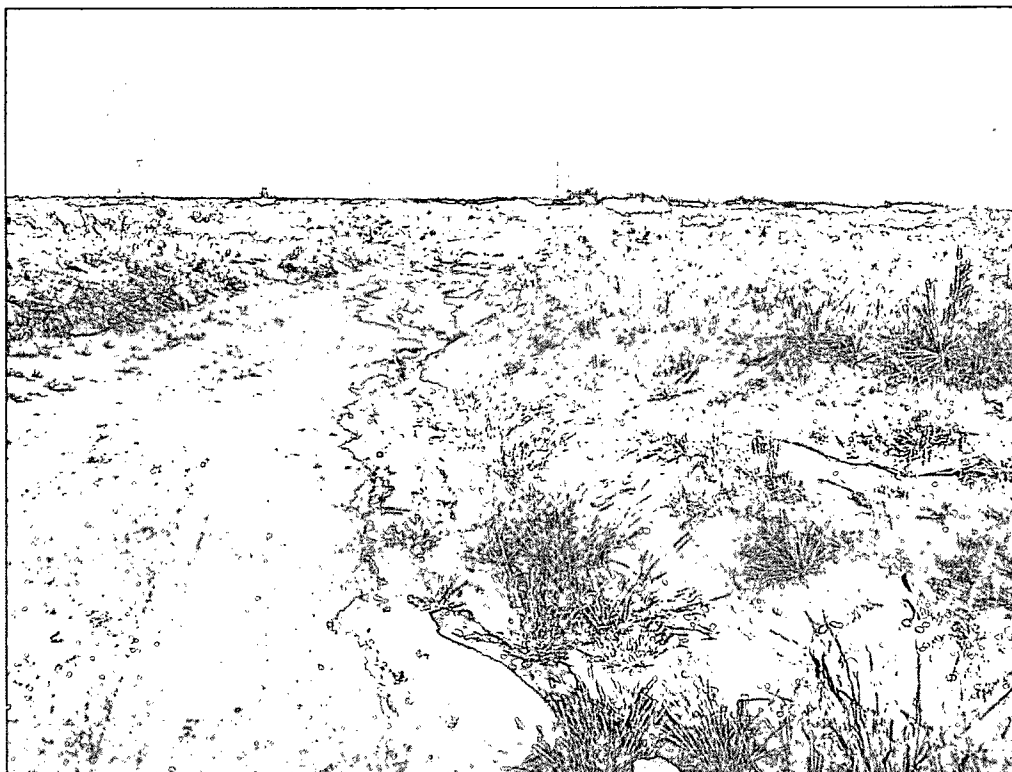
Area of SP6-SP8 from bottom center to top center, facing west 9/4/12

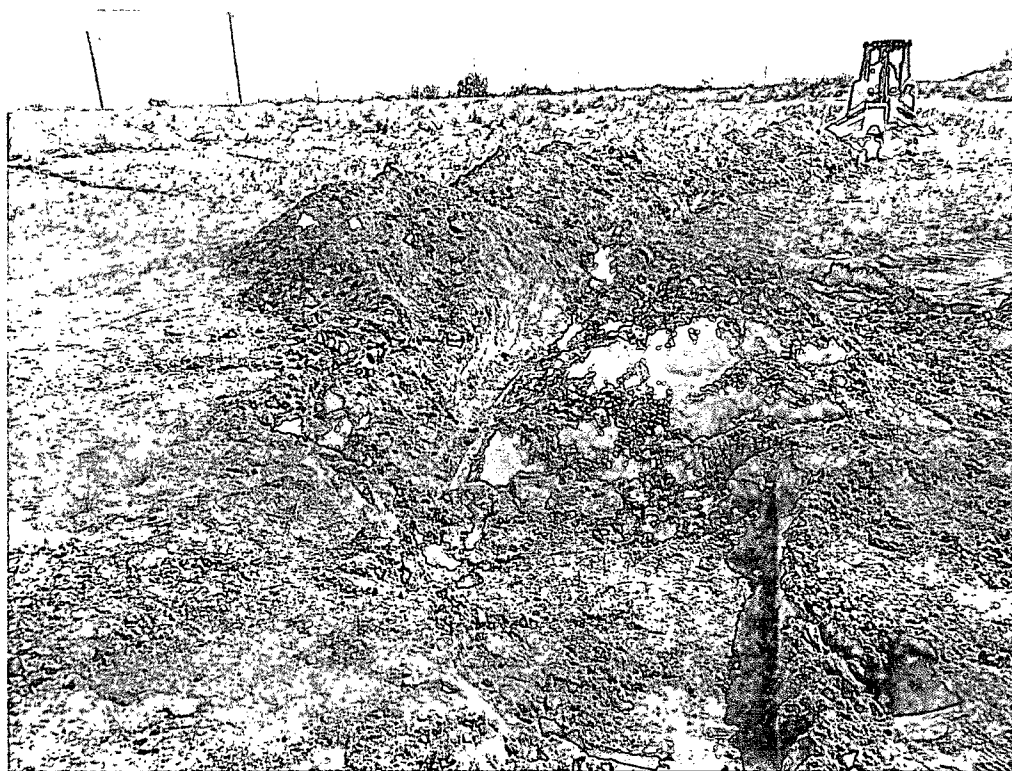
Excavation of line 09/05/13

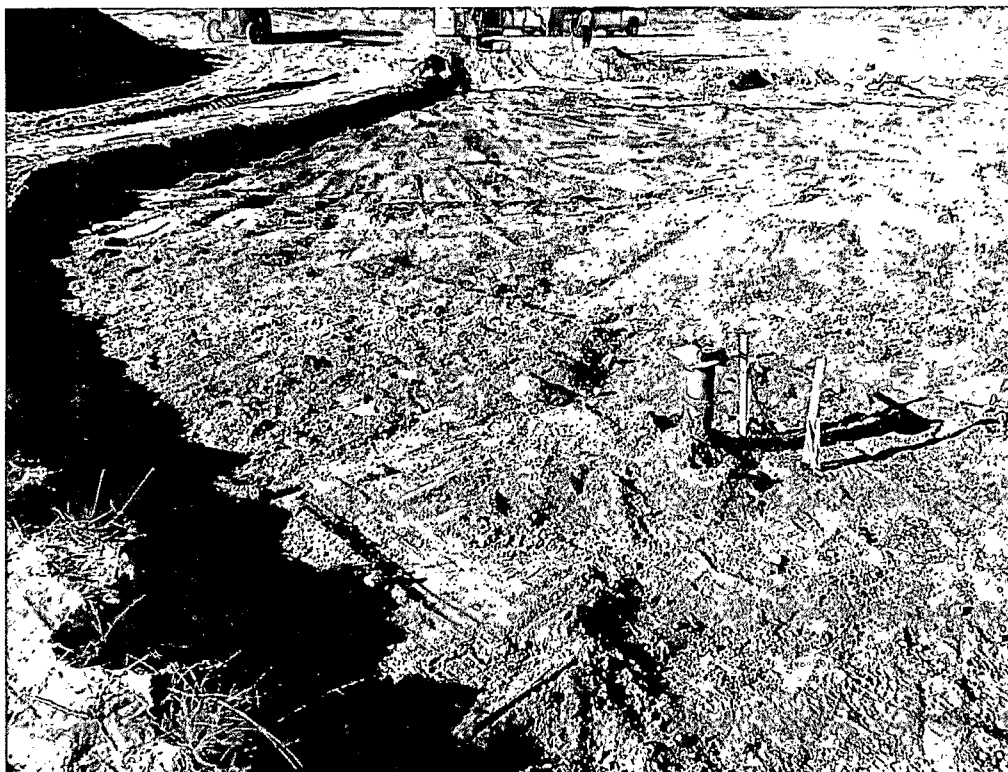
Excavation of impacted area at P&A'd well 10/26/13

Visually and chemically impacted soils were excavated throughout the entire leak area and removed to an NMOCD approved disposal facility. SP1 thru SP3 were at the source of the leak nearest to the plug and abandoned well head for the Skelly Unit #158. Chlorides were elevated at surface to depths of 5ft and 12ft. bgs., correspondingly. The remainder of sample points were located in and adjacent to the former lease road area. Simultaneous field testing revealed acceptable surface Chloride, however SP4 remained elevated at surface to 1ft. bgs where field testing revealed 199 mg/kg. , and SP6 remained elevated in Chloride at 2 ft. bgs., whereby the results were 2499 at 2ft. bgs, however at 3ft. bgs., the level of impact from Chloride was significantly reduced to 599 mg/kg. Since a portion of the later sample point positions were located in former lease road area it could be ascertained that a portion of impact was historical in nature. TPH totaled less than 10.0 mg/kg GRO and less than 10.0 mg/kg DRO, and BTEX totaled less than 0.300 mg/kg in all samples. Photographs of site activities can be viewed in Appendix II.

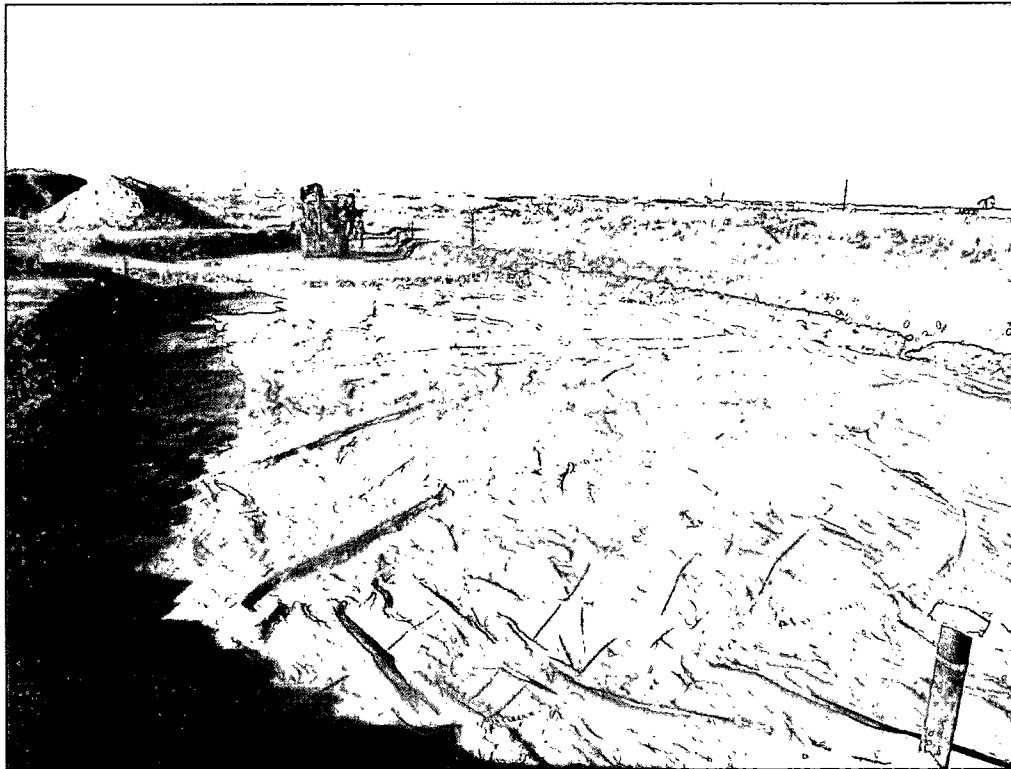
Installation of liner 01/16/14

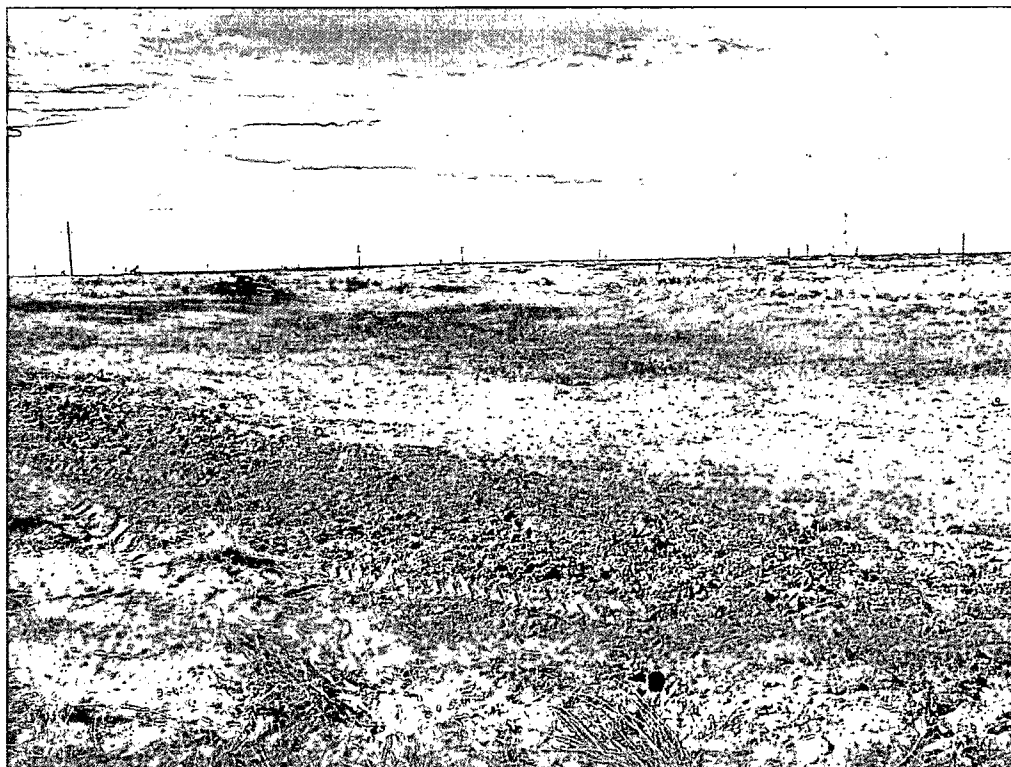
Seeding of impacted area 01/24/14

blended and seeded. On November 26, 2013, NMOCD representatives approved backfill of the excavation. On January 14, 2014 the pasture excavation was backfilled with imported topsoil and the site was contoured to the surrounding landscape. There were two adjacent lease roads into the site that were removed and backfilled with topsoil, in order to create the seed bed. On January 17, 2014 the site seeding activities were completed with 175 lbs. of Lesser Prairie Chicken seed mix per BLM requirements.
