## NEDU #606

# Closure Report

API 30-025-06587

**RE: TERMINATION REQUEST  
Apache – NEDU #606 AD  
UL/F sec. 15 T21S R37E  
API No. 30-025-06587**

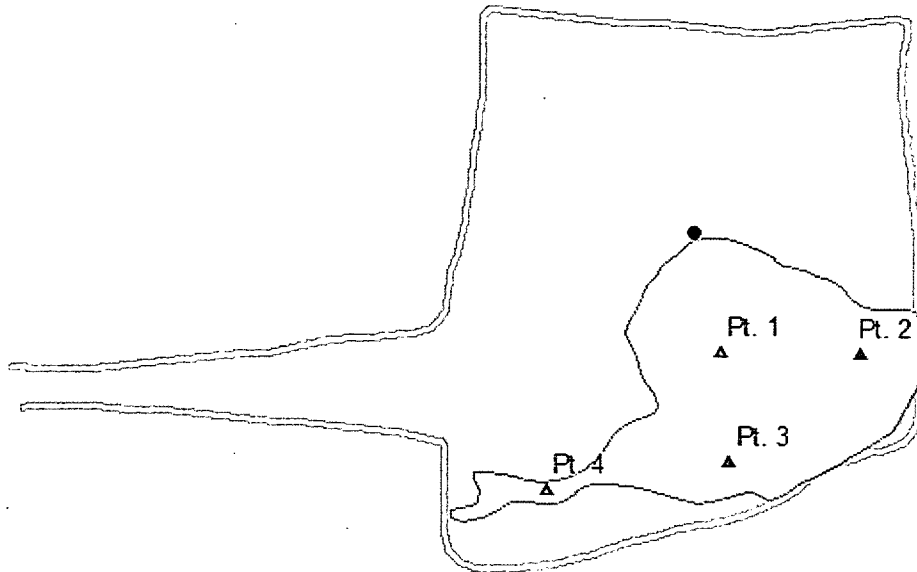
## Figure 1

On January 23, 2012, RECS personnel initiated work on the NEDU #606 (Figure 1). Surface soil samples were collected and field tested for chloride. Headspace measurements were also taken in the field using a Photo Ionization Detector (PID). The samples were submitted to a commercial laboratory for chloride and TPH (GRO/DRO) analyses (Appendix C). Chloride ranged from 512 ppm (parts per million or mg/kg) to 1,490 ppm. TPH ranged from 10 ppm to 69.5 ppm.

## INITIAL LAB DATA

Sample Description	Cl-	GRO	DRO
Pt. 1	512	<10	36.2
Pt. 2	1490	<10	69.5
Pt. 3	544	<10	10
Pt. 4	1170	10.2	13.1

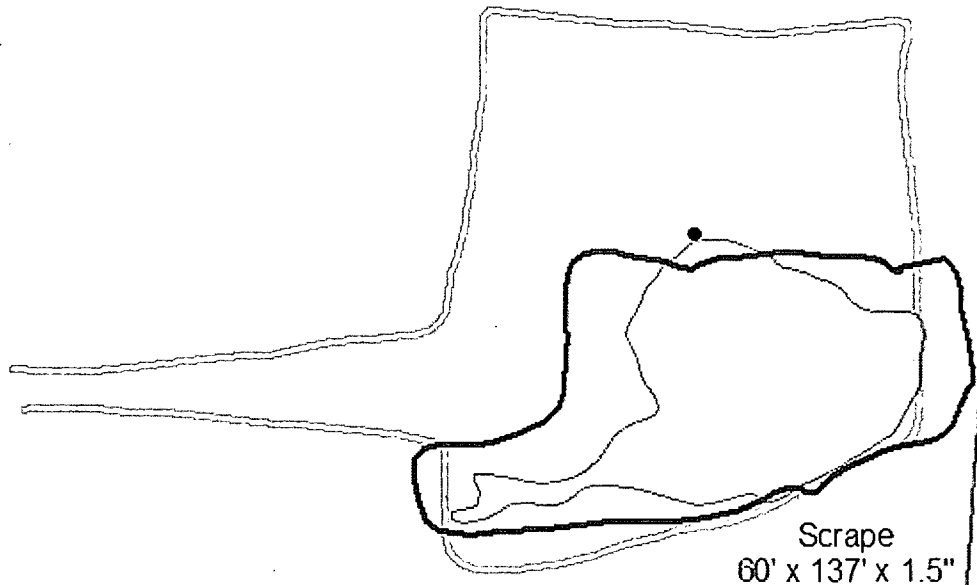
**Figure 2**

On March 19, 2012, RECS personnel collected and field tested final samples from the 1.5 ft. deep excavation (Figure 2). The representative grab samples from the excavation walls and the composite sample from the excavation bottom were submitted to a laboratory for chloride and TPH analyses (Appendix C). Chloride did not exceed 96.0 ppm and TPH did not exceed 135 ppm.

## FINAL EXCAVATION LAB DATA

Sample Description	Cl-	GRO	DRO
North Wall Center	<16	<10	<10
South Wall Center	96	<10	<10
East Wall Center	80	<10	<10
West Wall Center	32	<10	135
5 Pt Bottom	80	<10	<10

Impacted soils were removed from the excavation and transported to a NMOCD approved disposal facility. The excavation was backfilled with clean caliche (80 ppm chloride, Appendix C) and leveled. See Appendix B for photographs of field activities.

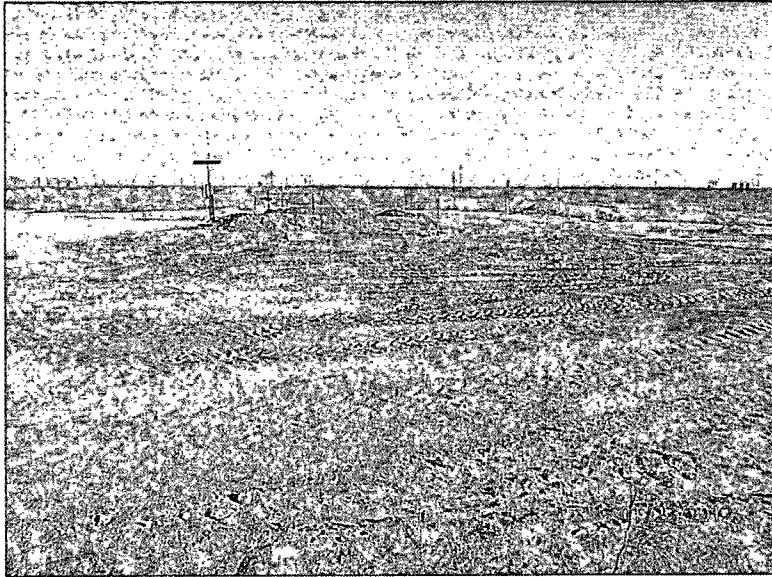
1/23/2012

Initial release, facing north

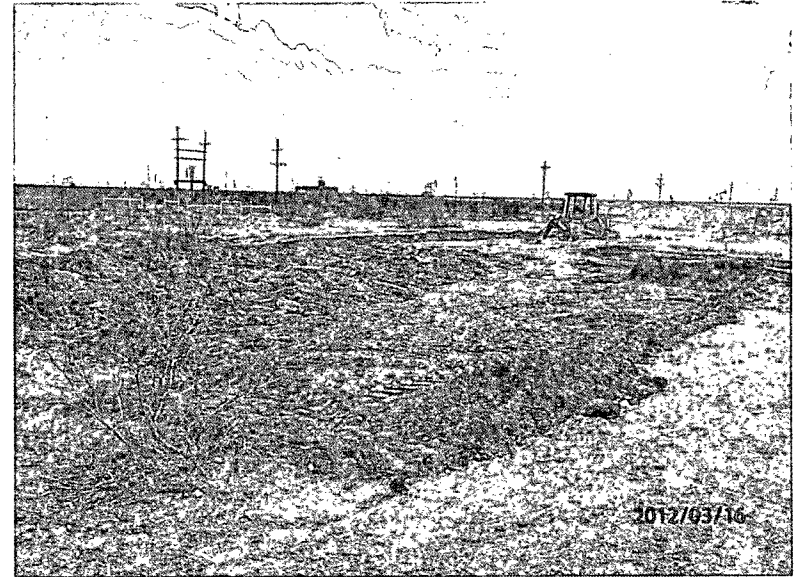
3/16/2012

Excavating release area, facing southwest

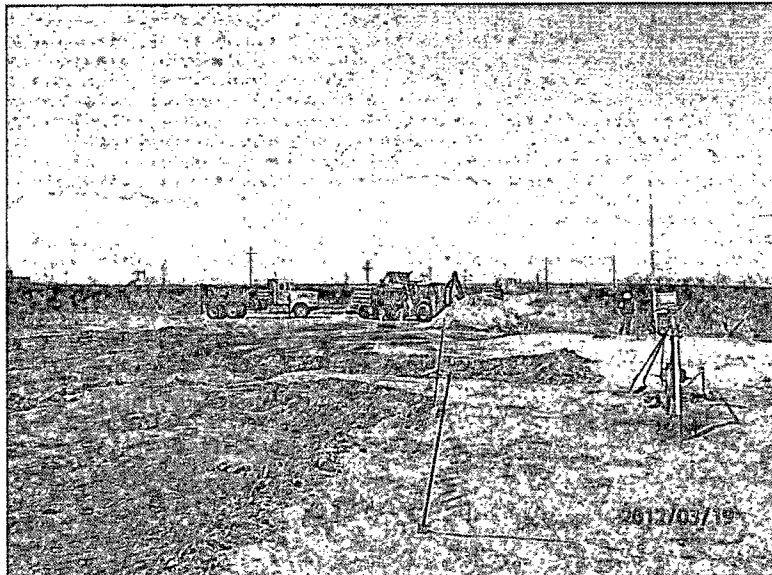
3/19/2012

Exporting soil, facing southwest

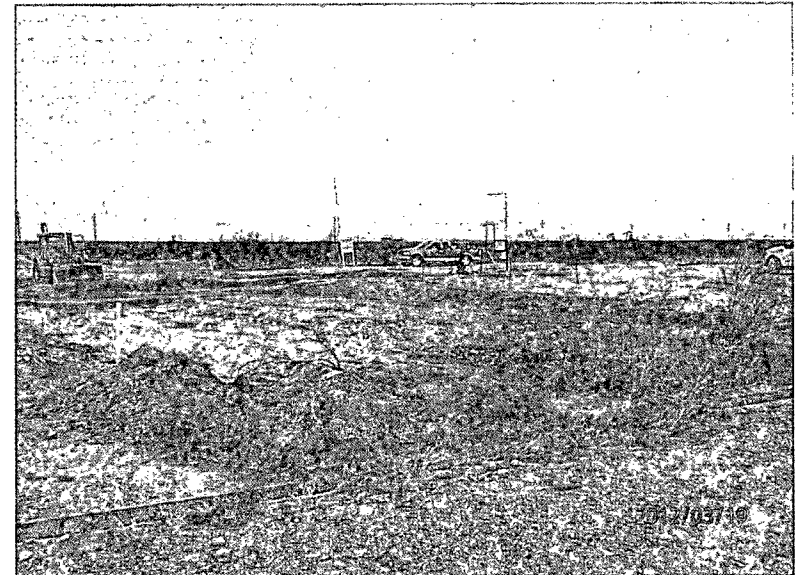
3/19/2012

Final excavation, facing southwest

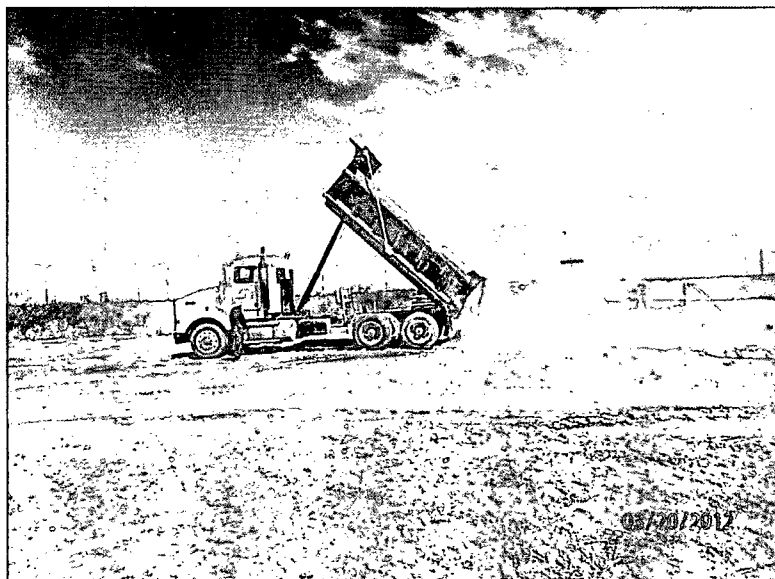
3/20/2012

Importing caliche, facing north

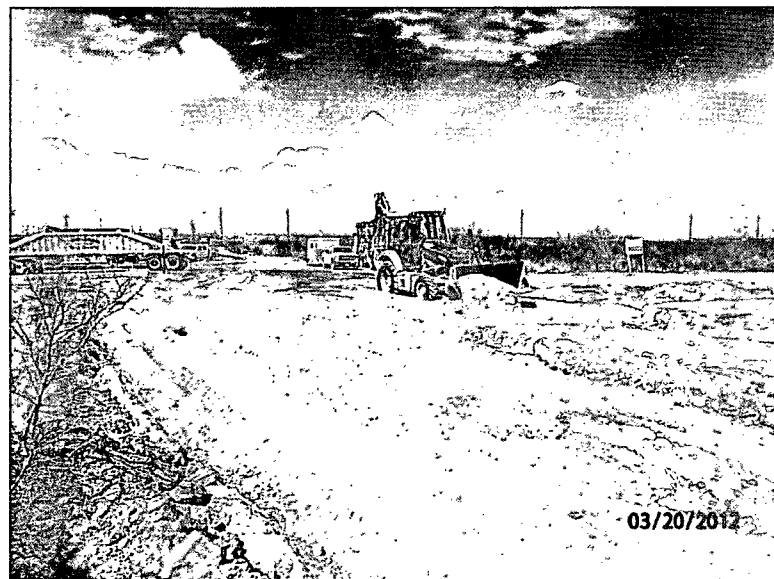
3/20/2012

Backfilling excavation, facing west

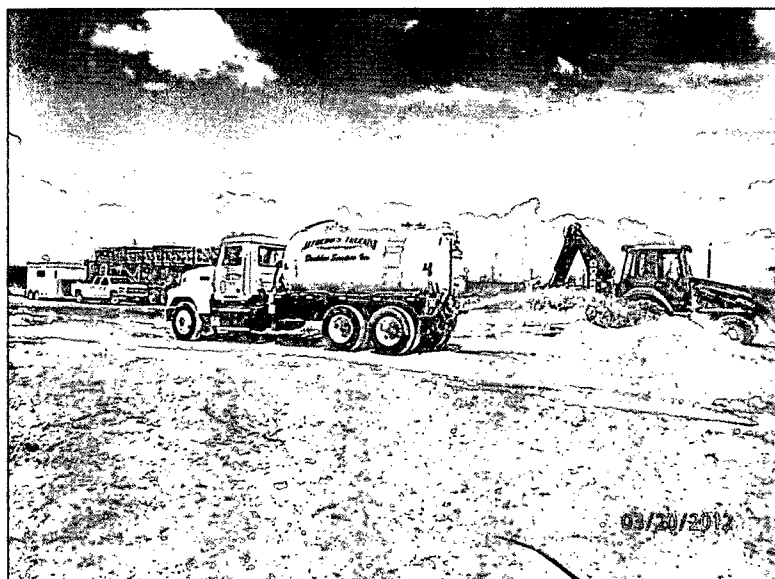
3/20/2012

Applying water to caliche, facing north

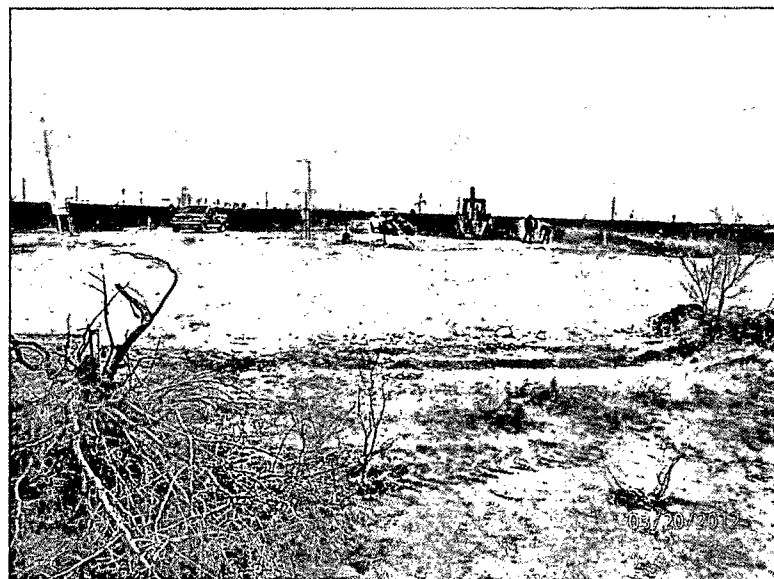
3/20/2012

Site backfilled, facing north
